NYC EDC East New York Industrial Business Zone:
116 Williams Ave, Brooklyn, NY 11207

Building Assessment Report

27 January 2025

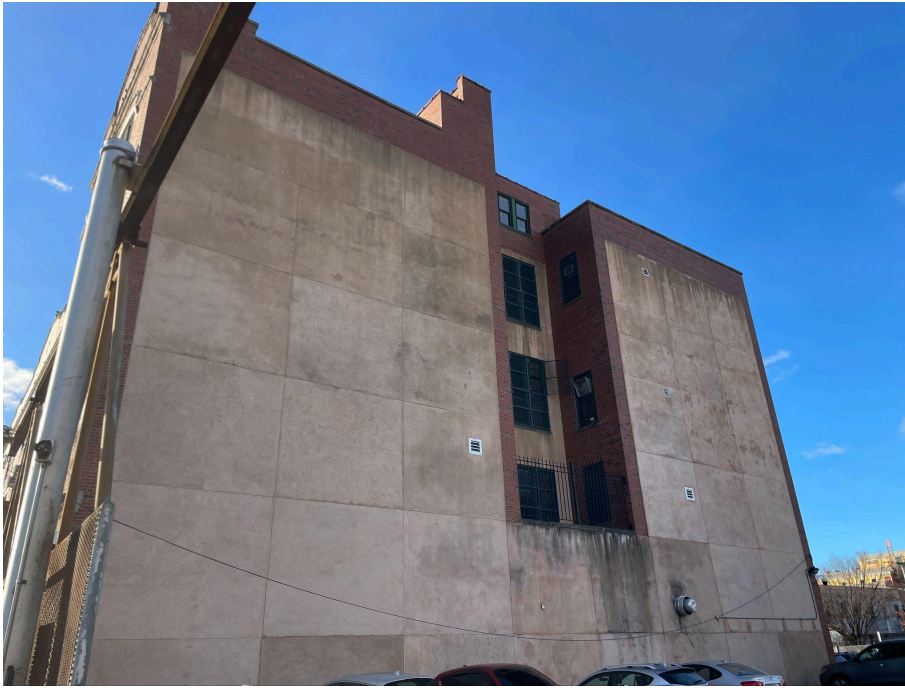
the pitched parapets. On the north facade, stucco panels were installed over the masonry around 2002 (see Appendix B). From the vantage point of the parking area, there appears to be some discoloration, cracking and signs of weathering. There are exhaust louvers and a mushroom exhaust fan located on this facade with exterior lighting that is over the property line. Photos 01, 02, 03, 04, 05, 06, 07, 08, 09, 10, 11.

On the north elevation, the condition of the stucco is less than fair condition with signs of wear and cracking.

Photo 08: South facade with light well above Ground Flr.

Recommendations: Closer inspection of the facades should be performed to identify movement of the facade and water penetrations. This should include all elevations and systems including the parapet at the roof and lightwell. Energy efficiency of the envelope should be taken into account on future renovations to meet updated codes.

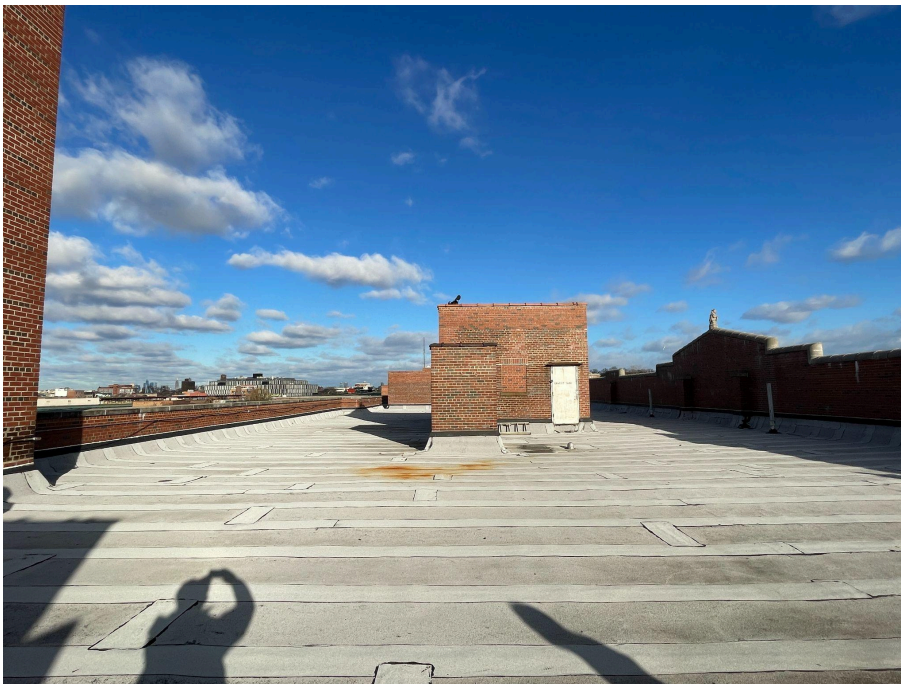
The roof appears to be a modified bitumen roofing with a granulated cap sheet, and assumed rigid insulation pitched to the drains. The roofing was installed multiple years ago with a coved base at all walls with elevated painted flashing and counterflashing (as indicated in the DHS drawing dated 02/23/98 and titled as Building Upgrade Brooklyn Women's Shelter). The condition of the roofing is poor with multiple patches and re-caulking evident in the maintenance over the years and fixing leaks. Some ponding was noted as well and what appears to be loose precast pieces to help divert the water from the scupper downspouts from the roofing of the top of house mechanical structures. Photos 12, 13, 14.

Photo 12: Roofscape looking North

Recommendations: Replacing the roofing system completely with a new roofing product should be considered as part of the renovation for the upper roof.

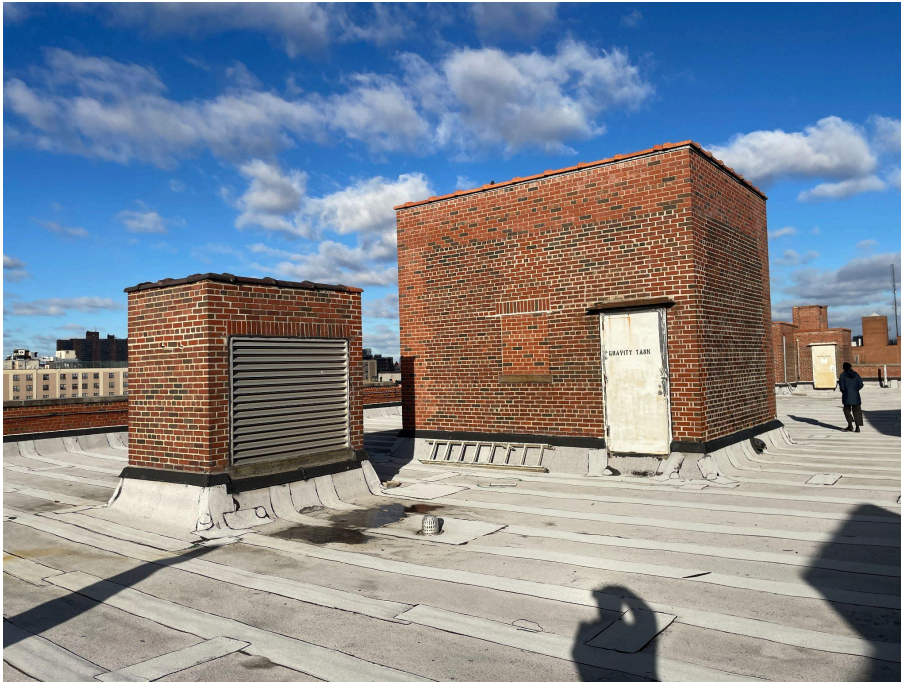
Photo 13: Mechanical structures on roof

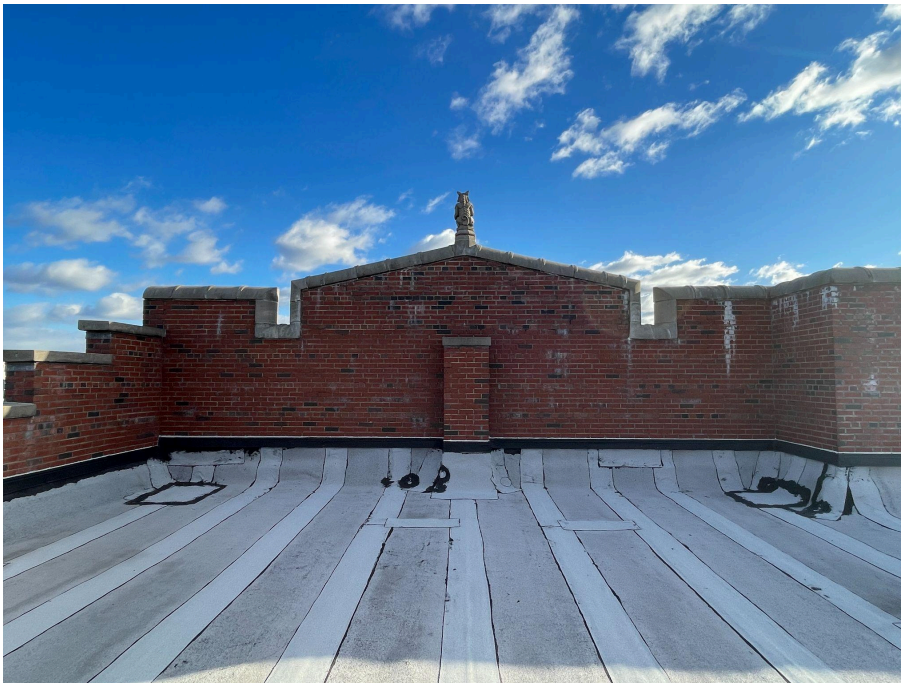
The building has a perimeter parapet consisting of exposed brick/masonry structure with stone coping with gargoyle sculptures at the Williams Ave side, which vary in height up to 9'-0" at the highest. Parapets for the mechanical penthouses and exhaust structures have terracotta coping that appears to have been re-caulked and re-flashed. The perimeter brick wall shows efflorescence and repointing done over the years. The condition of the parapet appears to be in fair condition. Photos 14, 15, 16, 17.

Photo 14: Looking at parapet on Williams Ave with gargoyle in stone

Recommendations: Re-pointing of the parapet walls should be part of the renovation and continued maintenance program to verify structural integrity of the parapet and any water penetrations or damages.

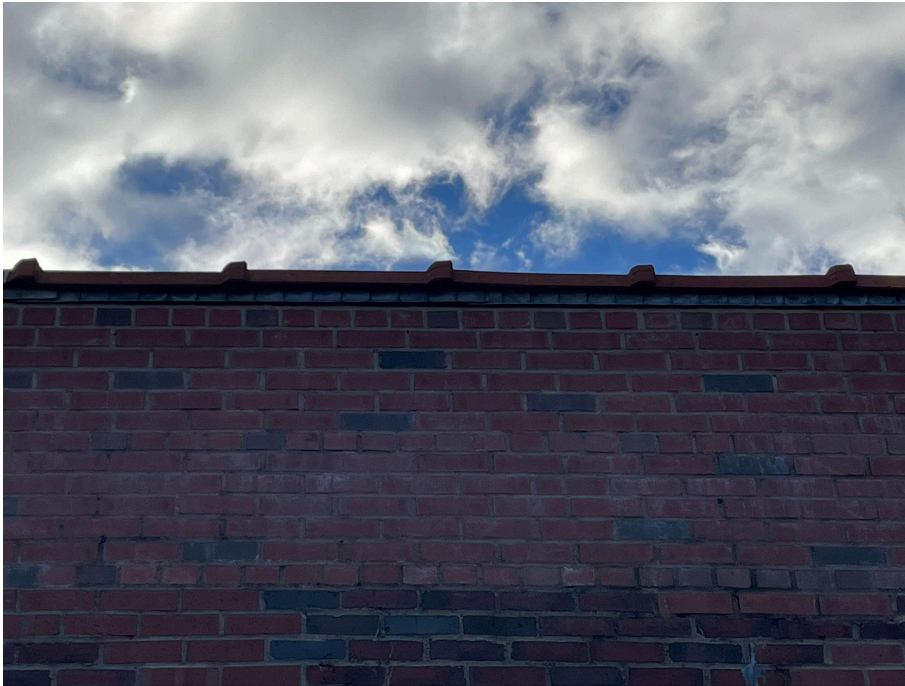
Photo 17: Renovated flashing under terracotta coping and mortar repair

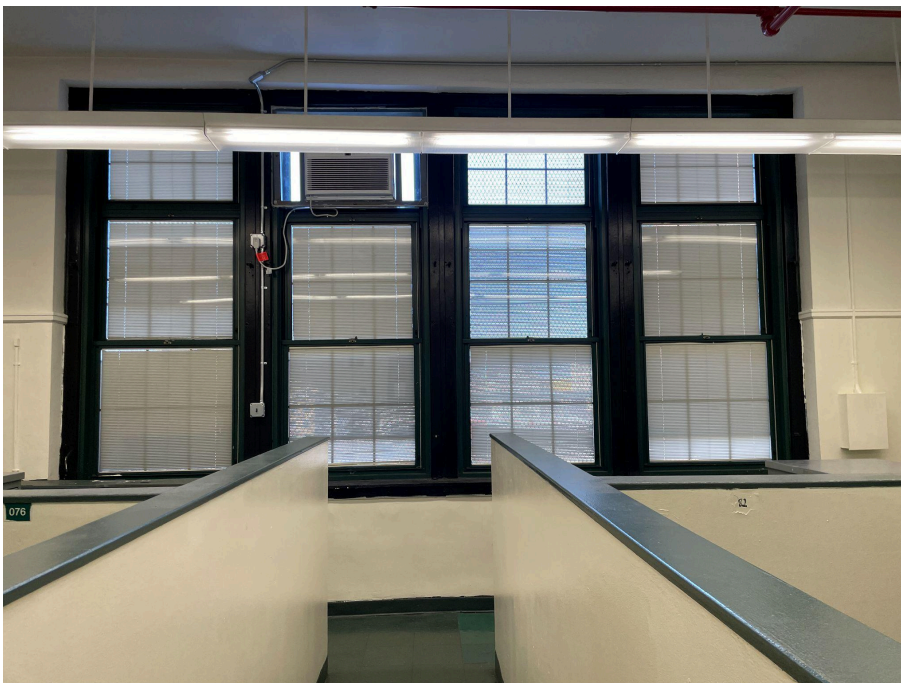
The windows were replaced around 2002 with aluminum windows that are glazed with units that contain integral horizontal blinds between the outer lite and inner lite that can be operated to open and close with a specialized tool. The configuration of the tall windows look to be proportioned to match the original configurations with segments on the bottom as double hung and segments at the top as a hopper, and fixed casement in the middle. On the interior, the caulking around the windows appears in good condition, keeping a good weatherseal. On the exterior, expanded metal mesh guards are installed as operable panels at all the windows. The metal mesh panels have been modified over the years to allow for AC window units to be installed at multiple locations, typically on the upper portion of the windows. Some windows have been modified for exhaust louvers - locations are random. Photos 32, 33, 34.

Photo 32: Typical window from interior

Recommendations: Coordination with new MEP systems will require repairs to the existing windows and replacement of louvers or glazing. Further investigation is required to ascertain air and water tightness of the window system, perimeter seal, and thermal performance.

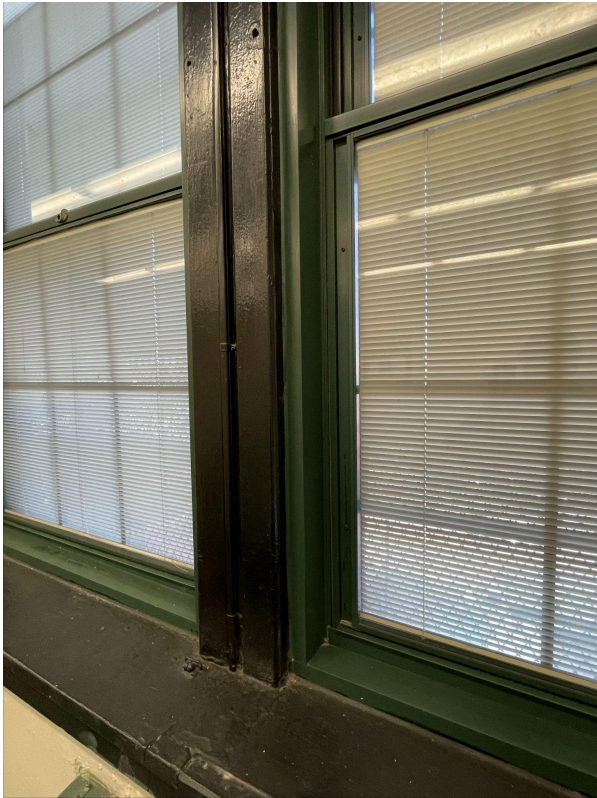
Photo 33: Window details

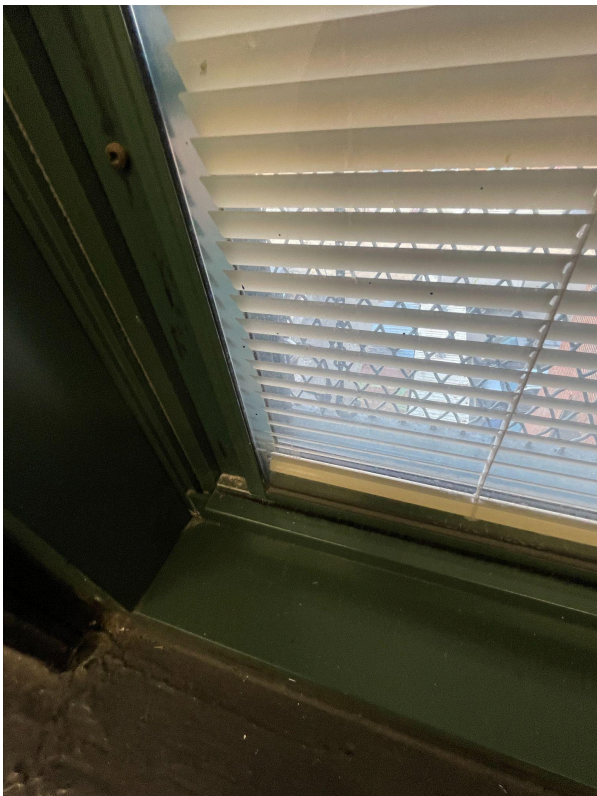
Photo 34: Window details

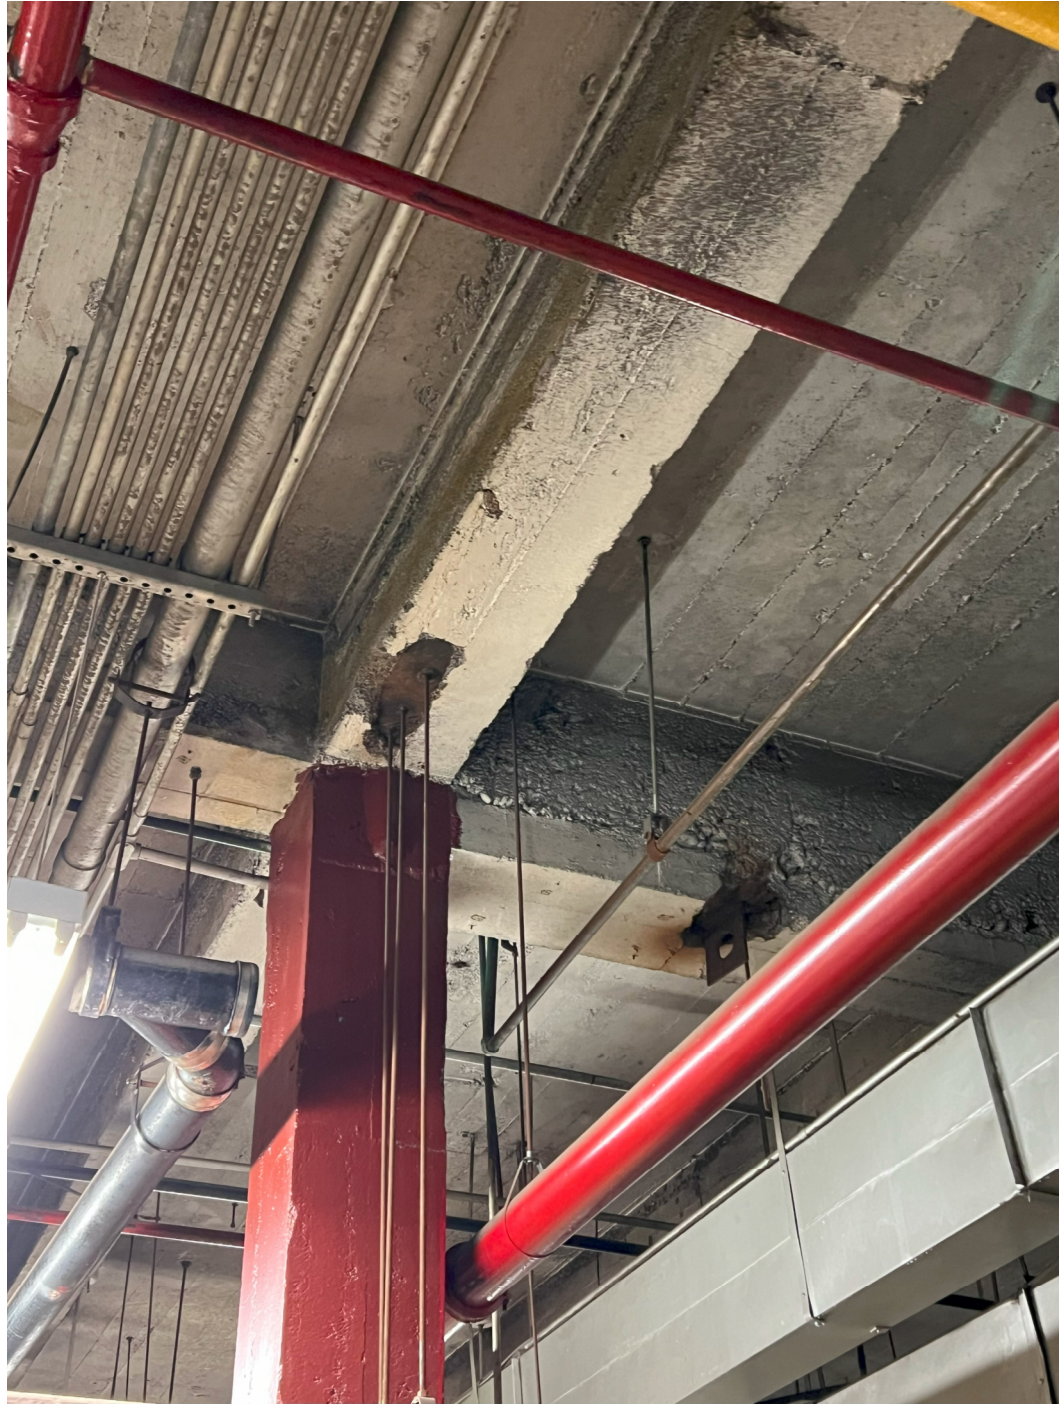
Exposed Steel Beam Soffits at MEP Hangers in Cellar

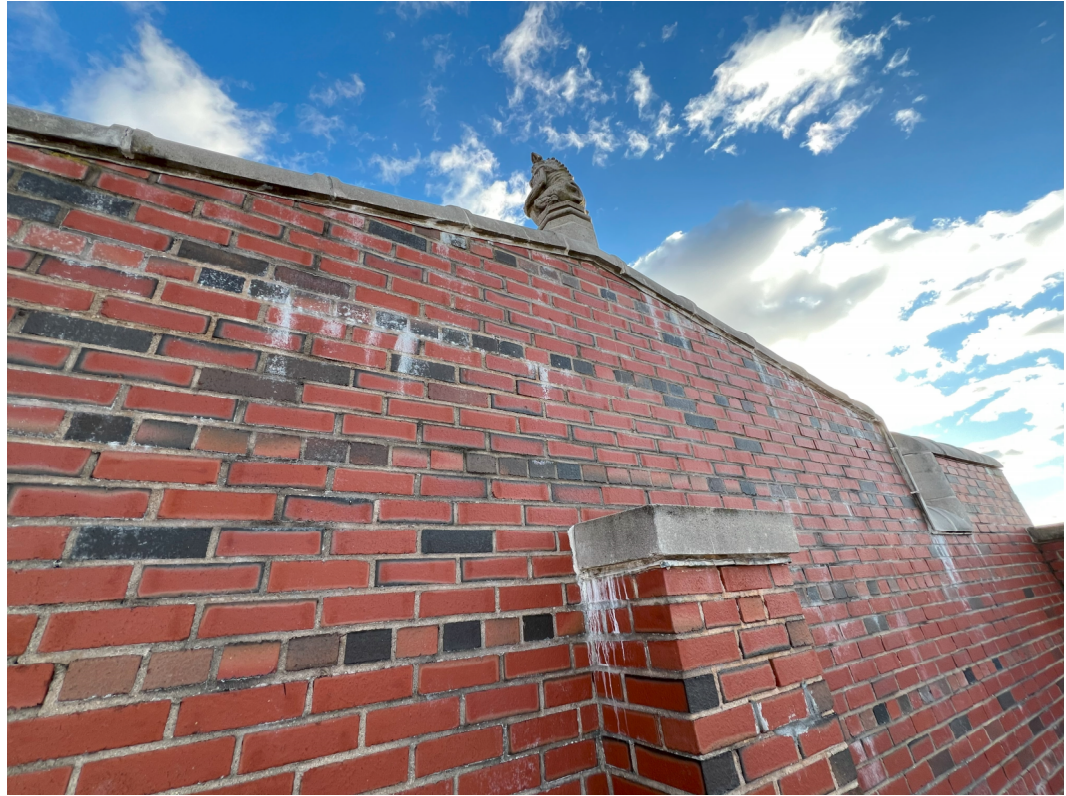
(see photo). The roof perimeter parapets show signs of moisture saturation as well as mortar joint deterioration in some locations (see photo). It is recommended that the exterior brick façade as well as adjacent interior spaces undergo maintenance and repair as part of any planned building use conversion.

Brick Efflorescence and Mortar Deterioration

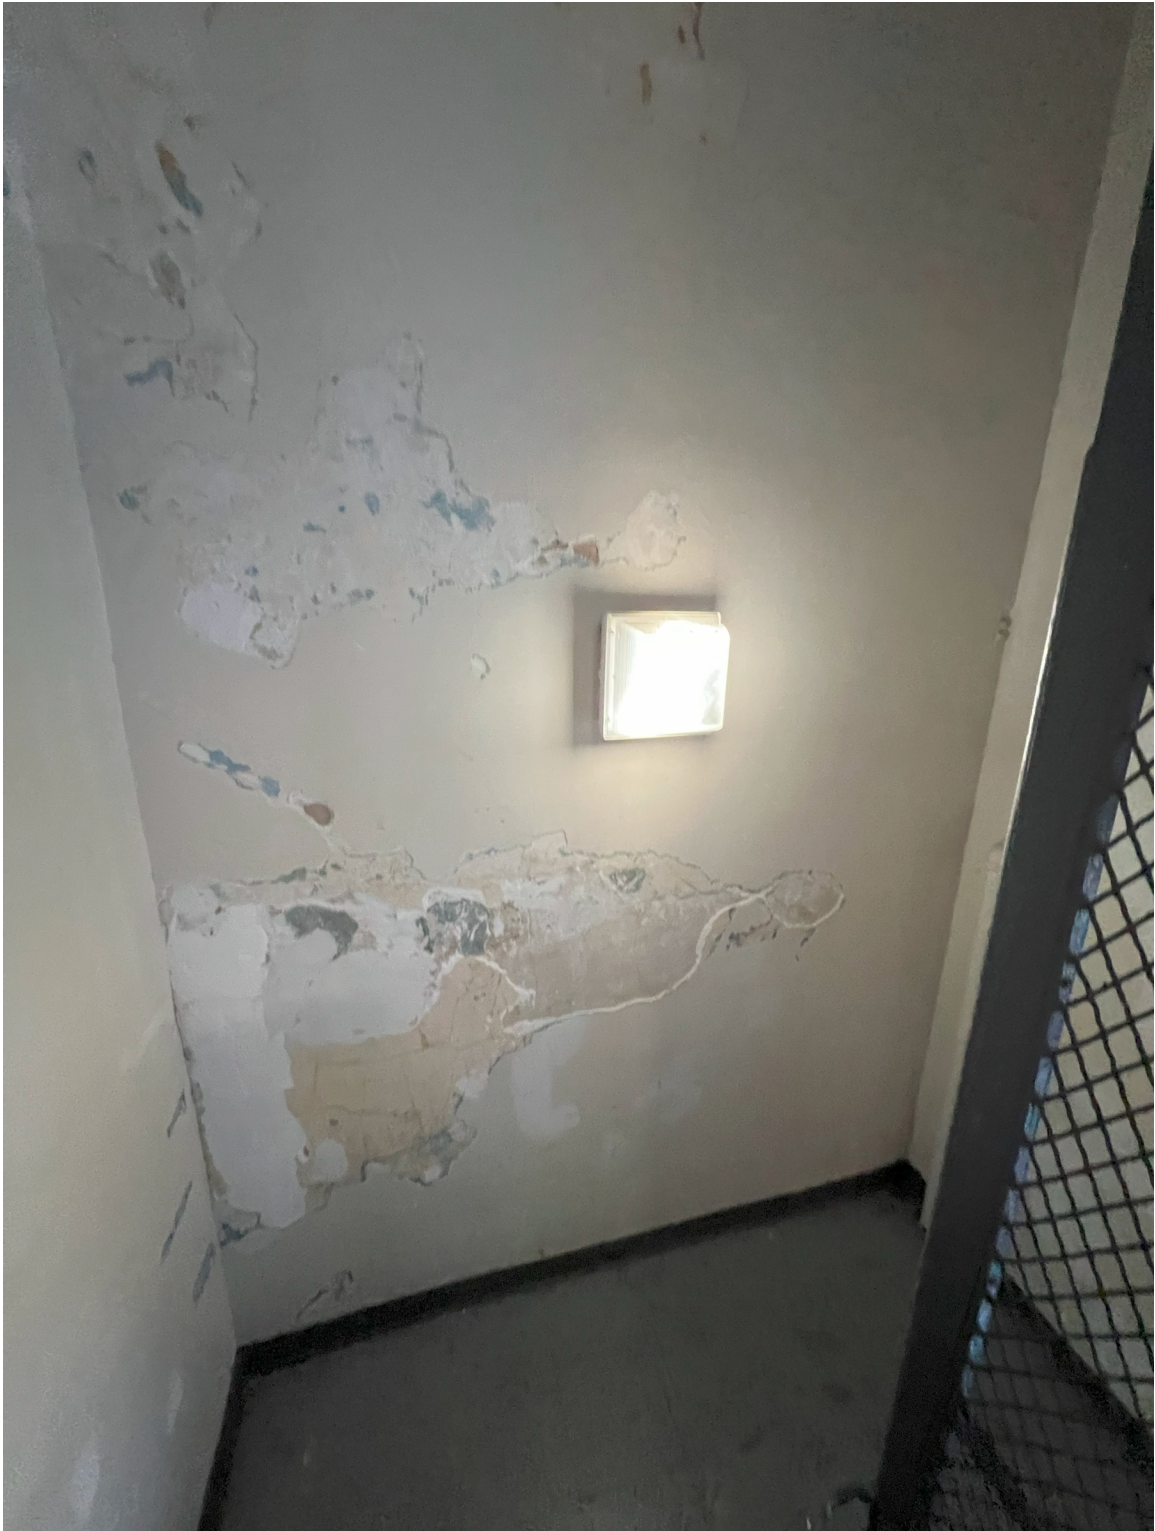
In general, the condition of the observed building structure, both interior encased framing and the exterior masonry, appeared to be in relatively good condition. In some of the stairwells adjacent to the perimeter masonry walls, there are signs of some water and moisture intrusion in the brick as well as concrete encasement

Signs of Previous Moisture Infiltration in Stairwell

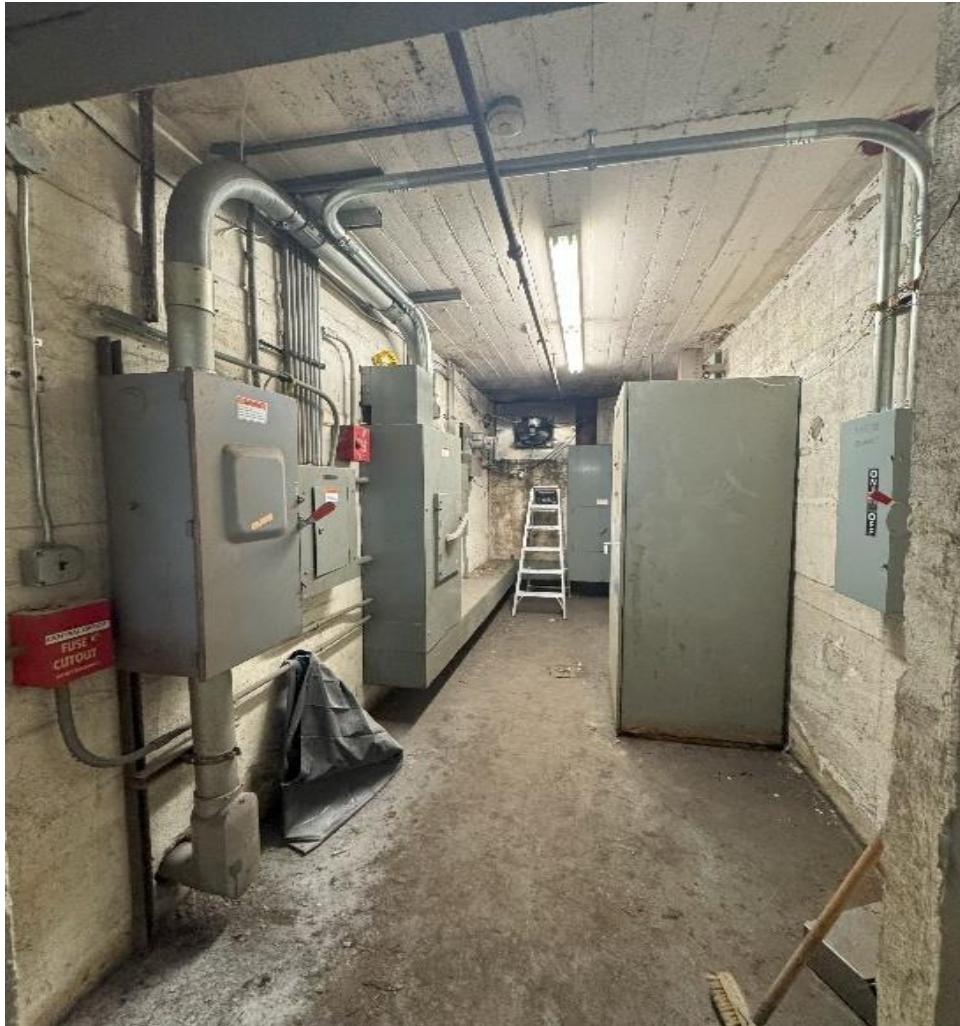
The main Electrical service is 1200A and original to the building, the existing main service board (MSP) is an old Royal Switchboard company. The main panel (MSP) has a Fused Switch of 1200A and serves other Panels within the service room. An old 16Pole Royal Switchboard fused lighting Panel feeds a labelled "24hour Panel" via the MSP. A labelled "Exit light cutout Panel" is also fed from MSP. There is also a 12 pole Main Lugs Only lighting panel labelled "clock terminal Cabinet" fed from the MSP. A New 200A fused switch feeds unknown loads on the fourth floor. A painted red 2000A bolted pressure switch has a service tap that feeds the Fire Pump. There is an old 1200A Automatic Transfer Switch within the service room that is abandoned.

Existing Electrical Service Room

The existing MDP, 208V, 3-Phase, 4-Wire 1200 ampere electrical infrastructure is sized for a warehouse type occupancy with partial office building fit-out undetermined programming. The existing panels located in the corridor and Electrical Service Room have met their useful life. These panels should be replaced in kind with megger tested feeders prior to reconnecting to new replacement panels. The panel replacement and new upgraded service will be based on the facility's final use.

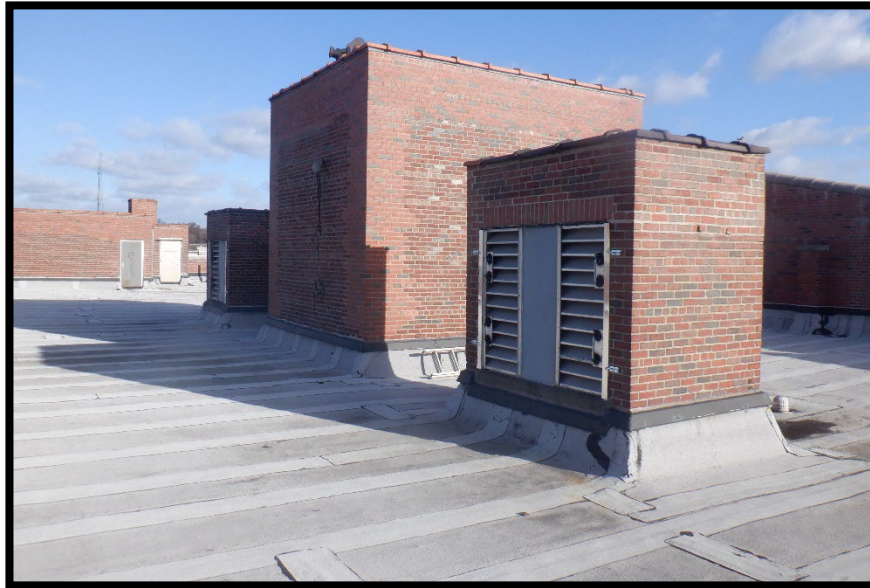
Photo #1: Suspect ACM roofing, flashing, coping stone mastic

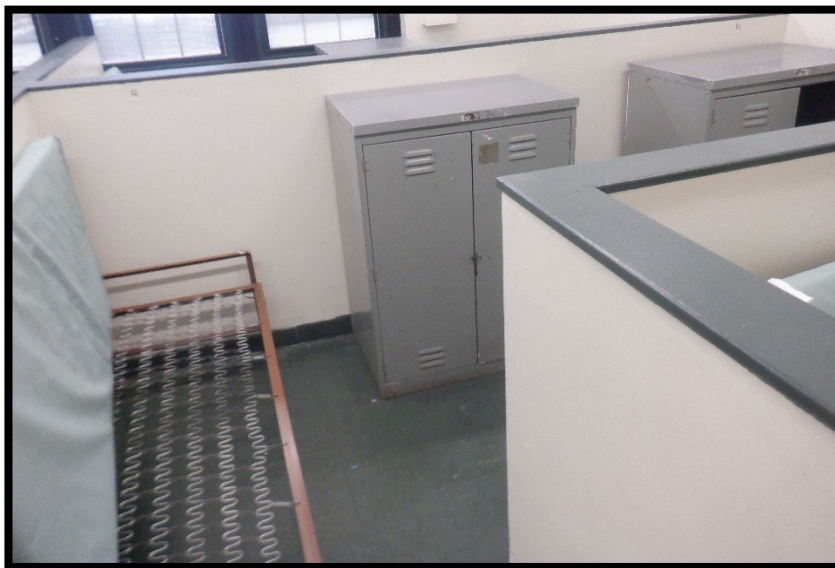
Photo #6: Suspect Sheetrock/Joint Compound, Carpet Glue

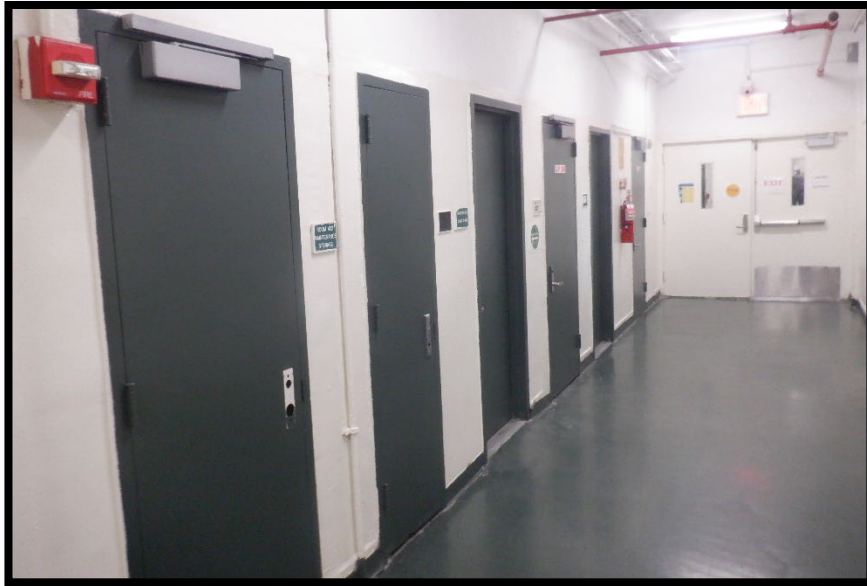
Photo #7: Suspect ACM Flooring and Door Core Insulation
