Project #11750  
Addendum #3  
Date 9/18/26

**TABLE E-1**  
**SUMMARY OF THE OVERALL CONDITION RATINGS AND COSTS**  
**AT HUNTS POINT CORRECTIONS BULKHEAD AND VERNON C. BAINE**  
**CORRECTIONS CENTER FLOATING DETENTION BARGE**

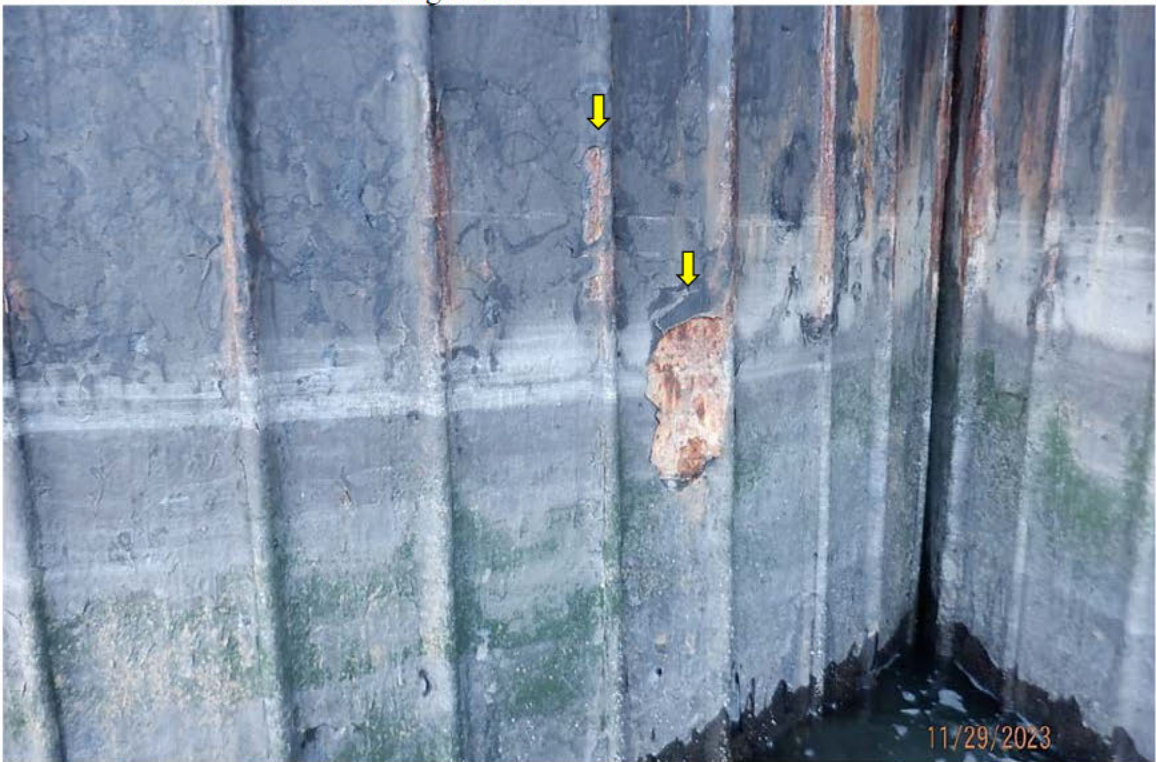
**Photo 3.1-3:** Example of coating failure in the tidal and splash zones above MHW. Note the interlocking joint knuckles typically exhibit coating failure.

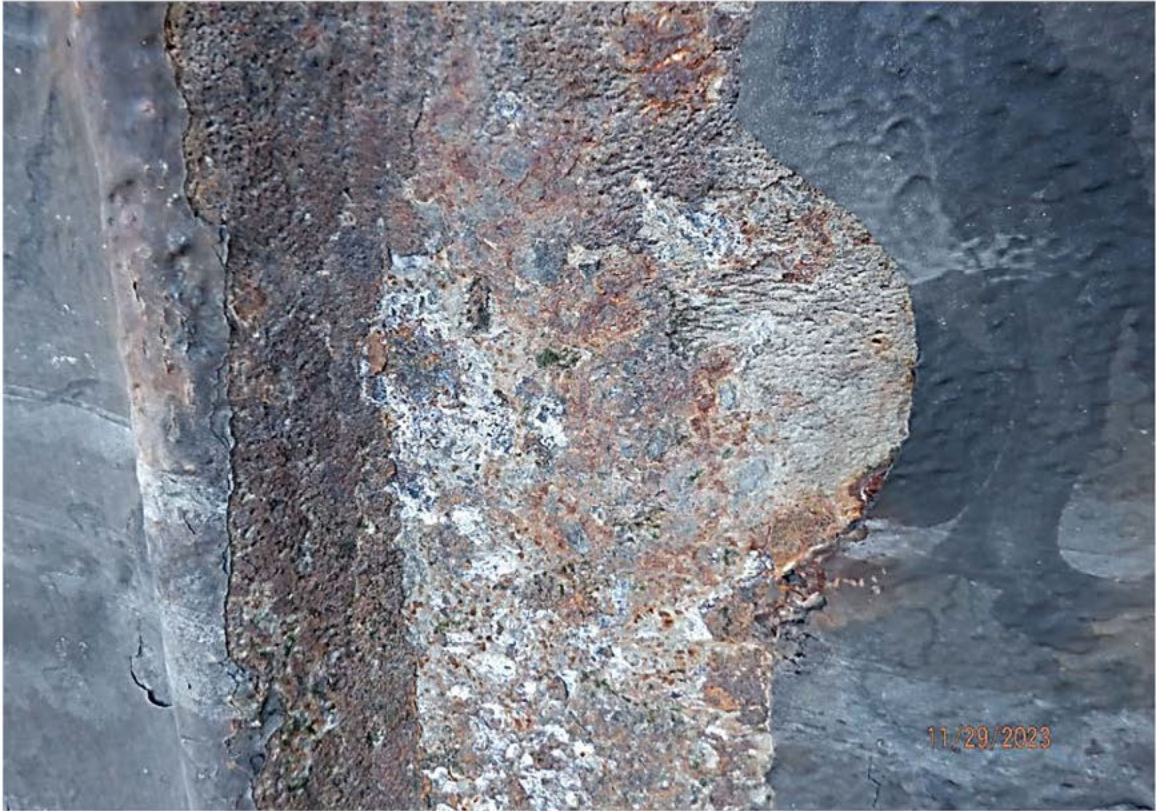
**Photo 3.1-4:** Closeup view of minor corrosion and pitting where the coating is failed.

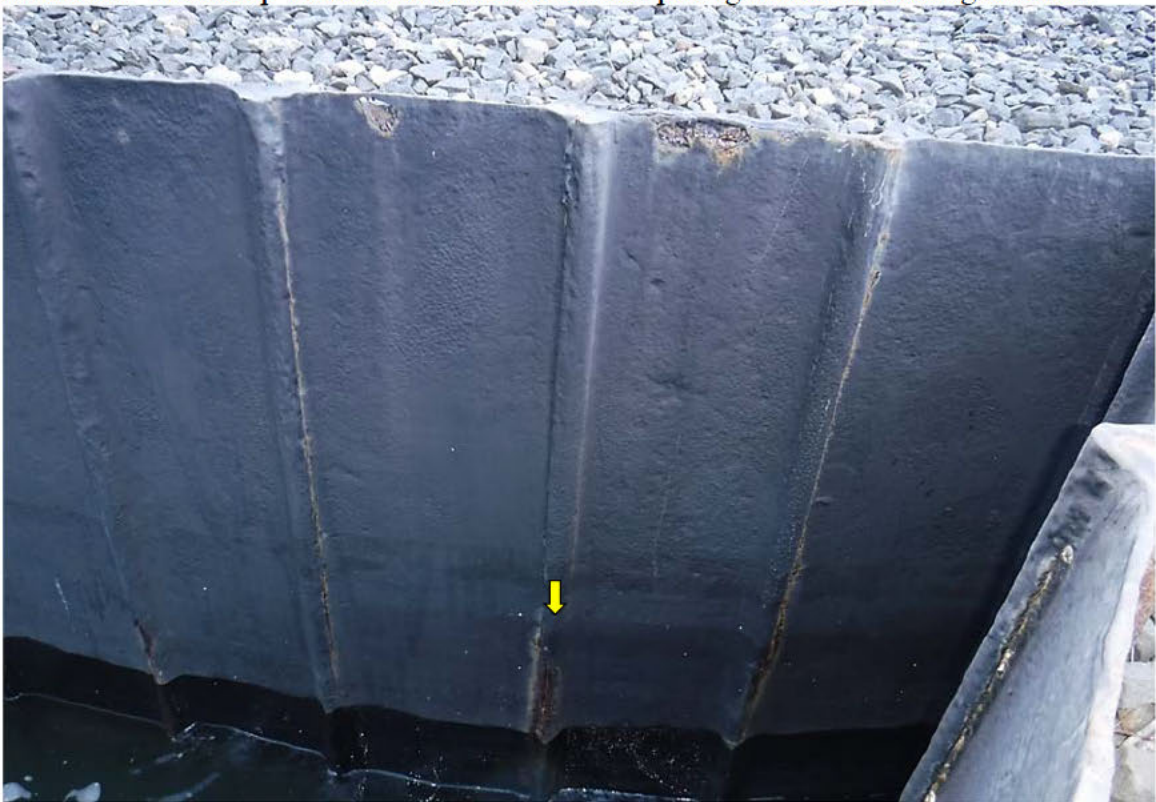
**Photo 3.1-5:** Typical coating failure on interlocking joints in the tidal zone. Note the previously pitted steel below the coating.

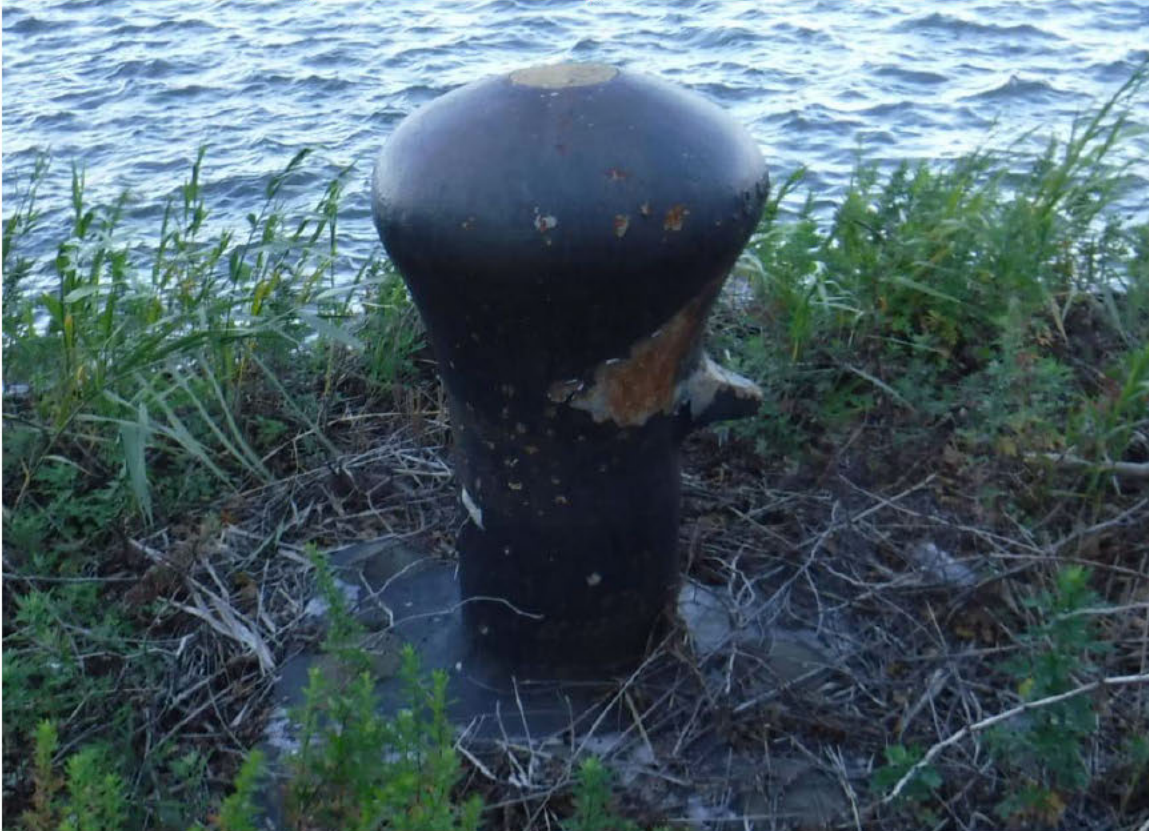
**Photo 3.1-6:** Bollard B-1 is inaccessible due to the security fence. Note the typical minor coating loss and surface rust.

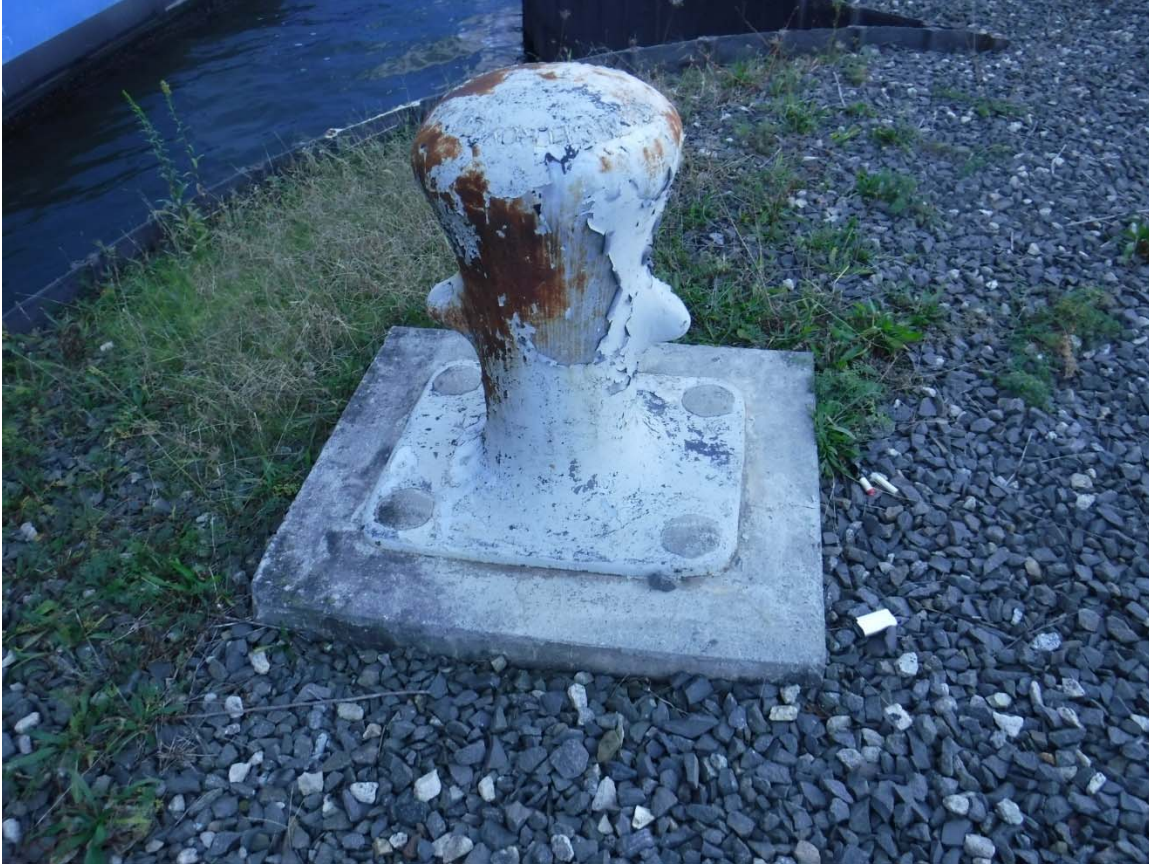
**Photo 3.1-7:** Bollard B-2 exhibits typical minor coating loss with surface rust. Note the anchor bolt pockets are filled.

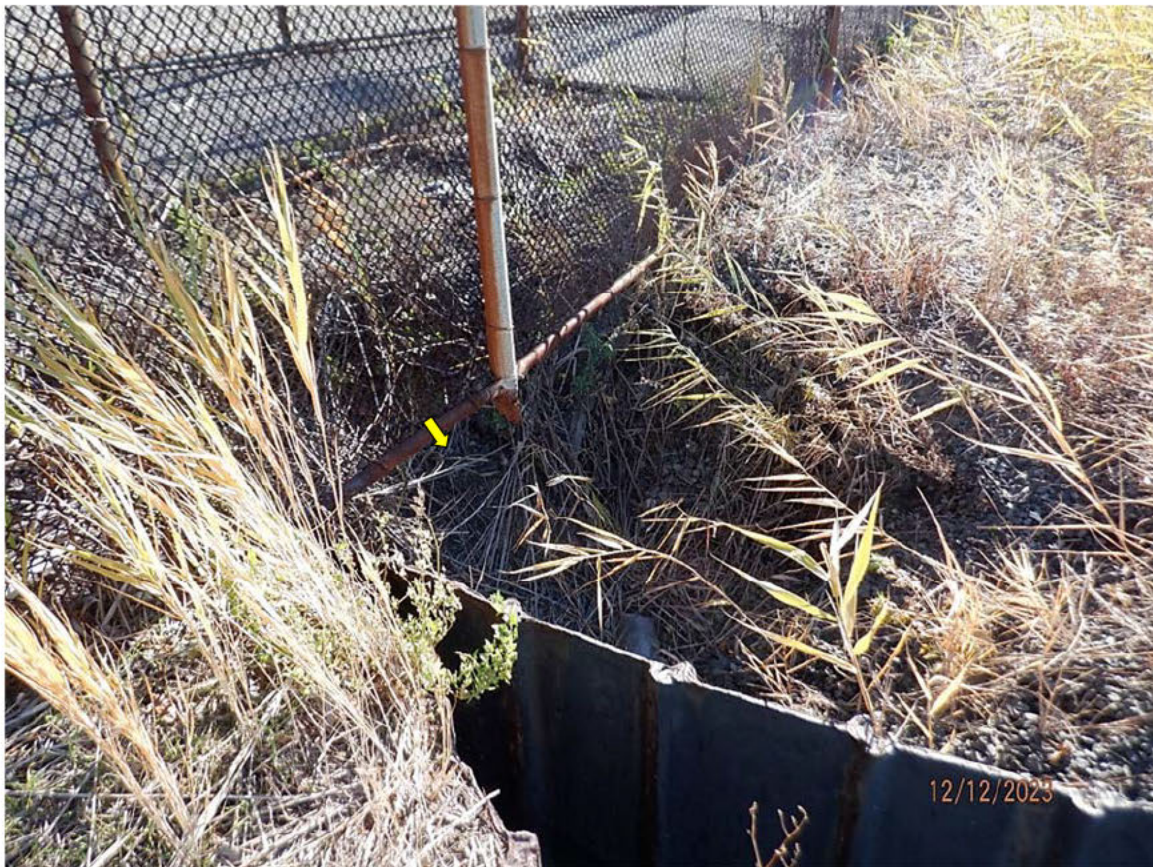
**Photo 3.1-8:** Sinkhole at the north side of Cell 24, approximately Sta. 0+40.

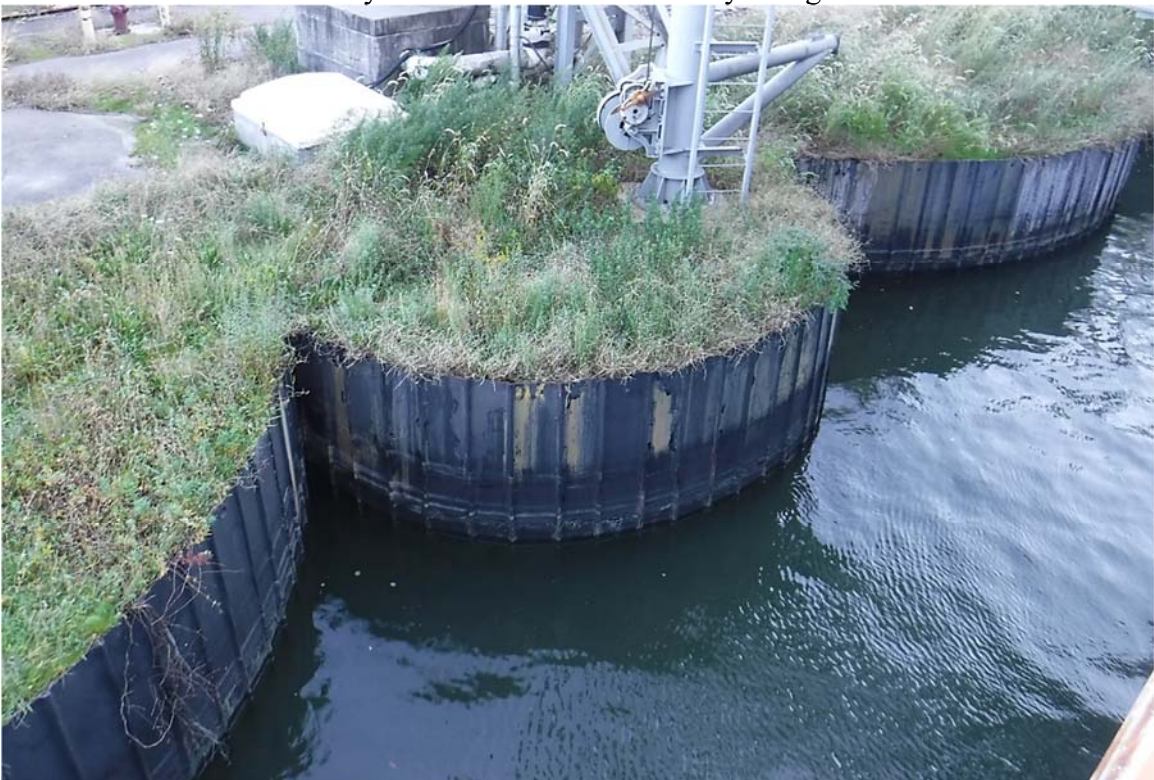
**Photo 3.1-14:** Typical excessive vegetation and overgrowth as shown at Cell 6.

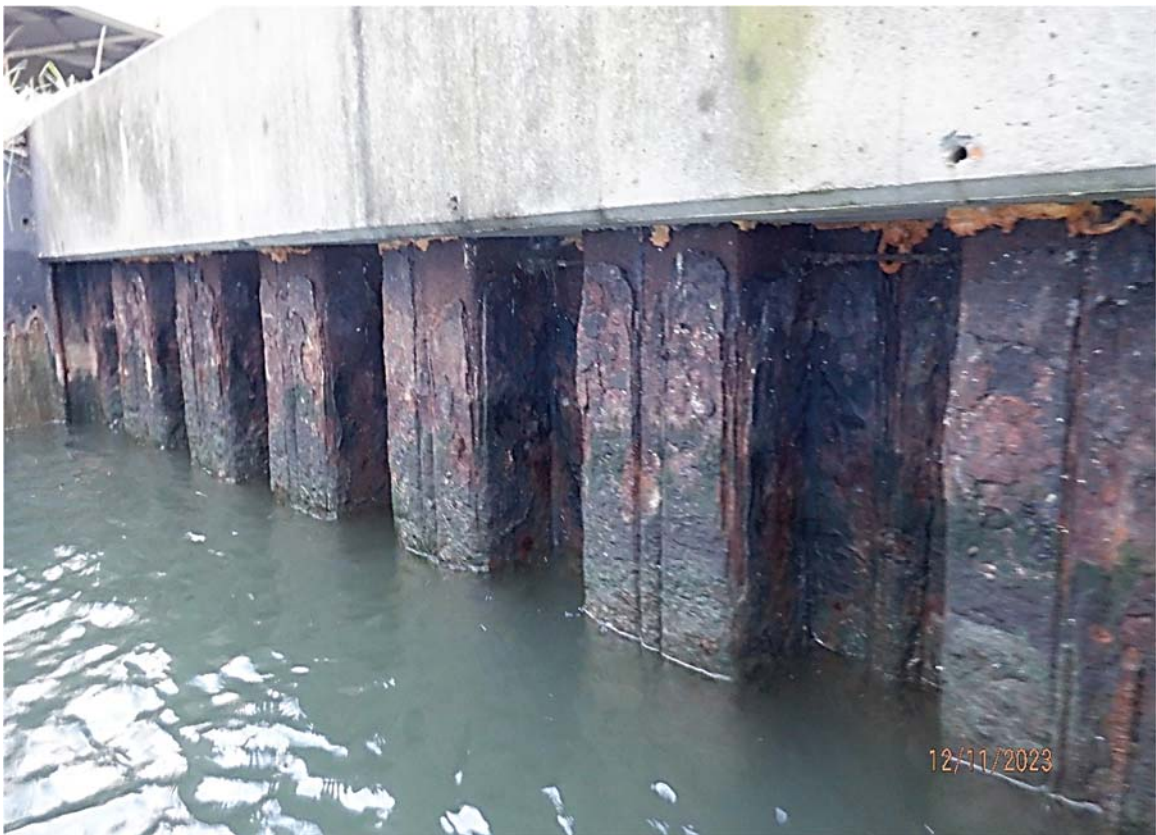
**Photo 3.2-2:** Closeup view of the moderate to advanced corrosion of the sheet piles in the splash zone above MHW.

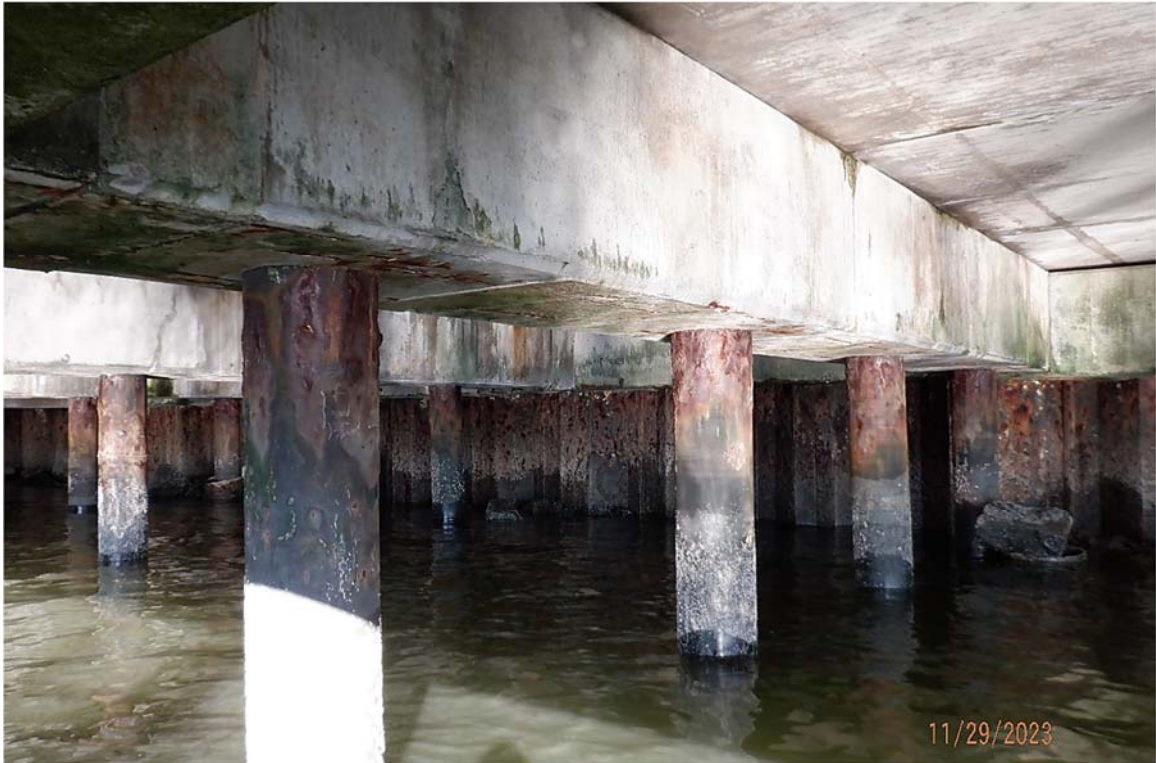
**Photo 3.3-1:** Typical condition of the steel pipe piles in the tidal and splash zones.

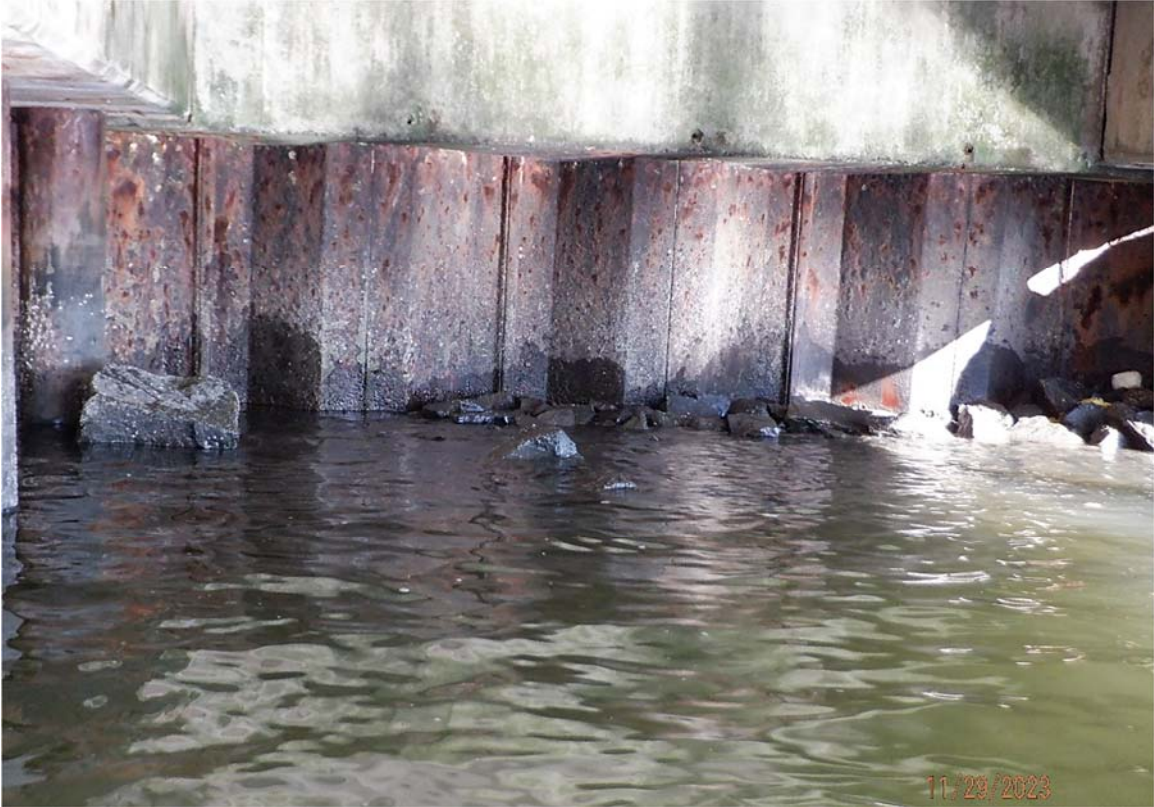
**Photo 3.3-6:** Typical coating loss and corrosion of the sheet pile cut-off wall in the splash zone.

| Action Type | Description | Implementation Date | Total Cost (2024 USD) |
|---|---|---|---|
| | Clean and recoat the steel sheet pile cut-off wall above the riprap and patch the corrosion holes at the strut penetrations. | FY 2027 | \$345,481 |

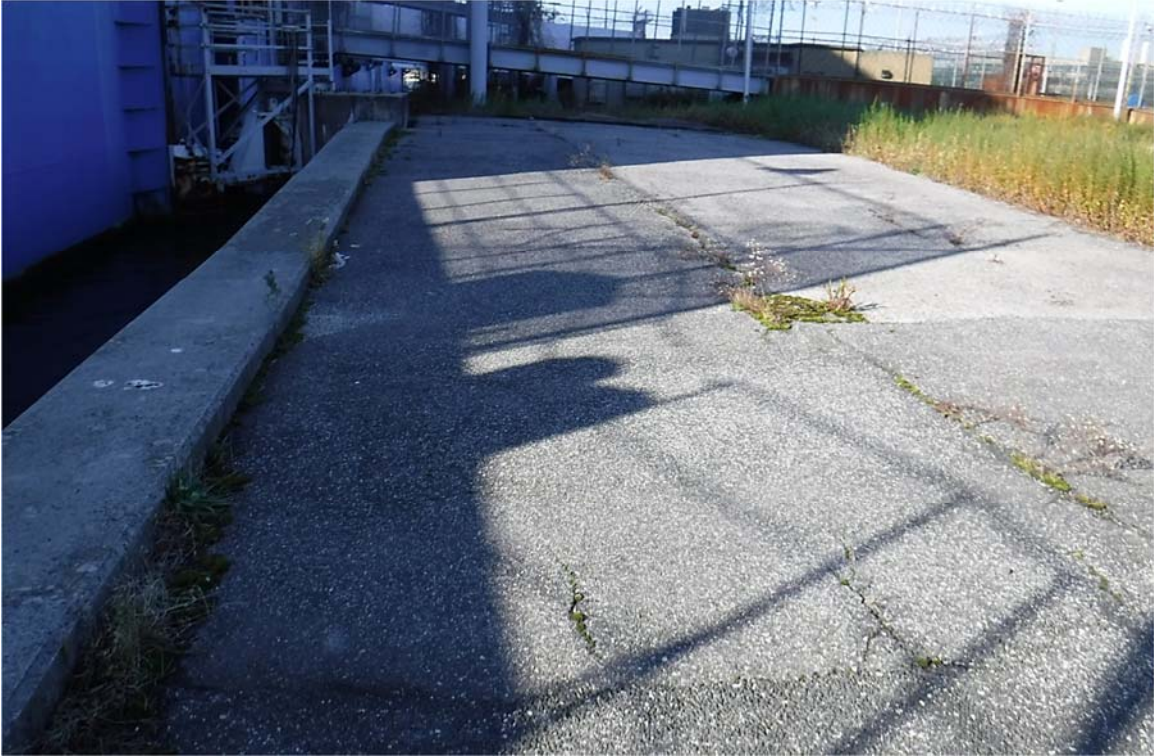
**Photo 3.3-8:** Overall view of the topside looking west. The pavement contains multiple cracks, excessive weathering, and the surface is uneven.

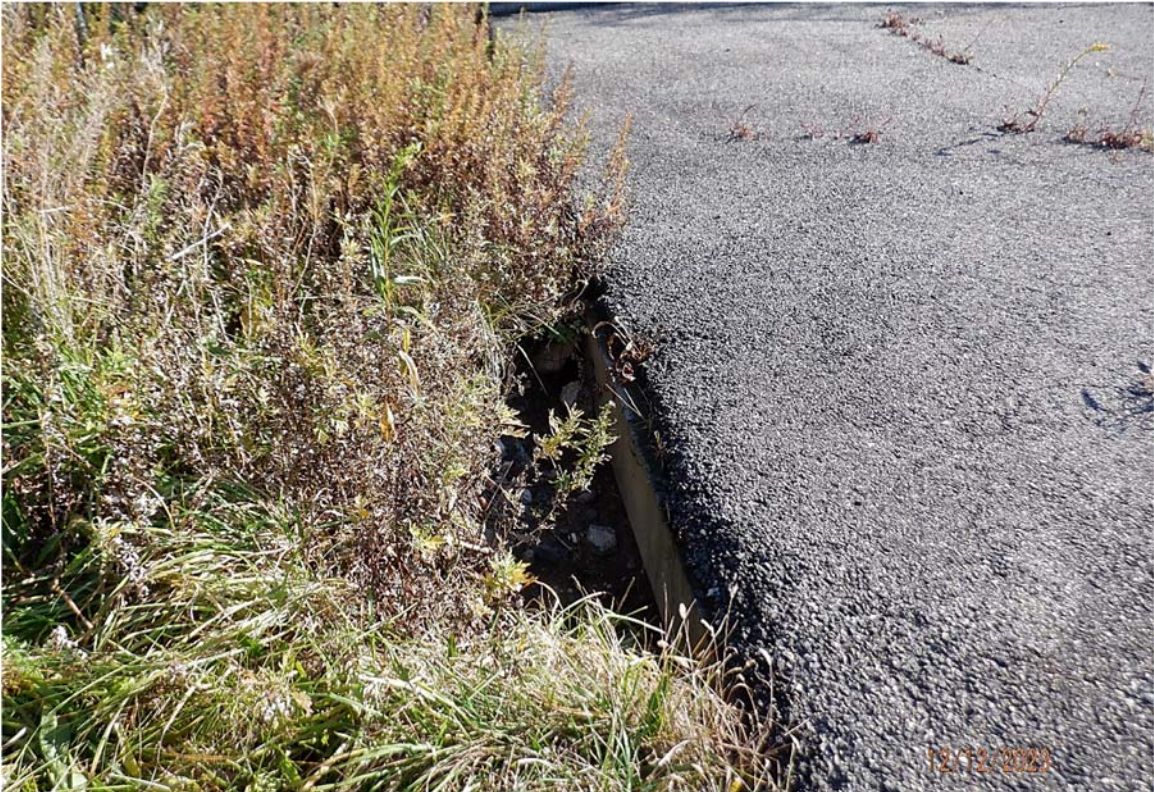
**Photo 3.3-9:** Sinkhole between Bents 1 and 3, approximately 18 in. deep.

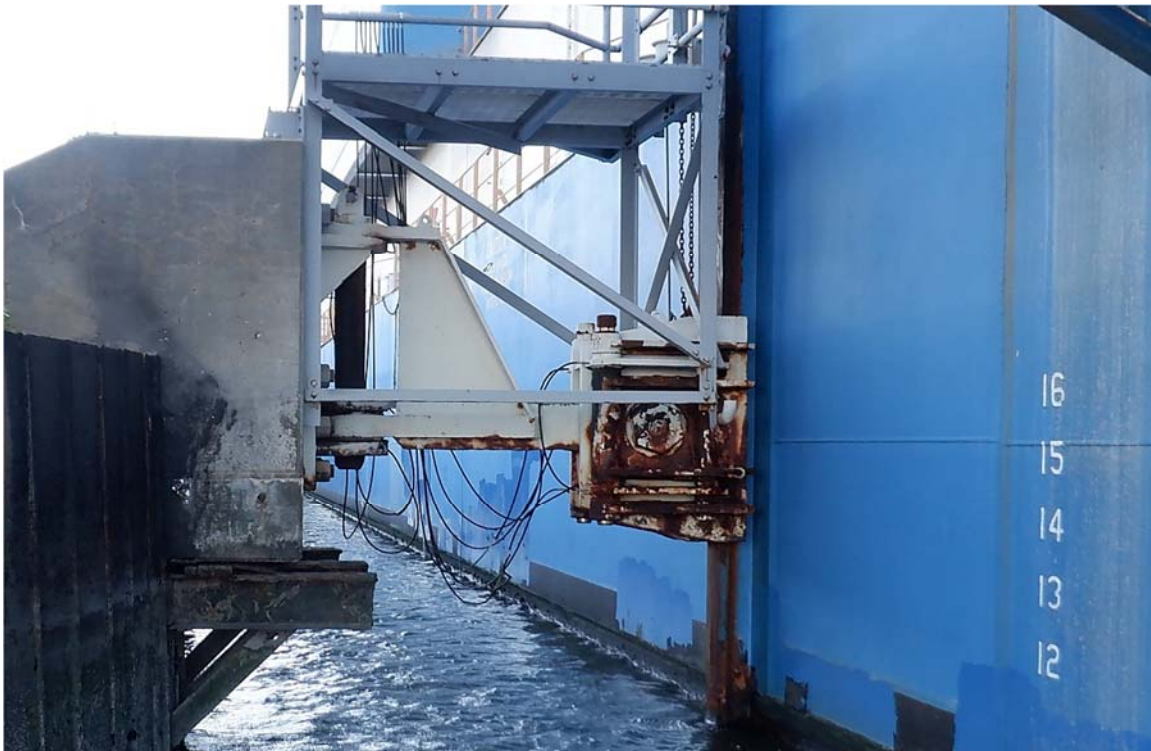
**Photo 3.4-1:** West elevation view of the single-leg mooring arm assembly. Note the coating loss and corrosion on the gripper clamps, leg, and T-guides.

| Action Type | Description | Implementation Date | Total Cost (2024 USD) |
|---|---|---|---|
| Priority | Clean and coat corroded steel components comprising the Crandal Mooring Arm Assembly. | FY 2026 | \$34,425 |

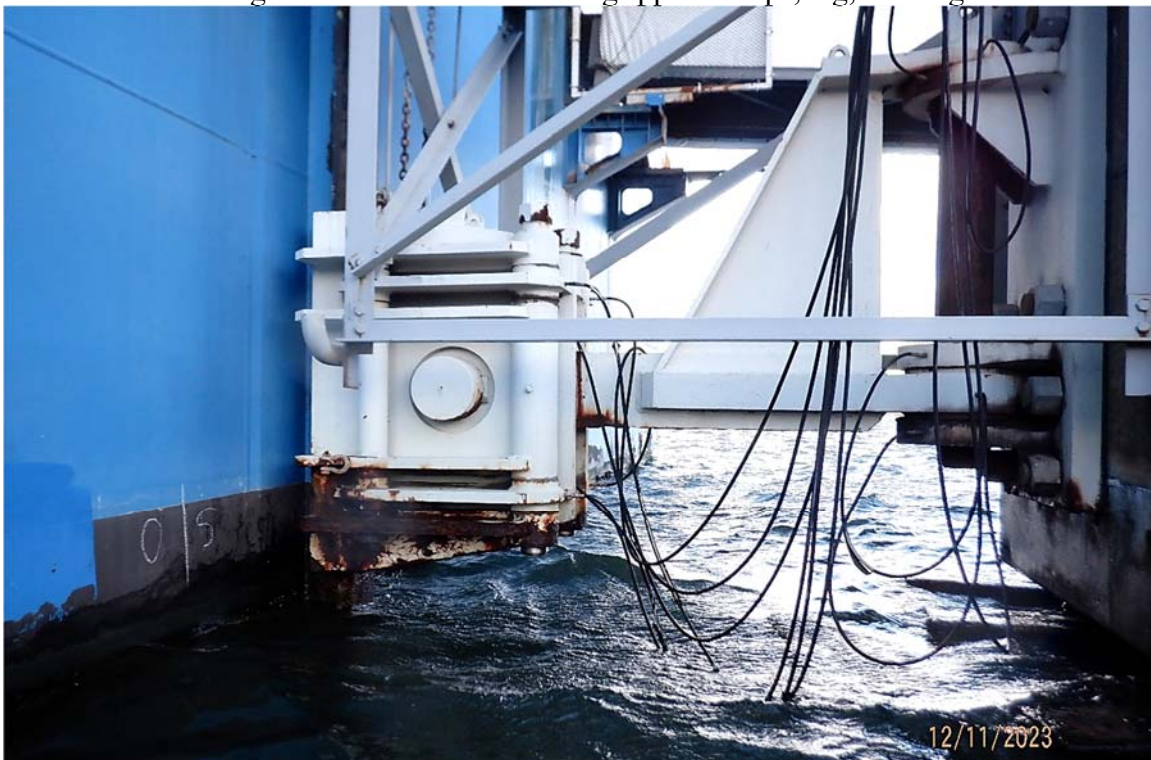
**Photo 3.4-2:** East elevation view of the single-leg mooring arm assembly. Note the coating loss and corrosion on the gripper clamps and anchor plate. Also note the grease fitting hoses hanging into the water.

| Action Type | Description | Implementation Date | Total Cost (2024 USD) |
|---|---|---|---|
| Routine | Verify Crandall Arm parts are adequately lubricated using the grease fittings and employ regular maintenance per the O&M manual recommendations | N/A | N/A |

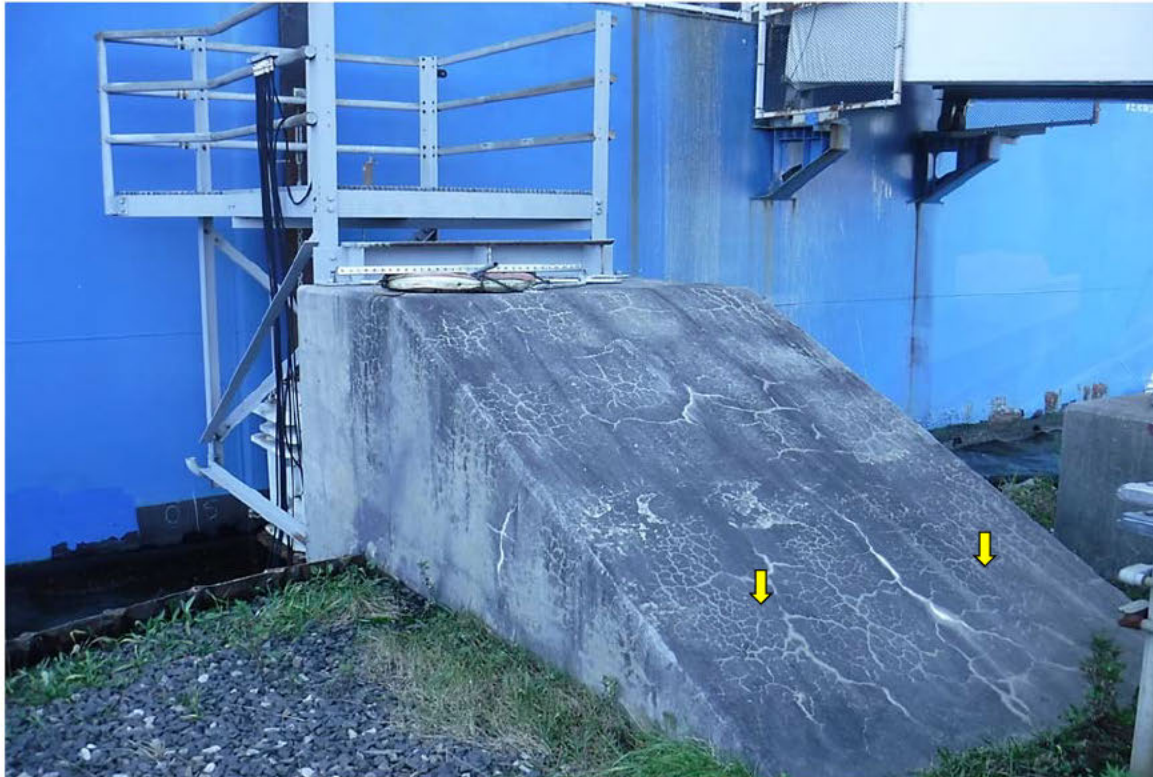
**Photo 3.4-3:** Overall view of the concrete support cap at the West Mooring Arm. Hollow sounding concrete exists where indicated by the yellow arrow.

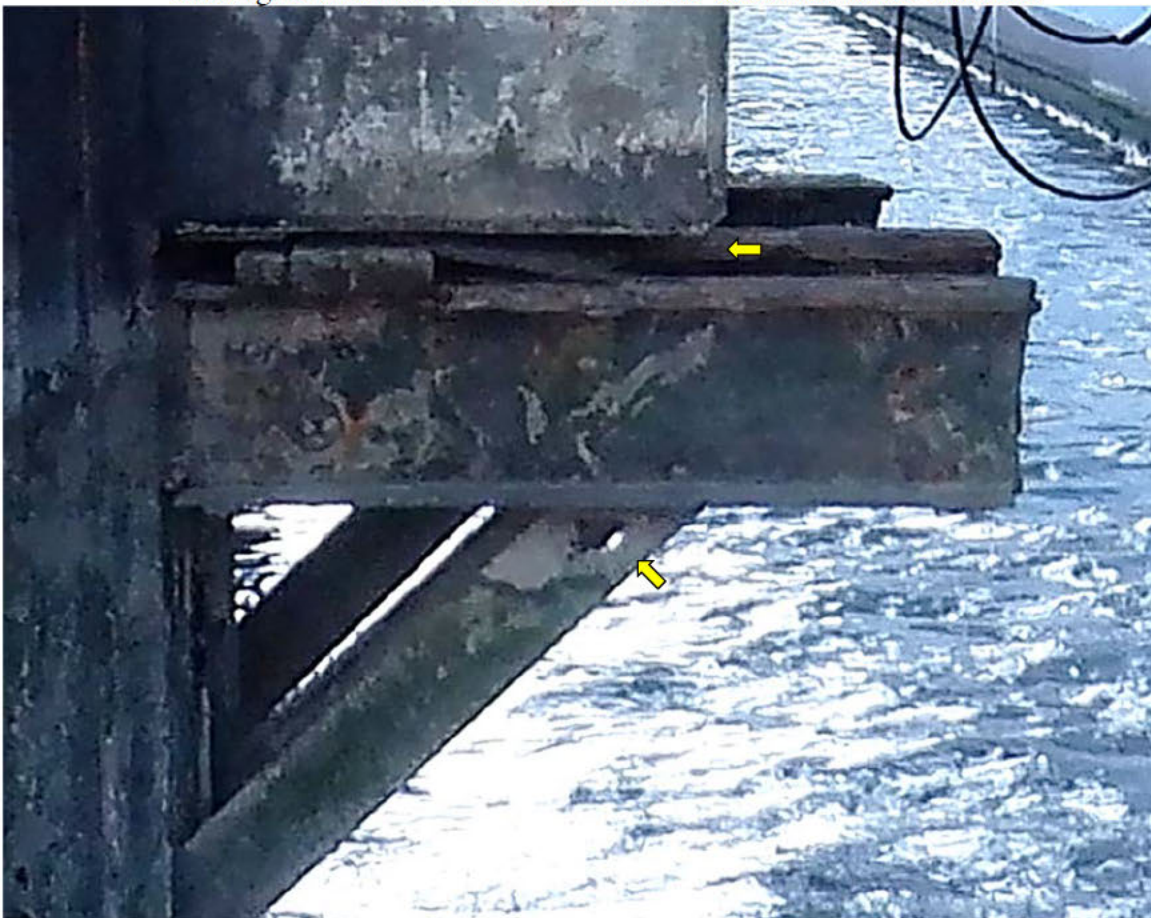
**Photo 3.4-5:** Closeup view of the corrosion hole in the western knee brace. Also note the gap between the top of the bracket and the underside of the support cap.

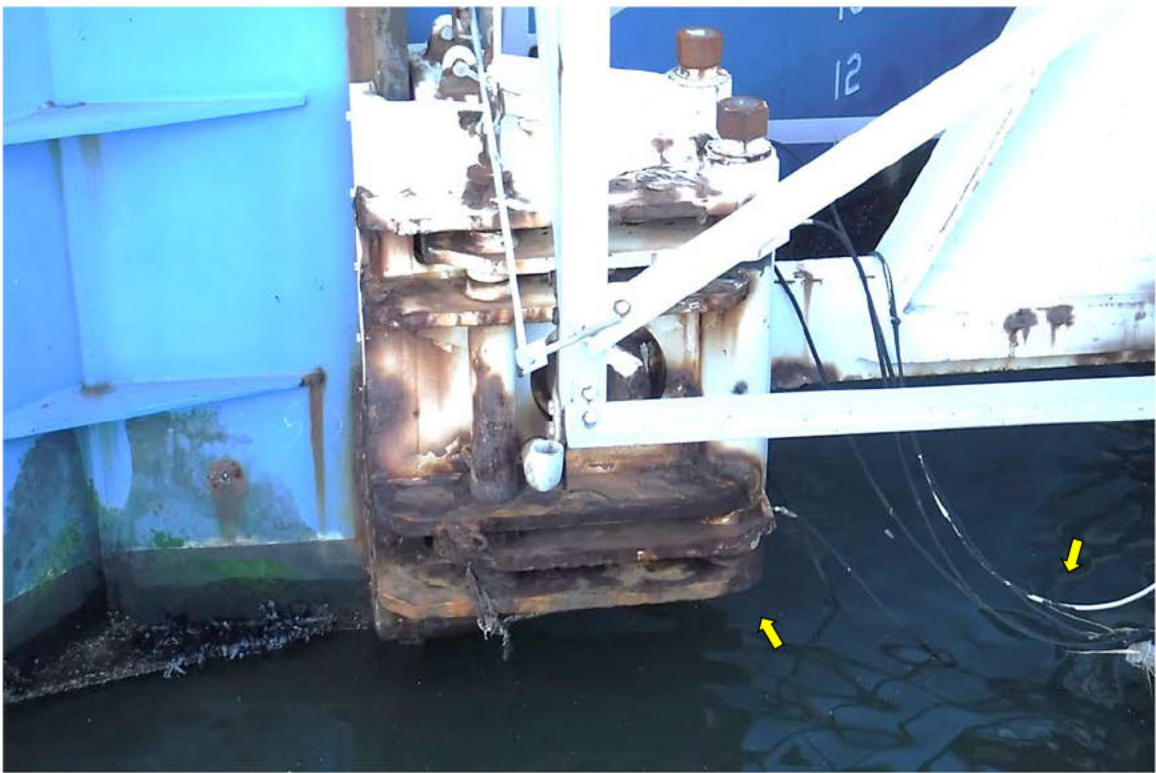
**Photo 3.5-2:** Closeup view of the east leg of the East Mooring Arm. Note the coating loss and corrosion of the assemblies immediately above the waterline. Also note the dangles grease hoses.

| Action Type | Description | Implementation Date | Total Cost (2024 USD) |
|---|---|---|---|
| Priority | Clean and coat corroded steel components comprising the Crandal Mooring Arm Assembly. | FY 2026 | \$33,822 |

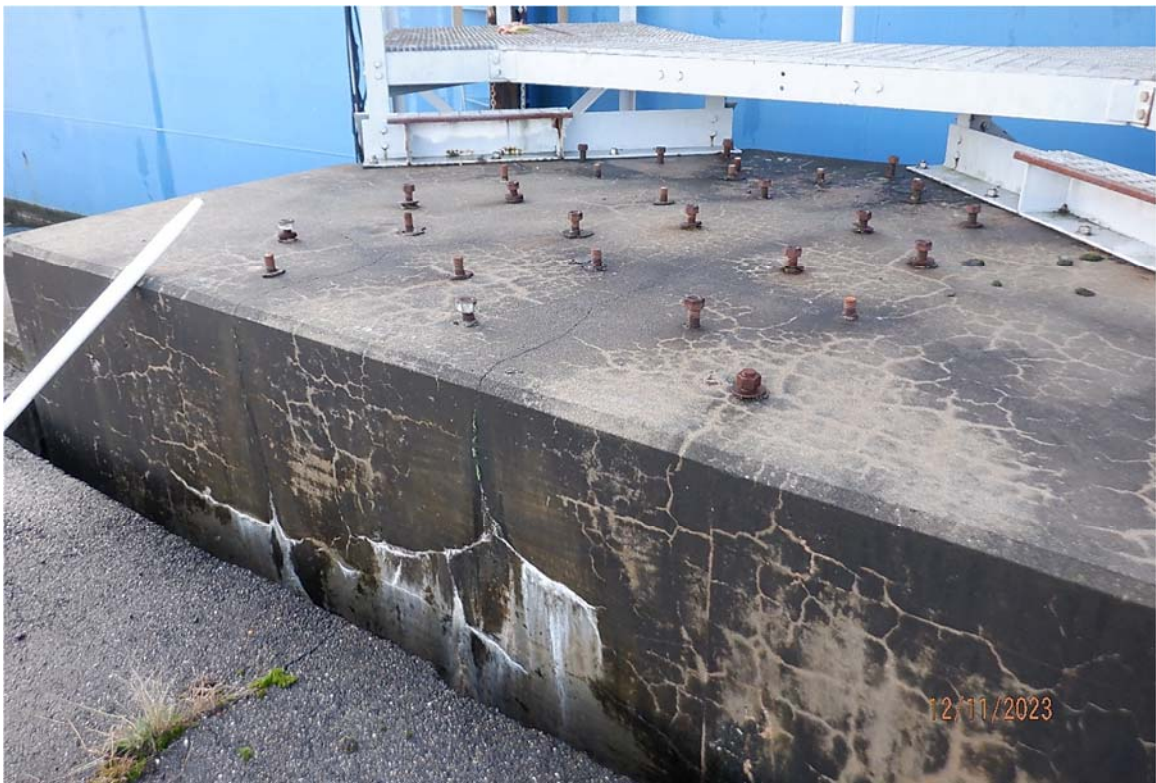
**Photo 3.5-5:** General view of cracks with efflorescence on the top face of the cap varying in width from general hairline map cracks up to 1/16".

| Action Type | Description | Implementation Date | Total Cost (2024 USD) |
|---|---|---|---|
| | Inject cracks in the concrete pile cap with an epoxy grout. | FY 2026 | \$53,924 |

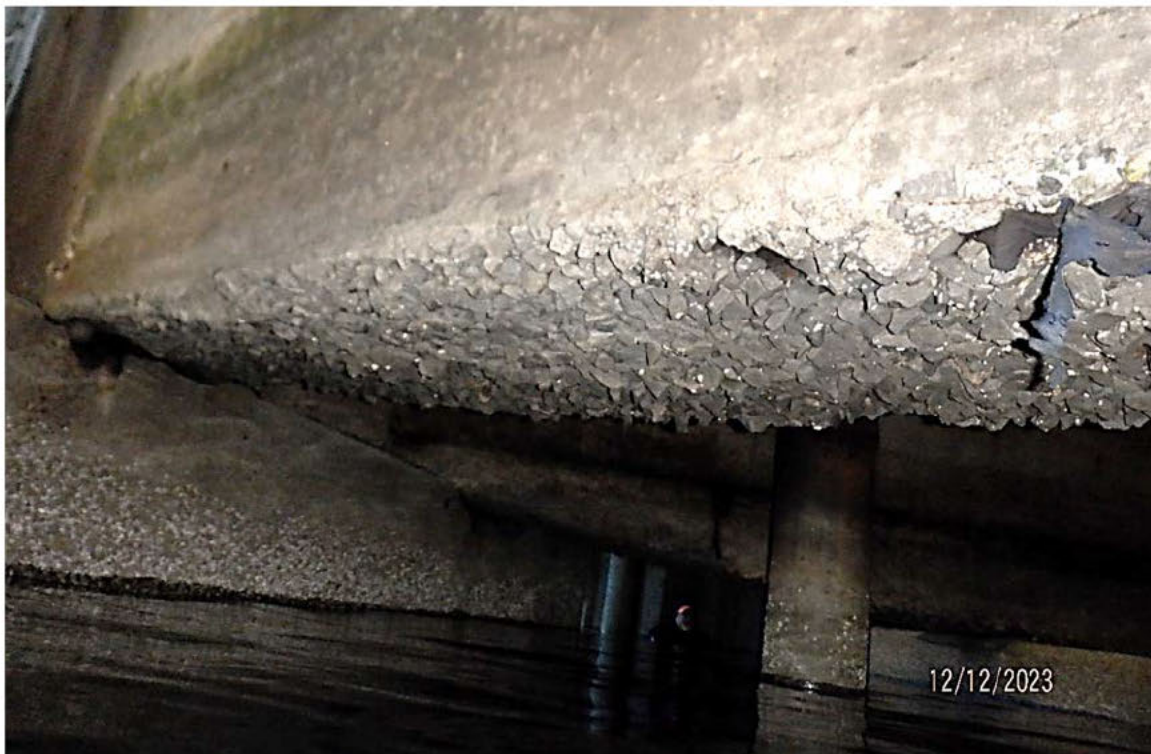
**Photo 3.5-8:** Typical condition of the strut underside illustrating gravel adhering to the underside of the concrete.

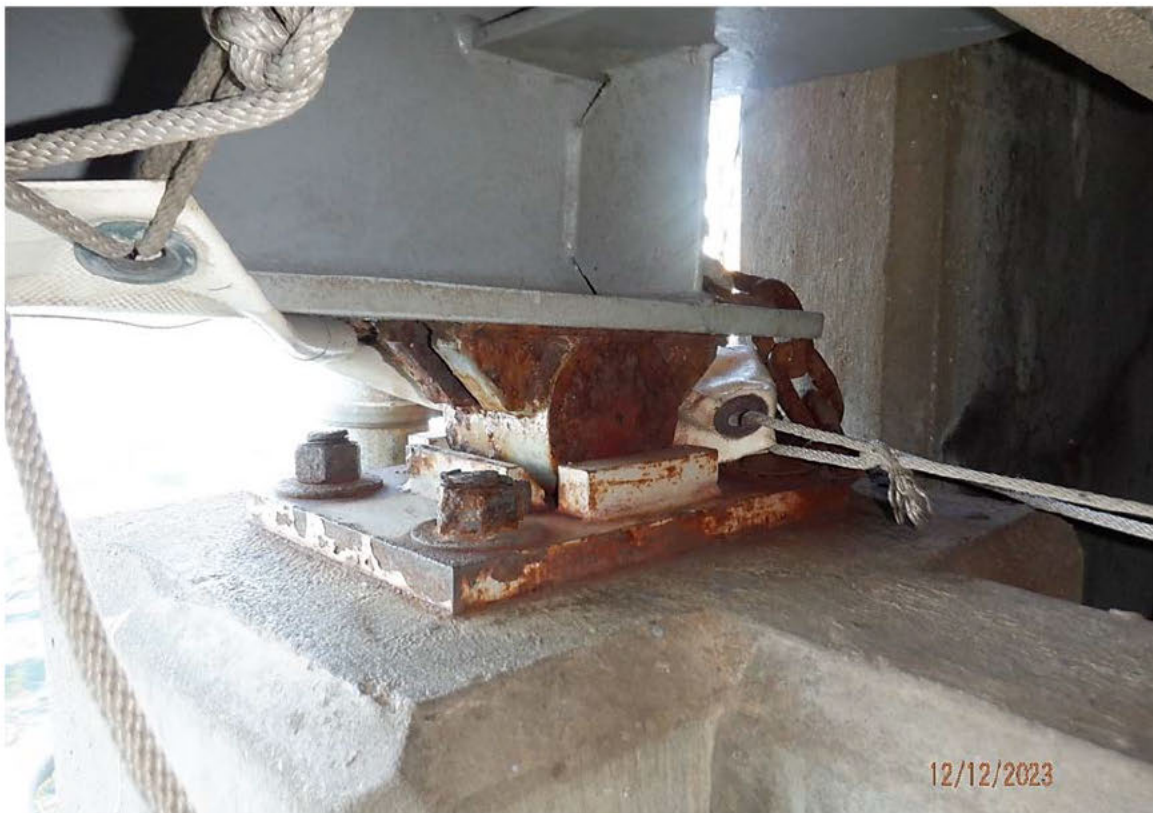
**Photo 3.6-4:** Condition of northwest rocker bearing at Pedestrian Gangway A. Assembly exhibits minor corrosion of the rocker bearing, bearing plate, and restraining safety chain. The anchor bolt nuts exhibit moderate to advanced corrosion.

| Action Type | Description | Implementation Date | Total Cost (2024 USD) |
|---|---|---|---|
| Priority | Remove debris from the rocker bearings and replace anchor bolt nuts. Restore or replace safety chains as applicable. | FY 2025 | \$28,644 |

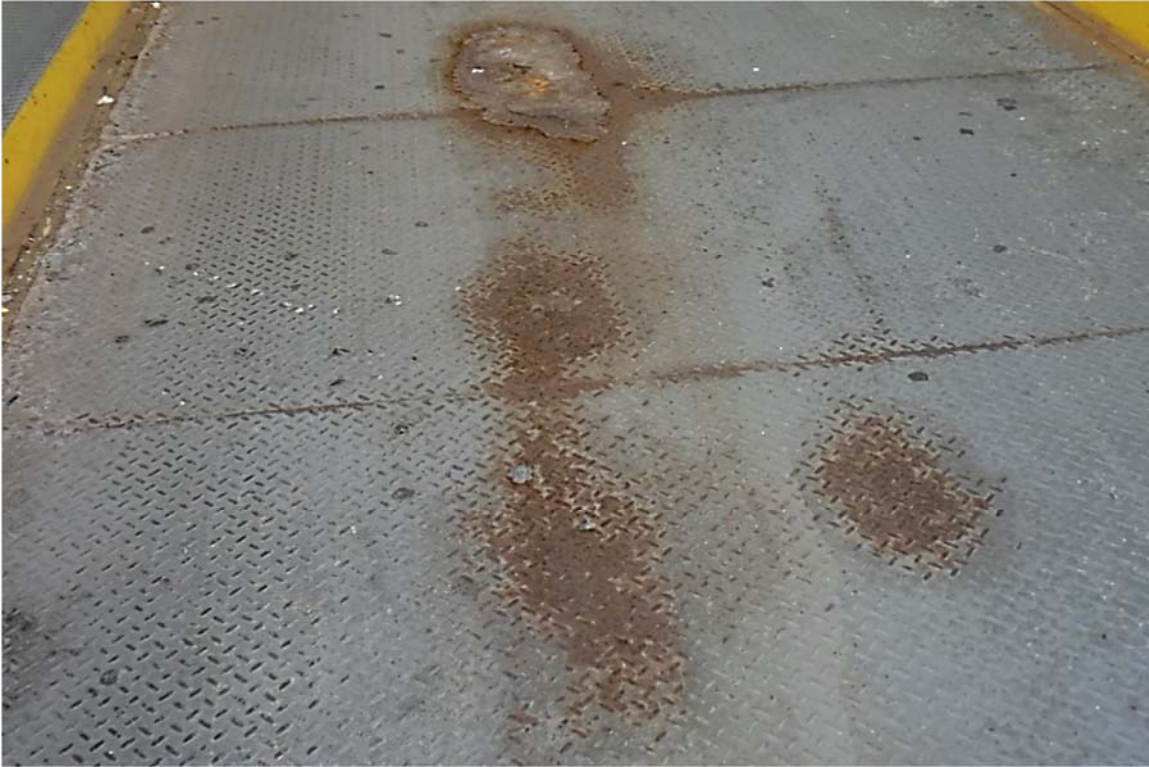
**Photo 3.6-6:** The steel diamond deck plate exhibits coating loss due to wear and abrasion at isolated locations. The steel exhibits minor to moderate surface rust.

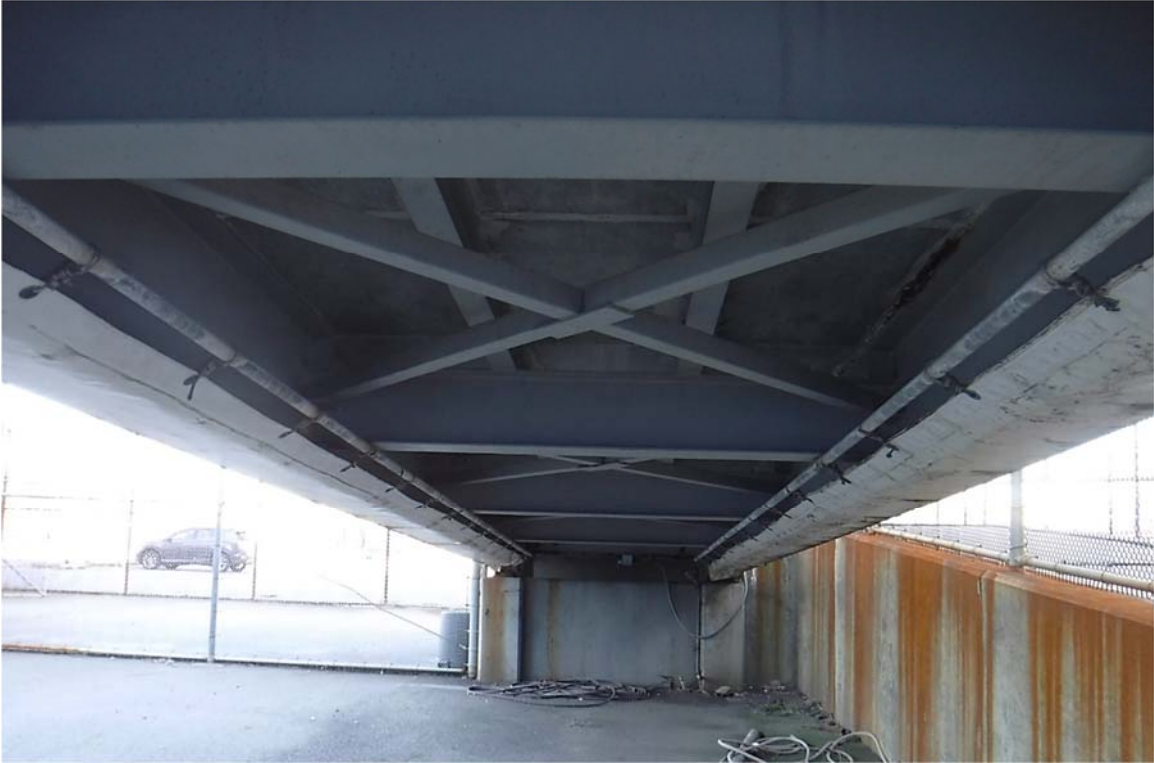
**Photo 3.7-1:** View of the Middle Pedestrian Gangway B framing looking north. The coating generally remains intact.

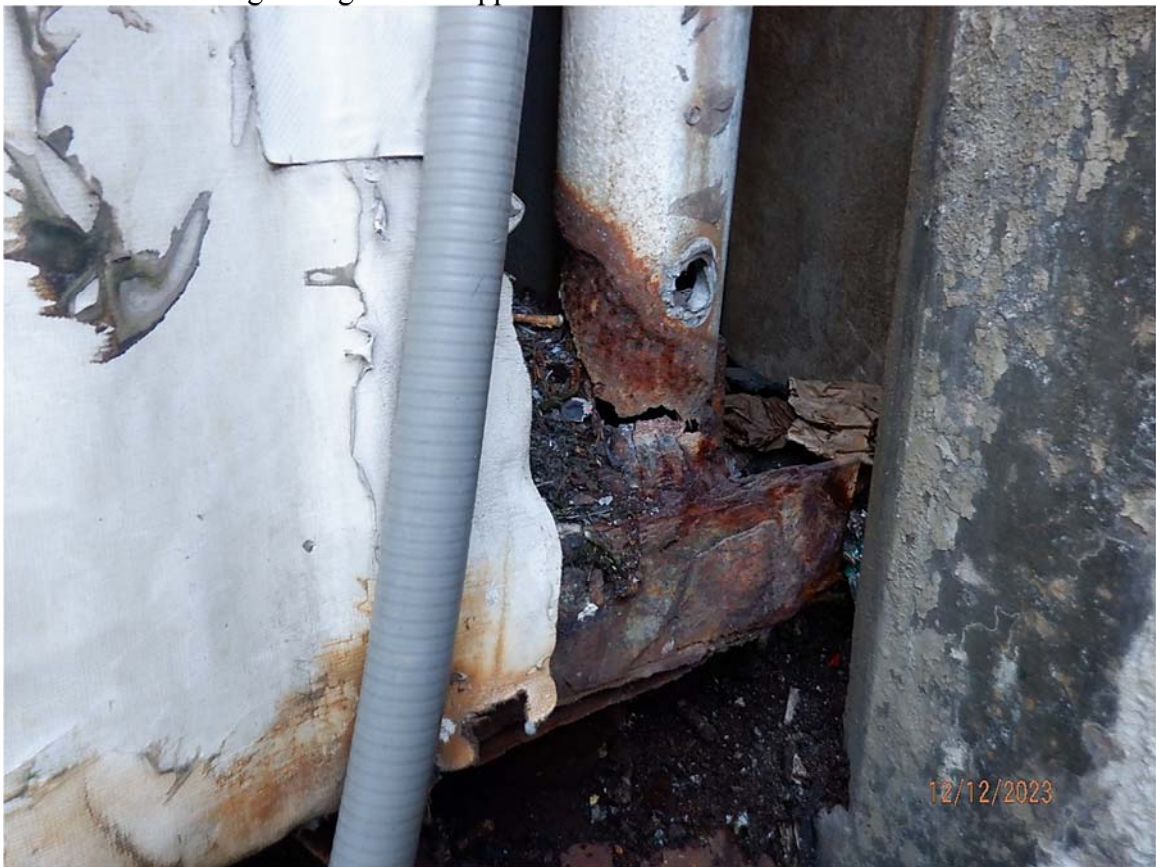
**Photo 3.7-6:** Severe corrosion of the northeast canopy post at the Middle Gangway B.
