Project #11750  
Addendum #3  
Date 9/18/26

**TABLE E-1**  
**SUMMARY OF THE OVERALL CONDITION RATINGS AND COSTS**  
**AT HUNTS POINT CORRECTIONS BULKHEAD AND VERNON C. BAINE**  
**CORRECTIONS CENTER FLOATING DETENTION BARGE**

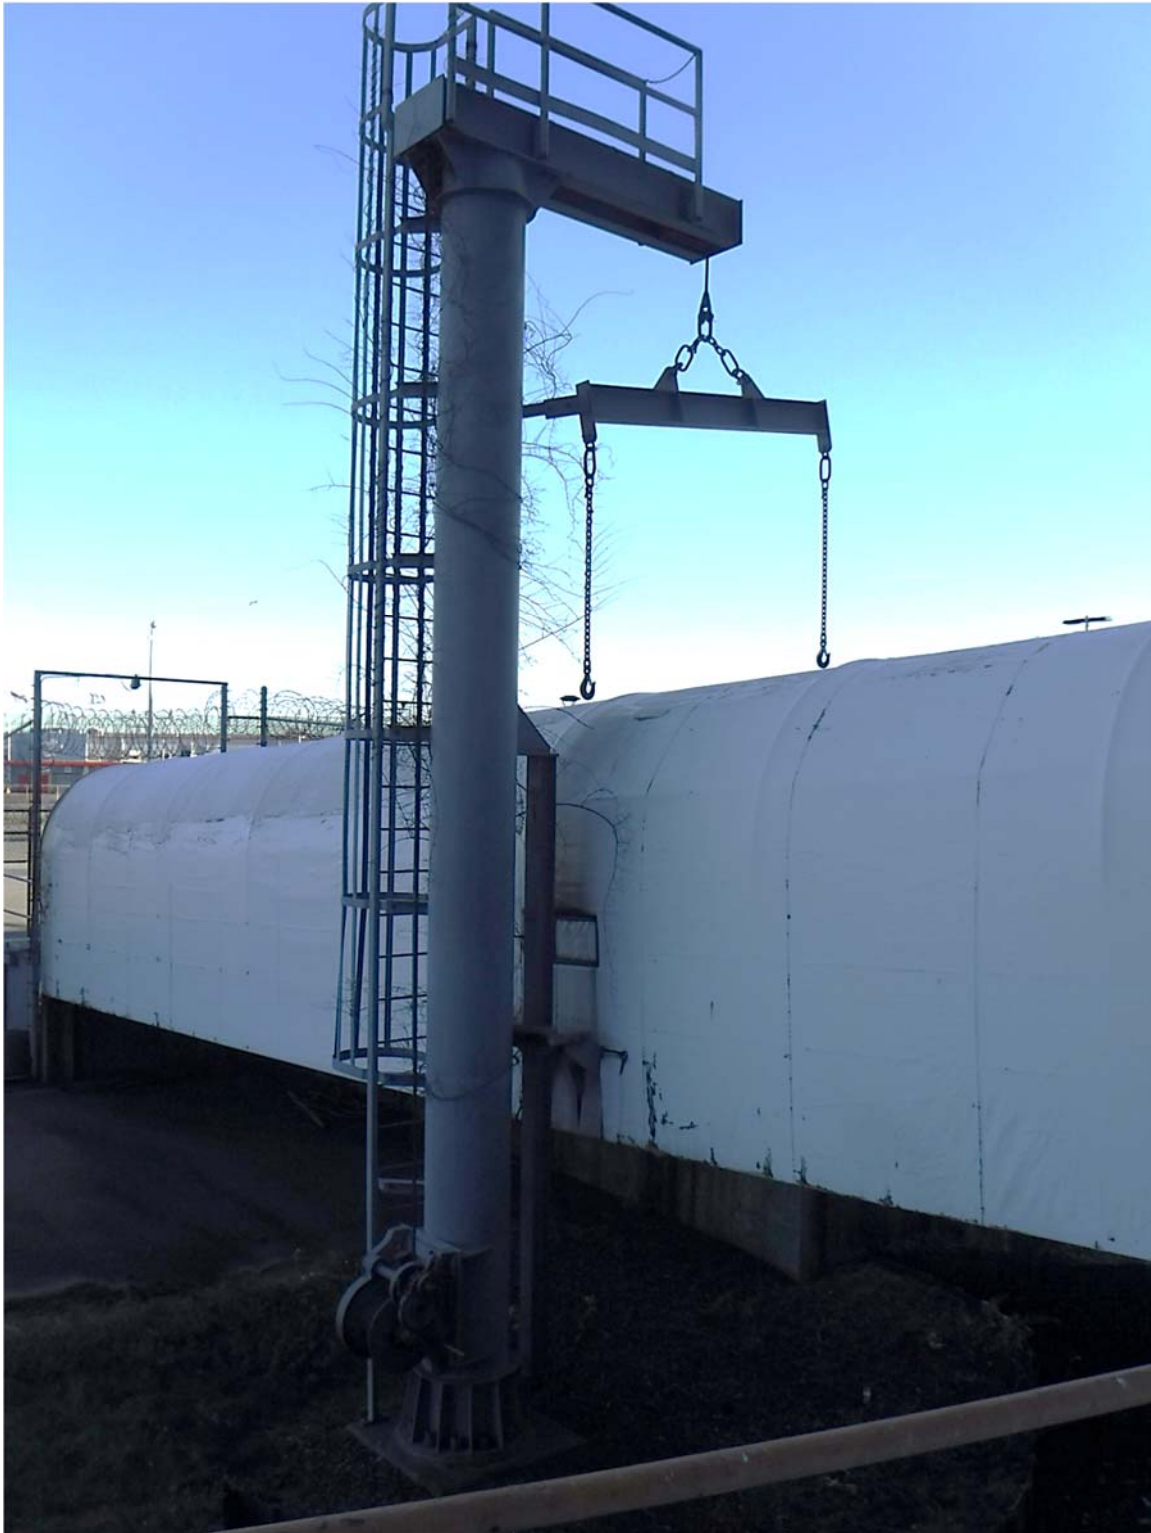
**Photo 3.7-8:** Overall elevational view of the gangway support frame at the Middle Pedestrian Gangway B. Note the vegetation growth along the steel cage ladder and mast. Some growth exists on the manual winch system.

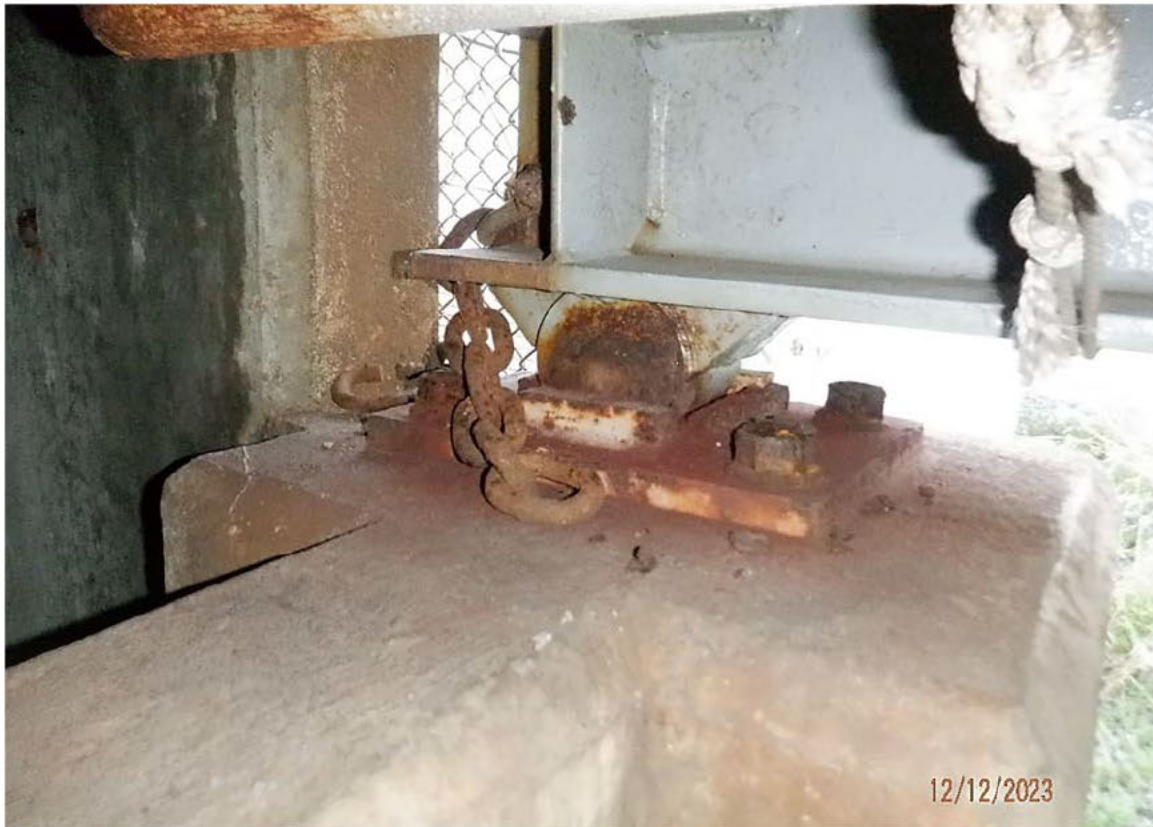
**Photo 3.8-3:** Example of typical anchor bolt and nut corrosion at the rocker bearings. Also note the broken or cut safety chain link at the northeast bearing.

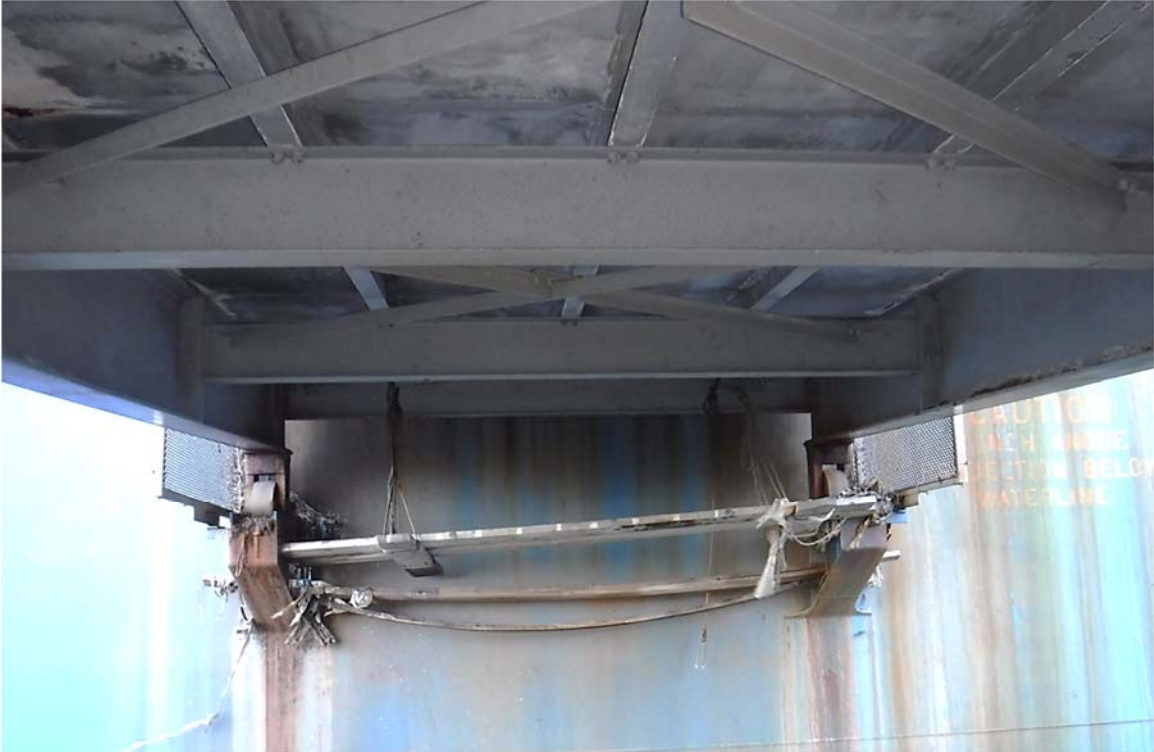
**Photo 3.9-3:** Overall view of the roller bearings at the Cargo Gangway. Note the debris interfering with the bearings.

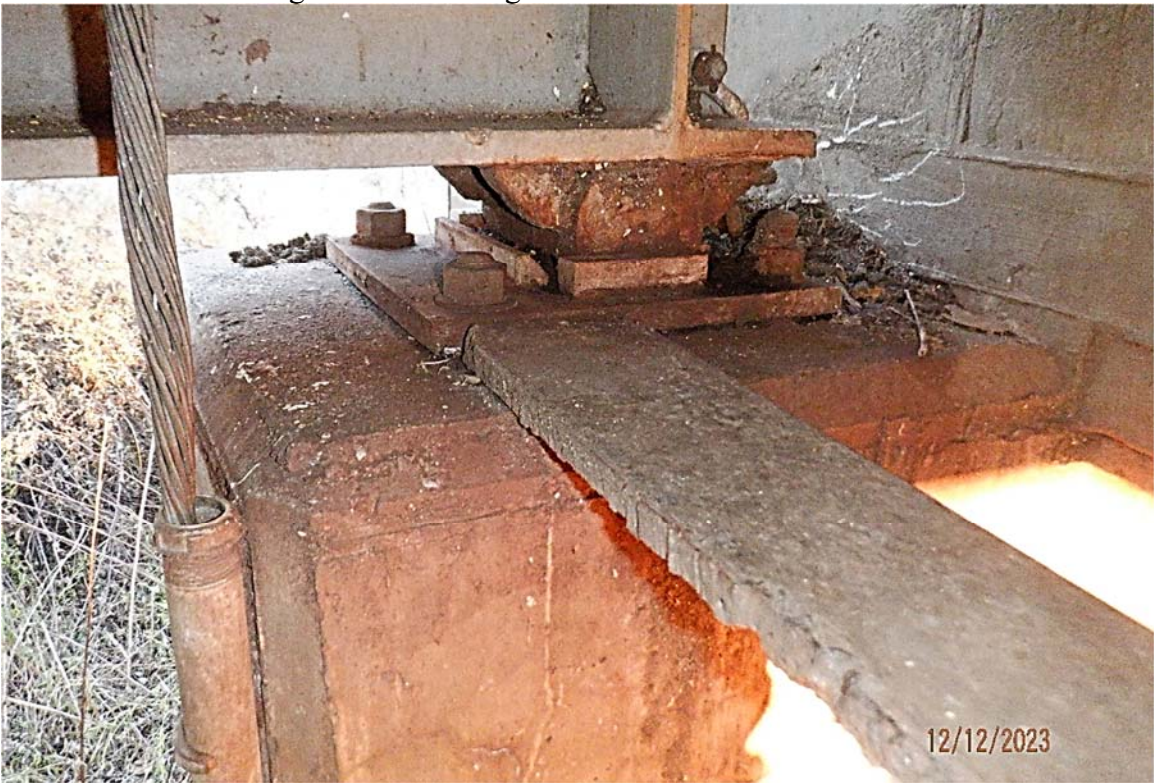
**Photo 3.9-4:** Debris accumulation and typical anchor nut corrosion as shown at the northwest rocker bearing.

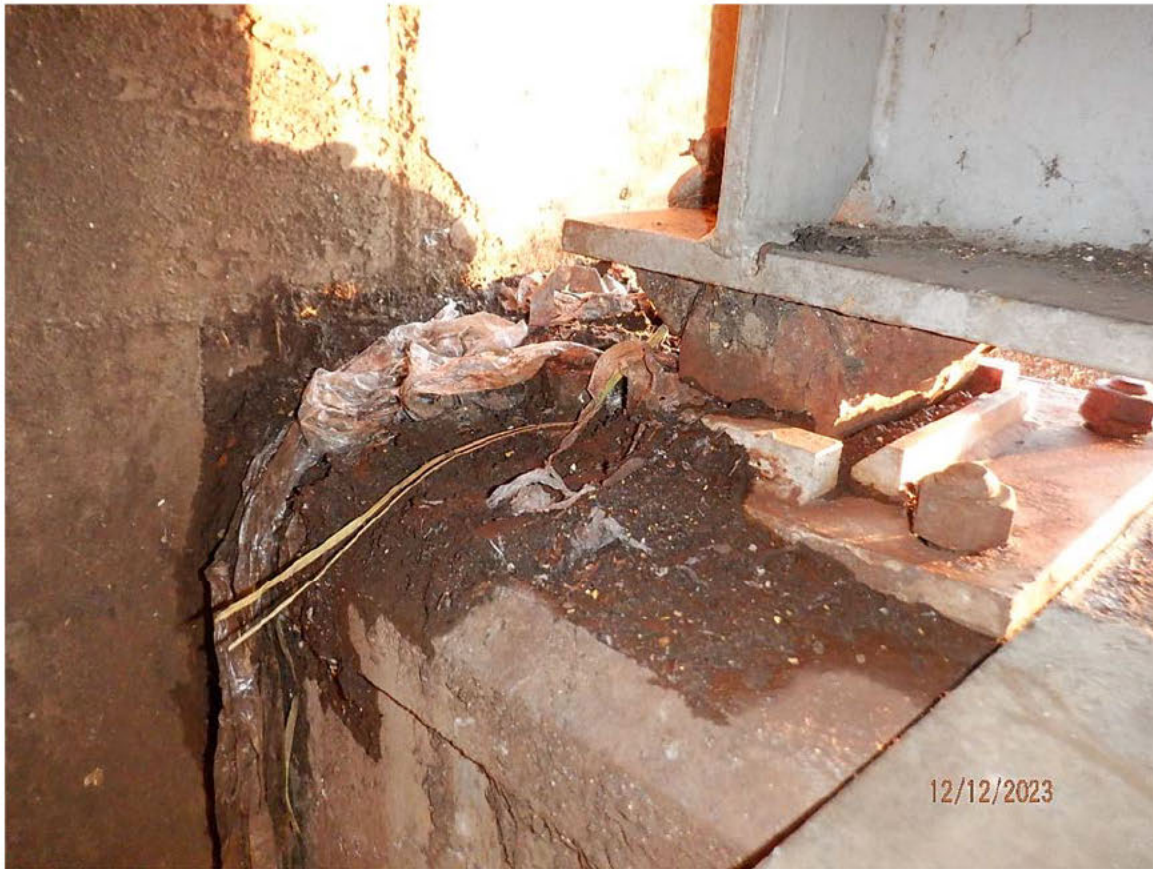
**Photo 3.9-5:** Debris accumulation at the northeast rocker bearing. Note the anchor nuts are not in contact with the bearing plate.

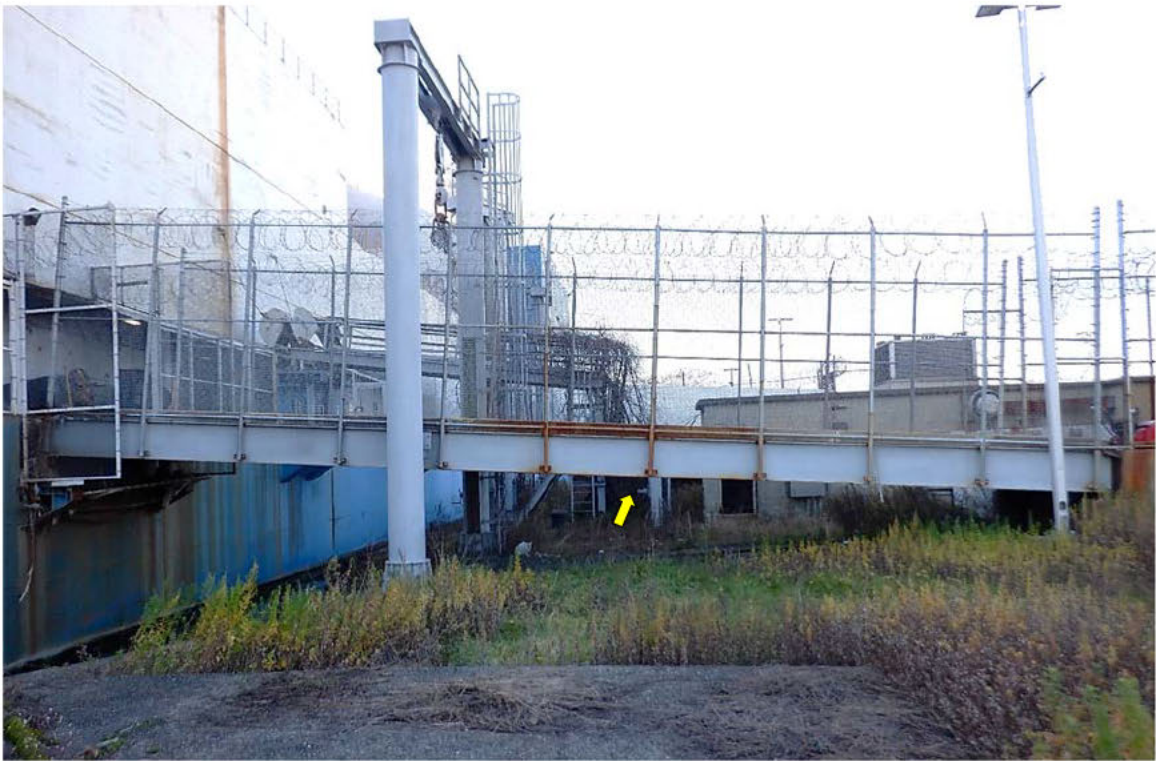
**Photo 3.9-6:** Overall east elevation view of the Cargo Gangway and support frame. Note the minor surface corrosion on the security fence posts along the girder.

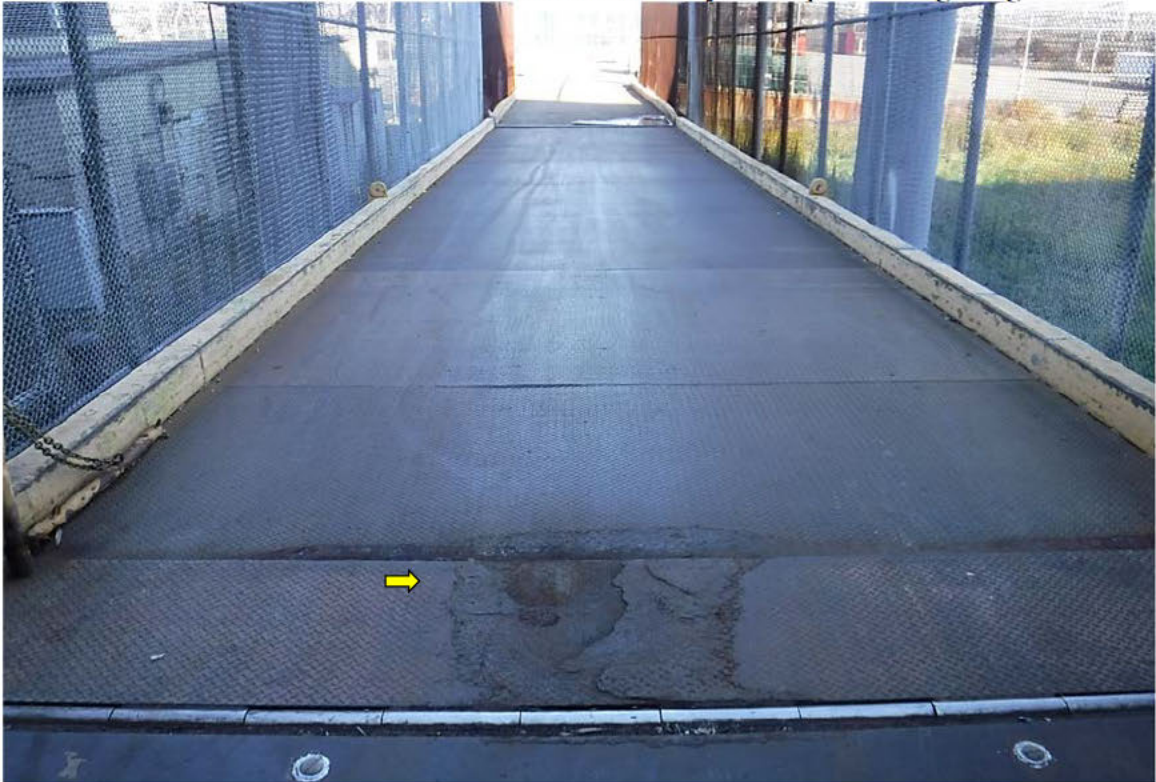
**Photo 3.9-7:** Overall view of the Cargo Gangway deck, curb, and security fence. Note the wear and corrosion on the transition plate.

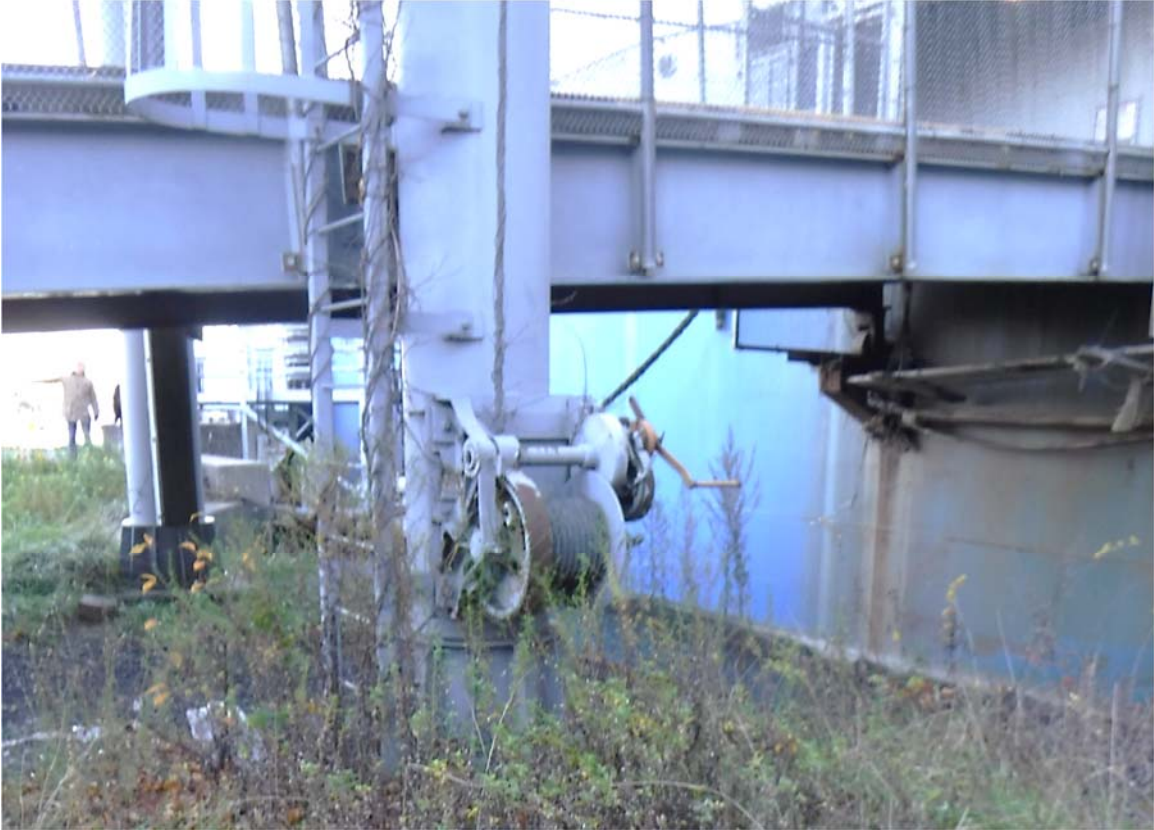
**Photo 3.9-8:** Moderate vegetation and vines growing on the support gangway cage ladder, mast, and winch restricting access and operation.

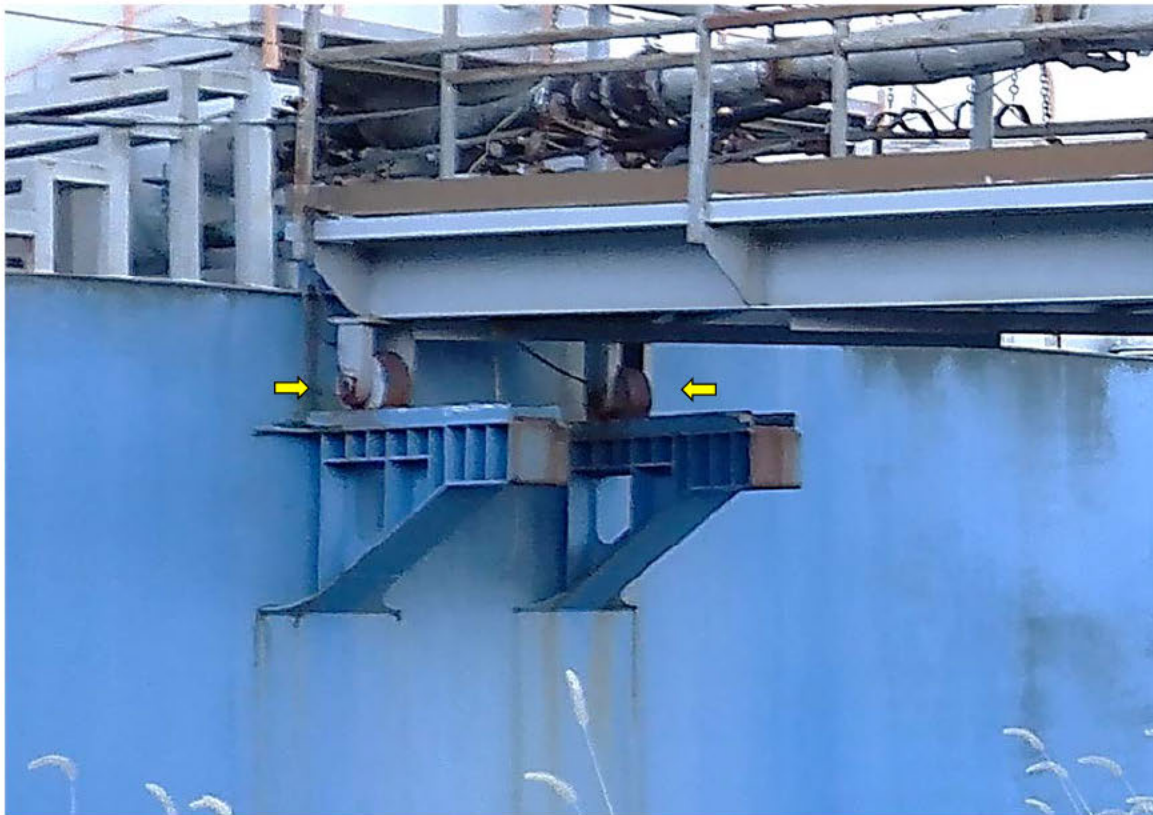
**Photo 3.10-3:** Enlarged view of the roller bearings at the Plumbing Gangway. Note the minor surface corrosion on the various surfaces.

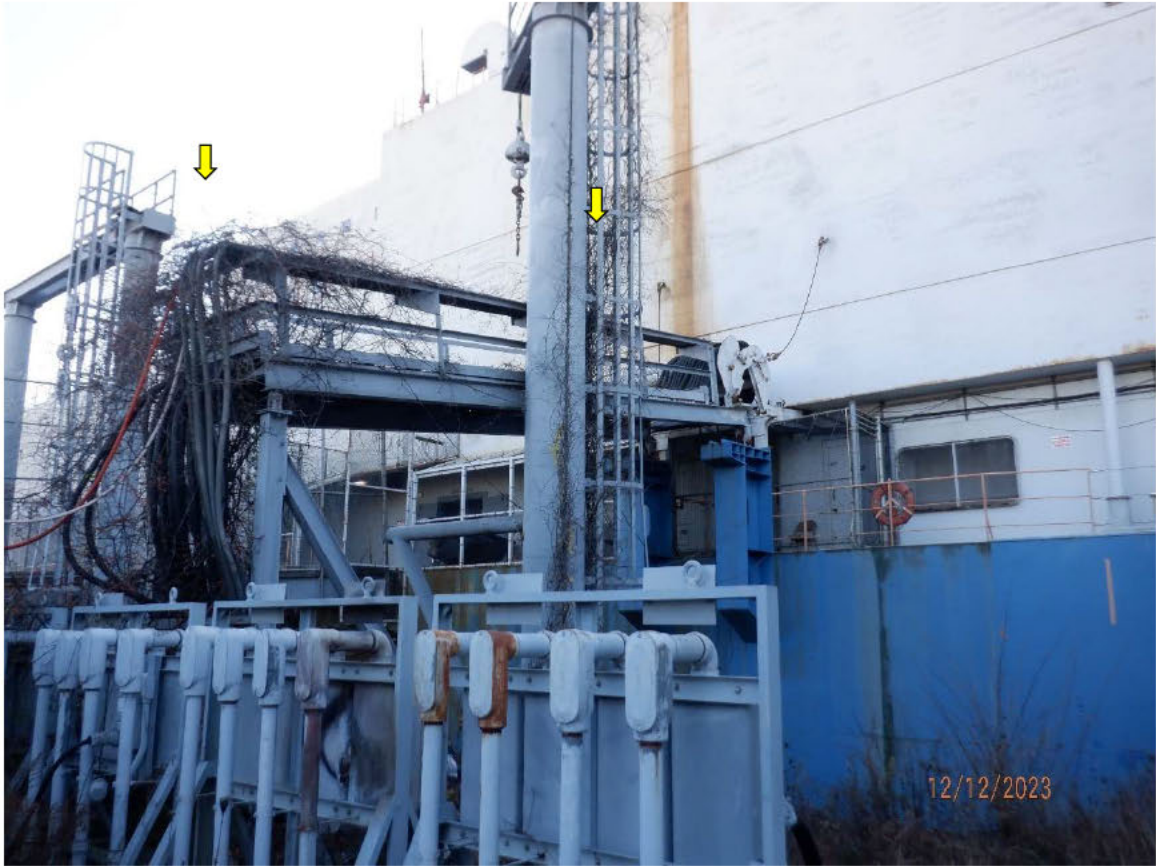
**Photo 3.11-3:** Overall view of the support frame with excessive vegetation on the Electrical Gangway and support frame.

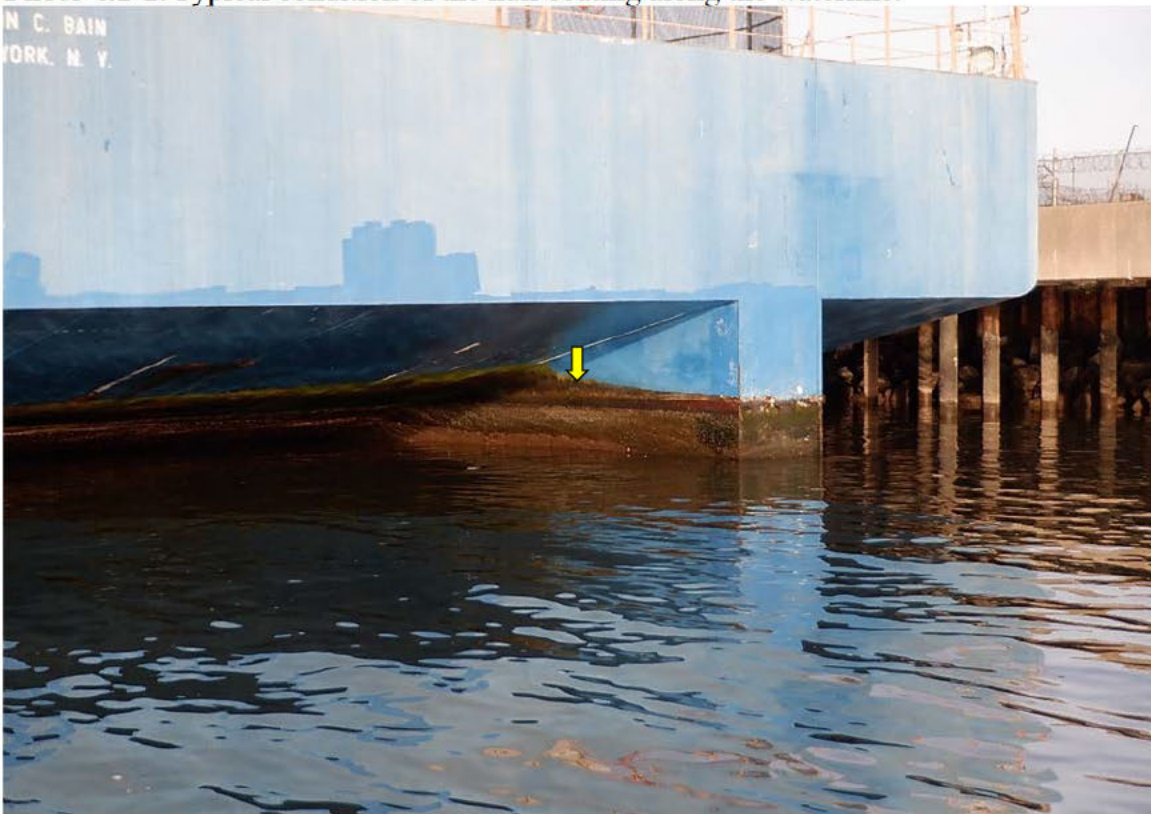
**Photo 4.1-2:** Loss of coating with minor corrosion along the waterline at the east rake of the barge.

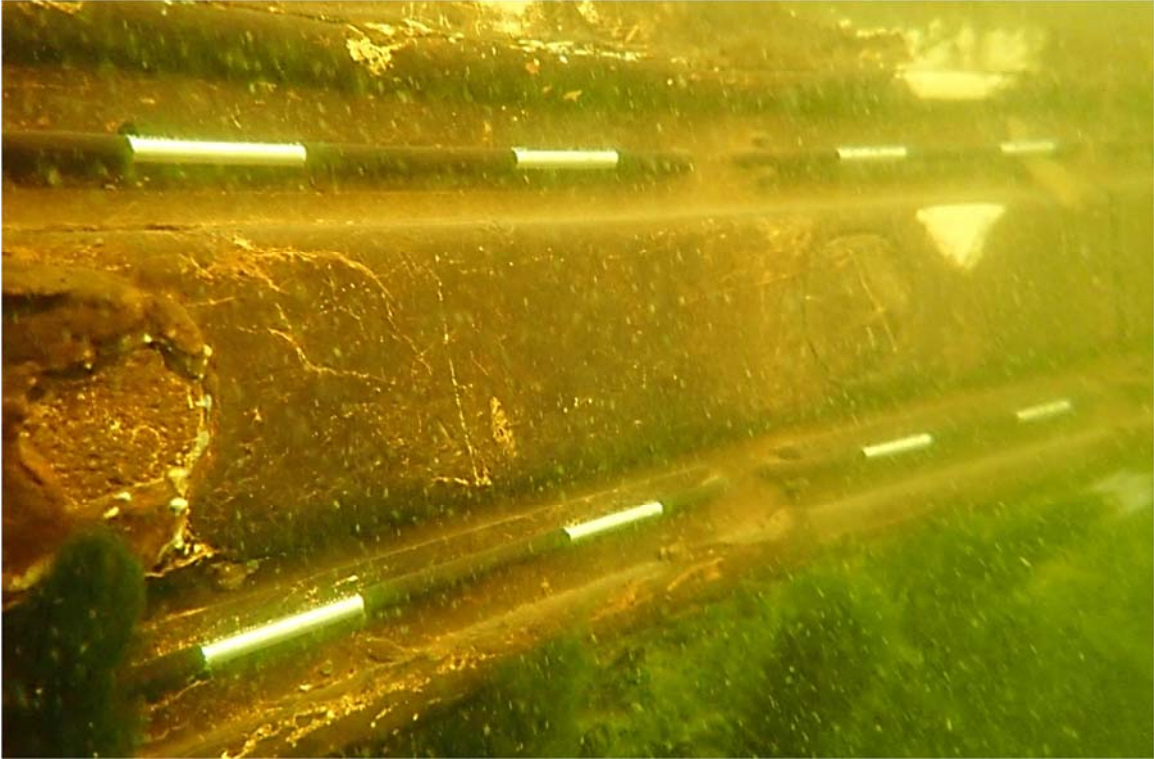
**Photo 4.1-3:** Missing anode on the side hull of the barge. Anode “clip” remains. The steel exhibits minor corrosion and pitting in local areas (south side, at approximately 80 ft from the west end of the barge).

| Action Type | Description | Implementation Date | Total Cost (2024 USD) |
|---|---|---|---|
| | Install two anodes to replace the missing anodes on the north and south sides. | FY 2025 | \$40,654 |

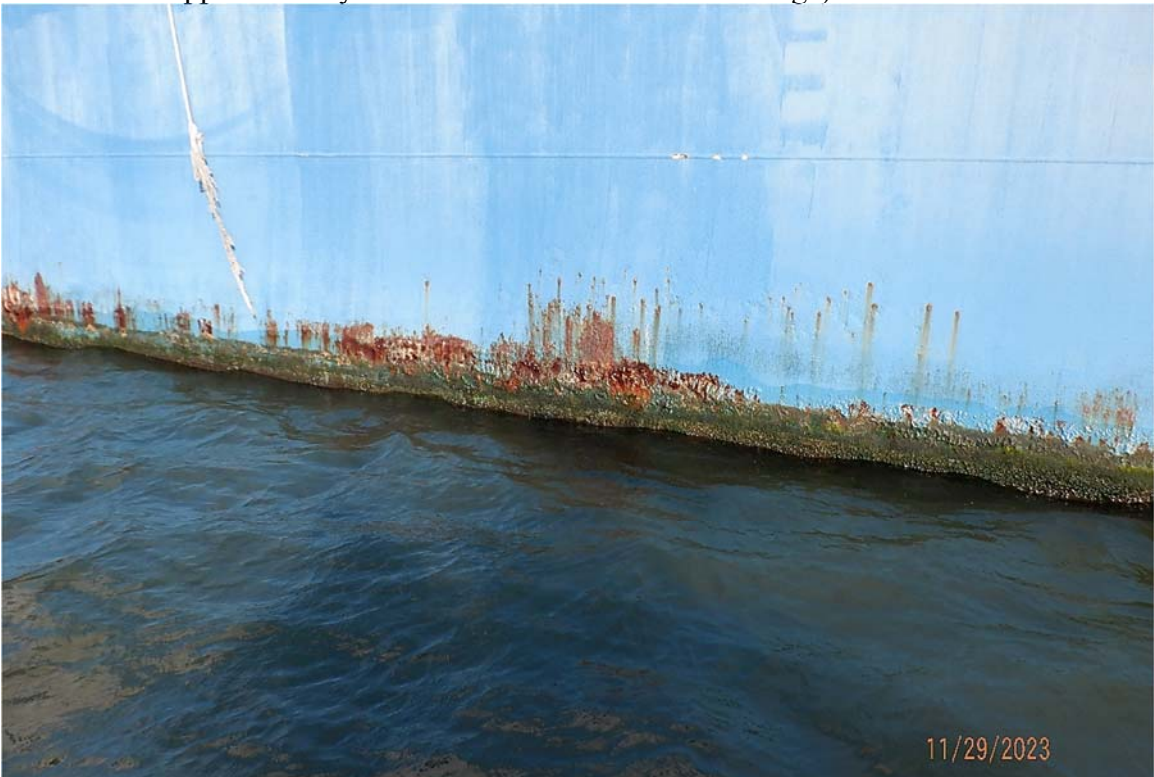
**Photo 4.1-4:** Minor coating loss and blistering with corrosion at the waterline along the south side of the barge.

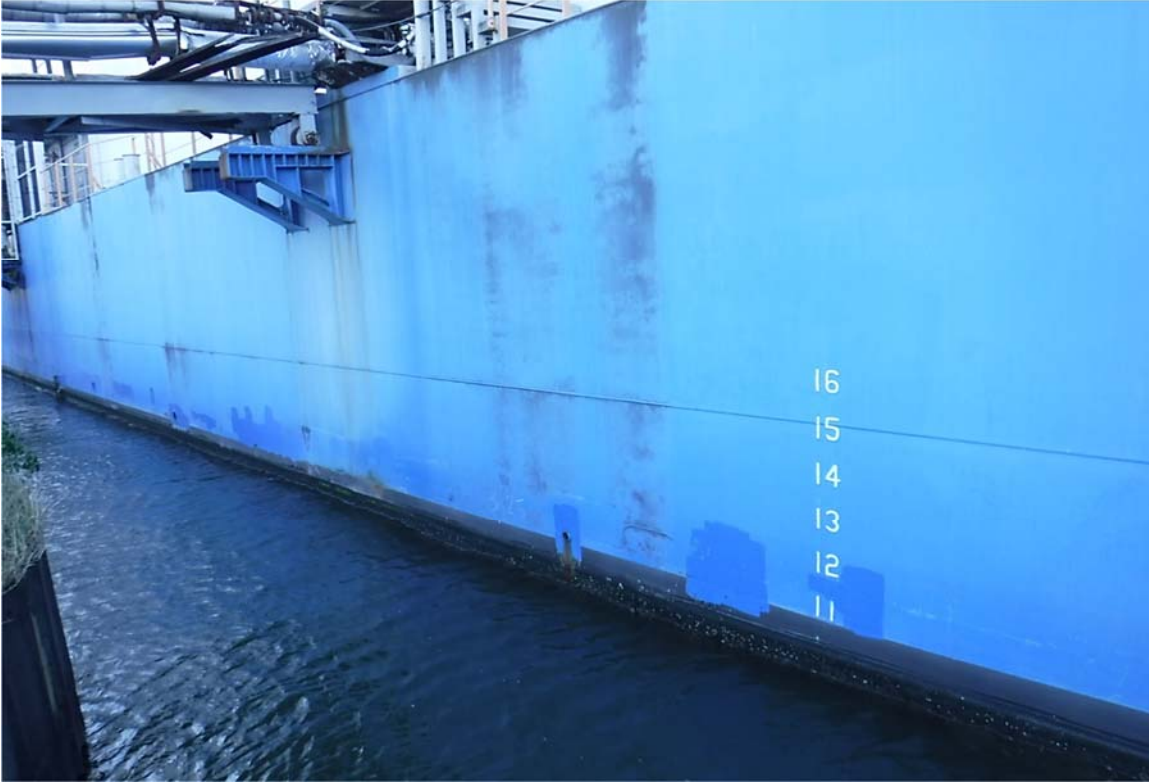
**Photo 4.1-5:** Barge markings indicate a draft of approximately 9'-8" below the waterline.
