Project #10563 Addendum # 1 May 9, 2025

PHYSICAL CONDITIONS ASSESSMENT REPORT

West New Brighton Library 976 Castleton Ave, Staten Island, NY 103010

Physical Conditions Assessment (PCA) West New Brighton New York Public Library

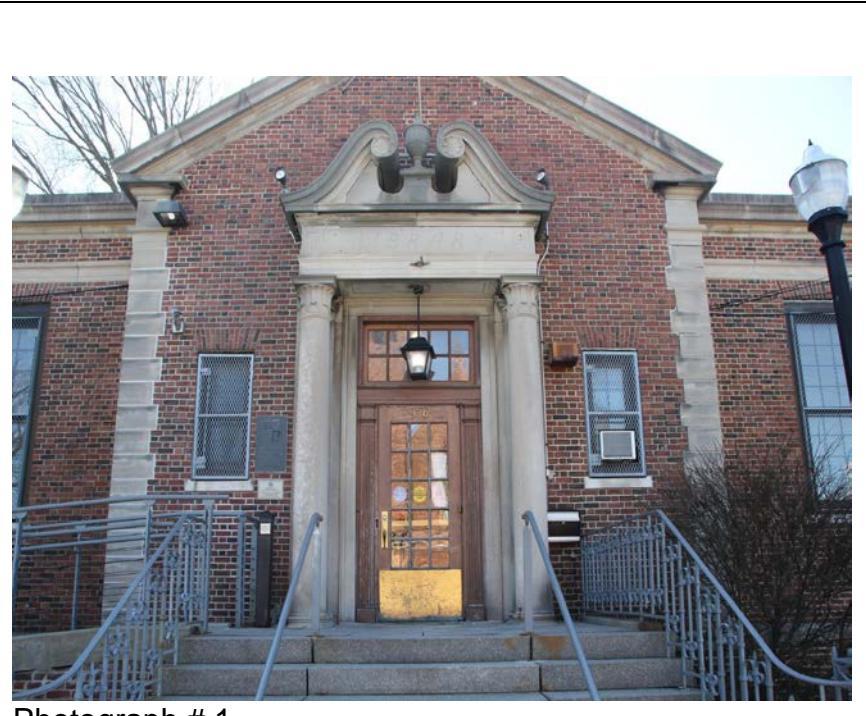
Photograph # 1

The entrance canopy columns at the main entrance show visible weather damage due to a lack of proper maintenance, affecting their finishing and overall appearance.

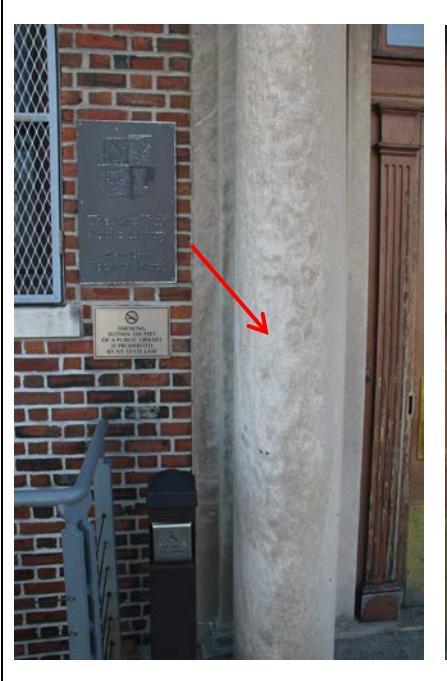
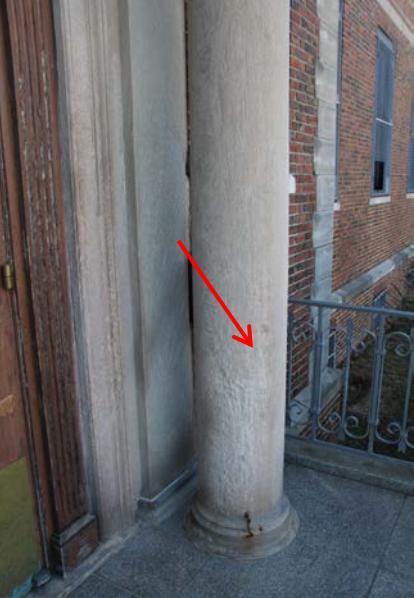
Photograph # 2 & 3

The decorative entrance canopy columns at the main entrance show visible weather damage due to a lack of proper maintenance, affecting their finishing and overall appearance. This damage is evident in the attached Photographs 1, 2 and 3.

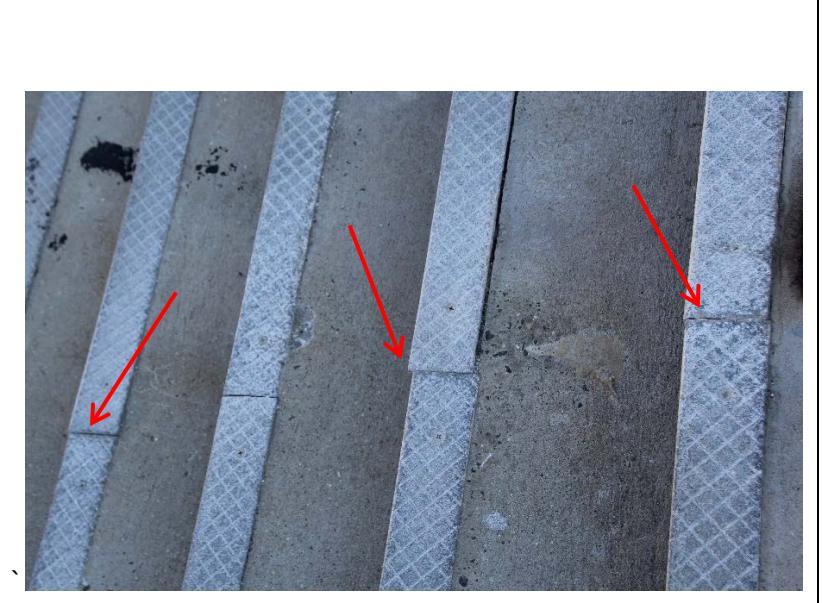
Photograph # 31

The entrance stair treads non slip corners are damaged and misaligned, posing a potential tripping hazard. This issue can be seen in the attached.

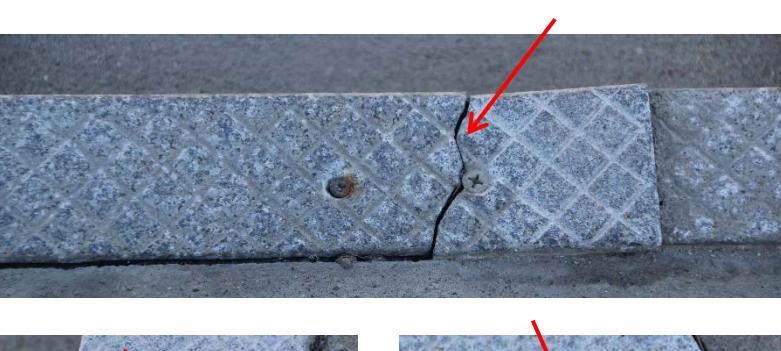
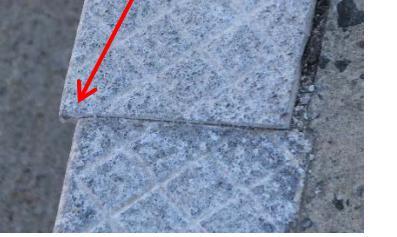
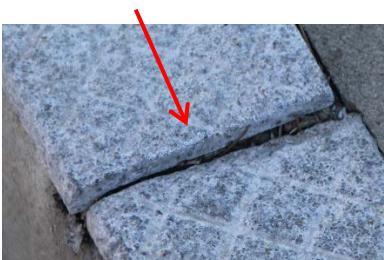
Photograph # 32

The entrance stairs that tread nonslip corners are damaged and misaligned, posing a potential tripping hazard. This issue can be seen in the attached.

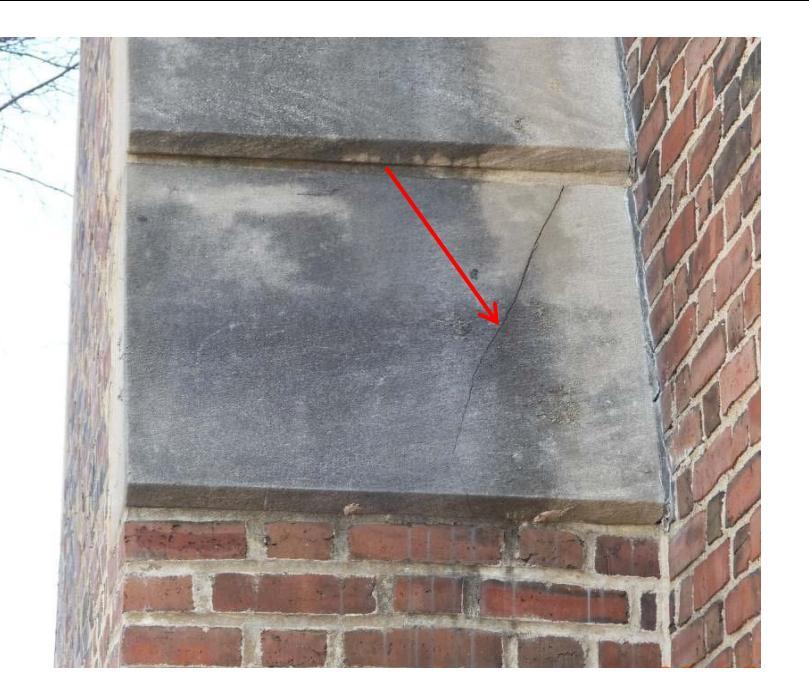
Photograph # 55

There is a cracked stone panel on the west side of the rear elevation.

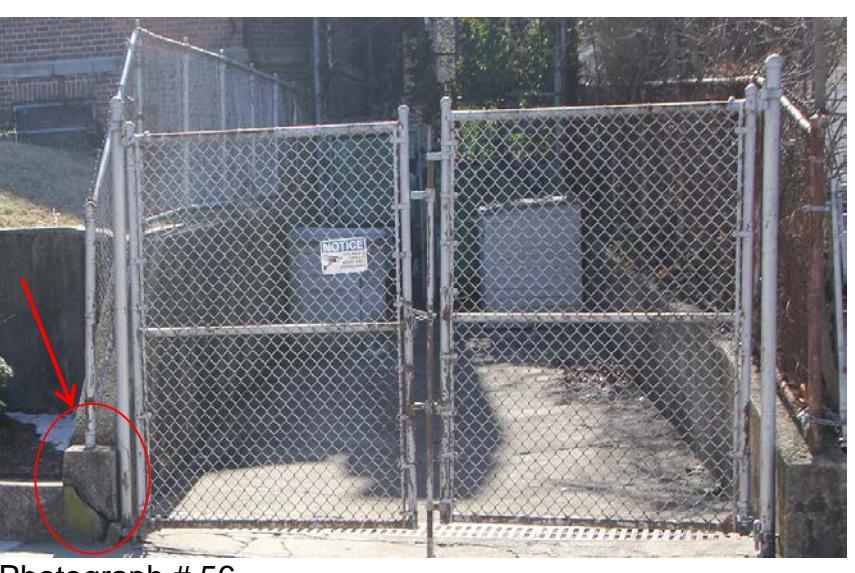
Photograph # 56

A chain-link fence is installed along the property boundary on North Burgher Avenue. The fence appears to be structurally stable and is generally in good condition, providing a secure perimeter along that side of the site. However, there are some areas of damaged fencing. (See Photographs 46, 47, 48 (Pg. 47) and 56 (Pg. 51)

During the site visit, it was observed that on the Castleton Avenue side, the staff parking gate foundation upstand is damaged and needs repairs, as seen in Photograph 56.

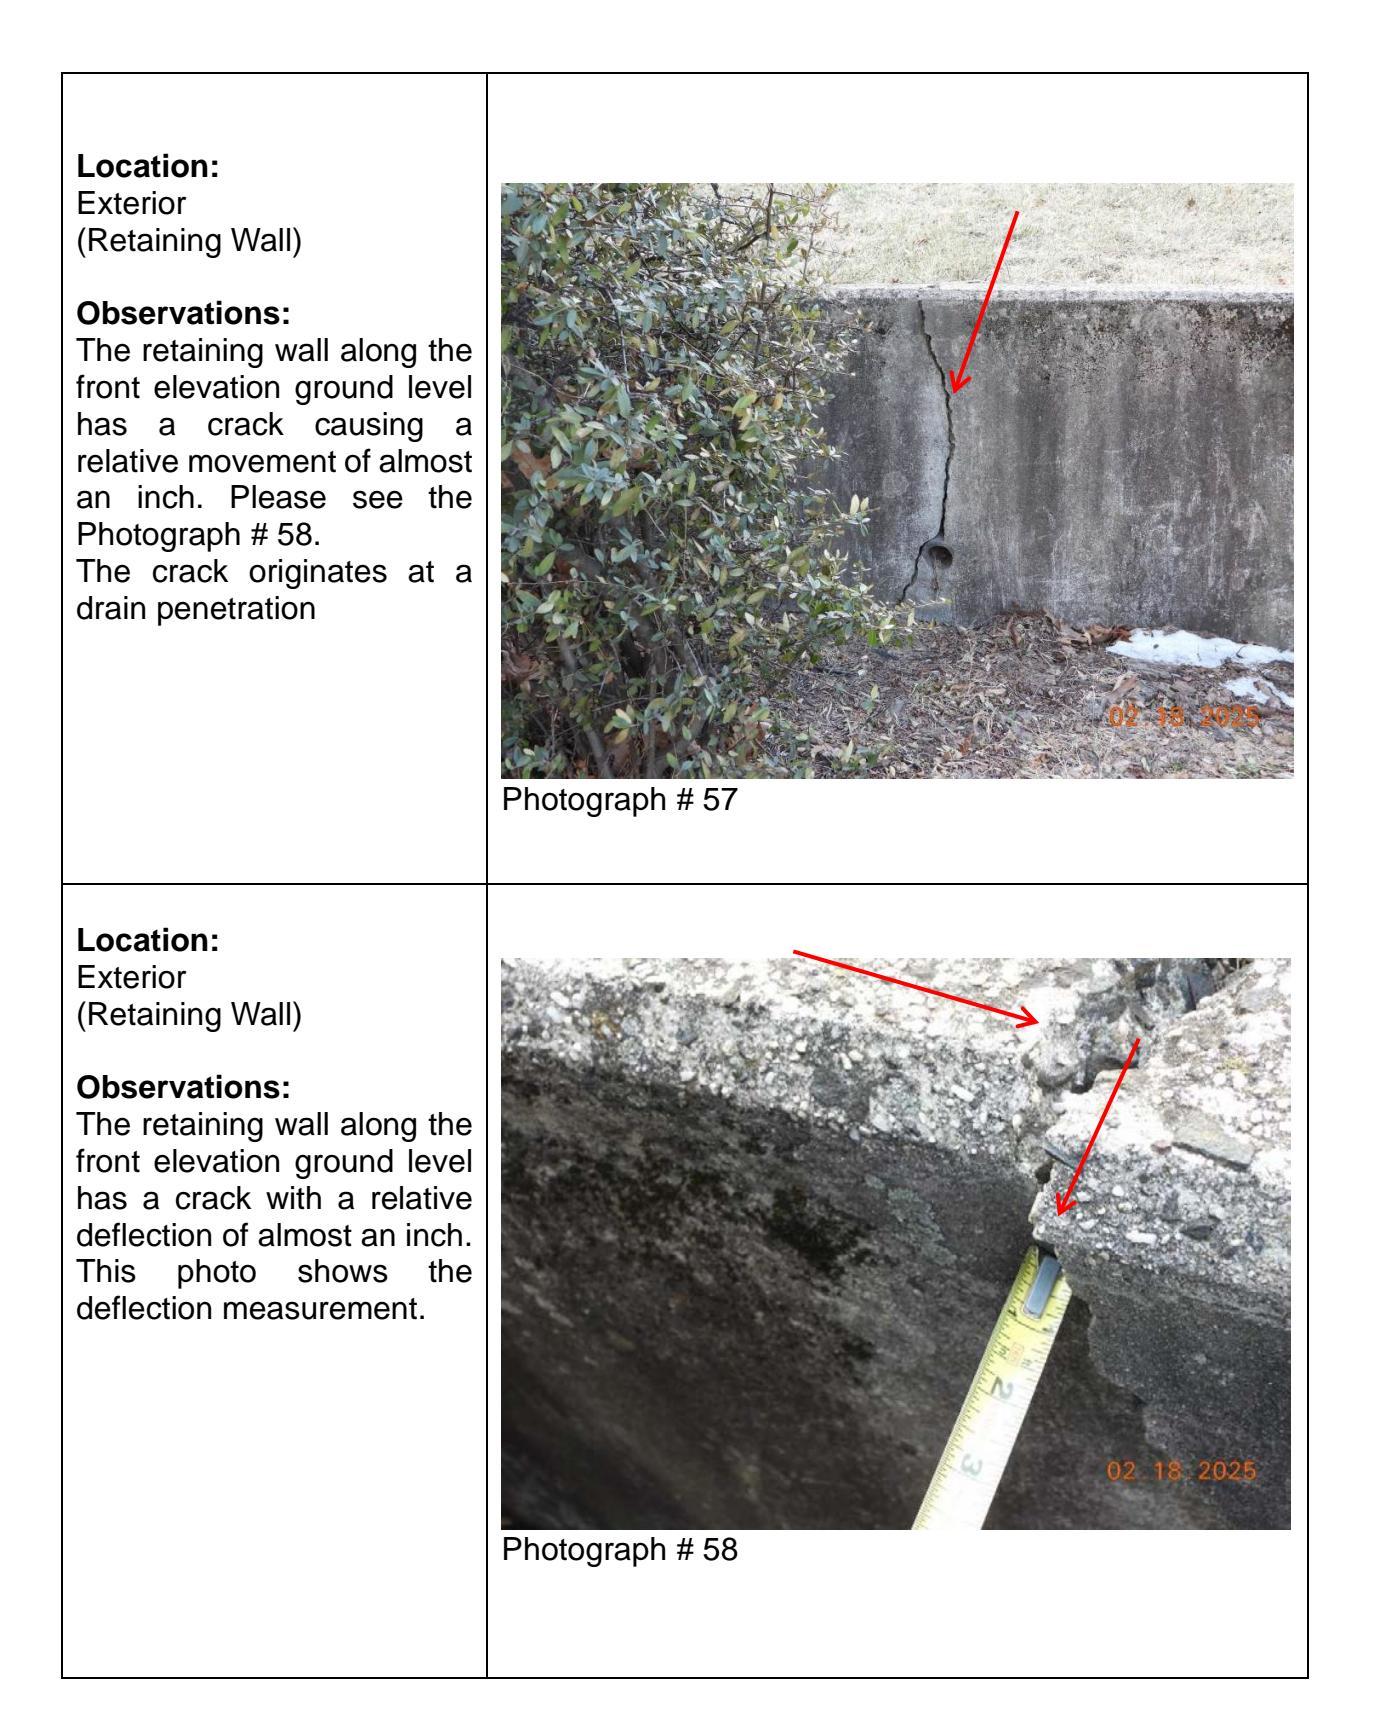
The retaining walls surrounding the library are generally in good condition, playing a crucial role in maintaining site stability and structural integrity. However, there is a specific area of concern at the front of the building where a noticeable crack has developed in the retaining wall. This crack has resulted in a relative movement of approximately one inch between the two adjoining sections of the wall. (See Detailed Photographs 57 & 58 (Pg. 52)

This movement suggests a potential structural issue that may have arisen due to foundation settling, shifts in the surrounding soil, or the impact of water drainage. While most of the retaining walls remain stable and functional, the displacement in this particular section requires further inspection and monitoring to assess its severity. If left unaddressed, the crack could widen over time, compromising the wall's ability to retain soil and prevent erosion or shifting.

To mitigate further deterioration, a detailed evaluation of the crack, surrounding conditions (such as moisture levels and drainage patterns), and the overall structural design of the wall is recommended. This assessment will help determine if corrective measures such as foundation stabilization, reinforcement, or partial reconstruction are necessary.
