# **SAW MILL CREEK PILOT WETLAND MITIGATION BANK STATEN ISLAND, NEW YORK**

## **MITIGATION BANKING INSTRUMENT**

**June 2015**

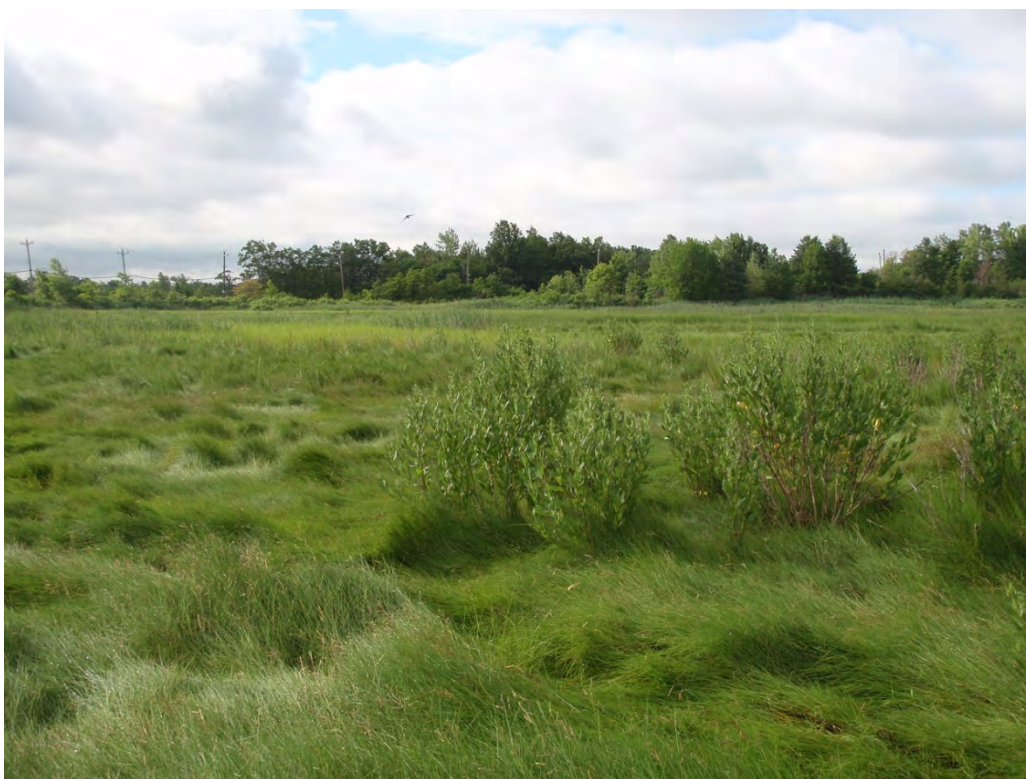
Photo 1: Salt meadow hay and high tide bush in high marsh - east of Chelsea Road.

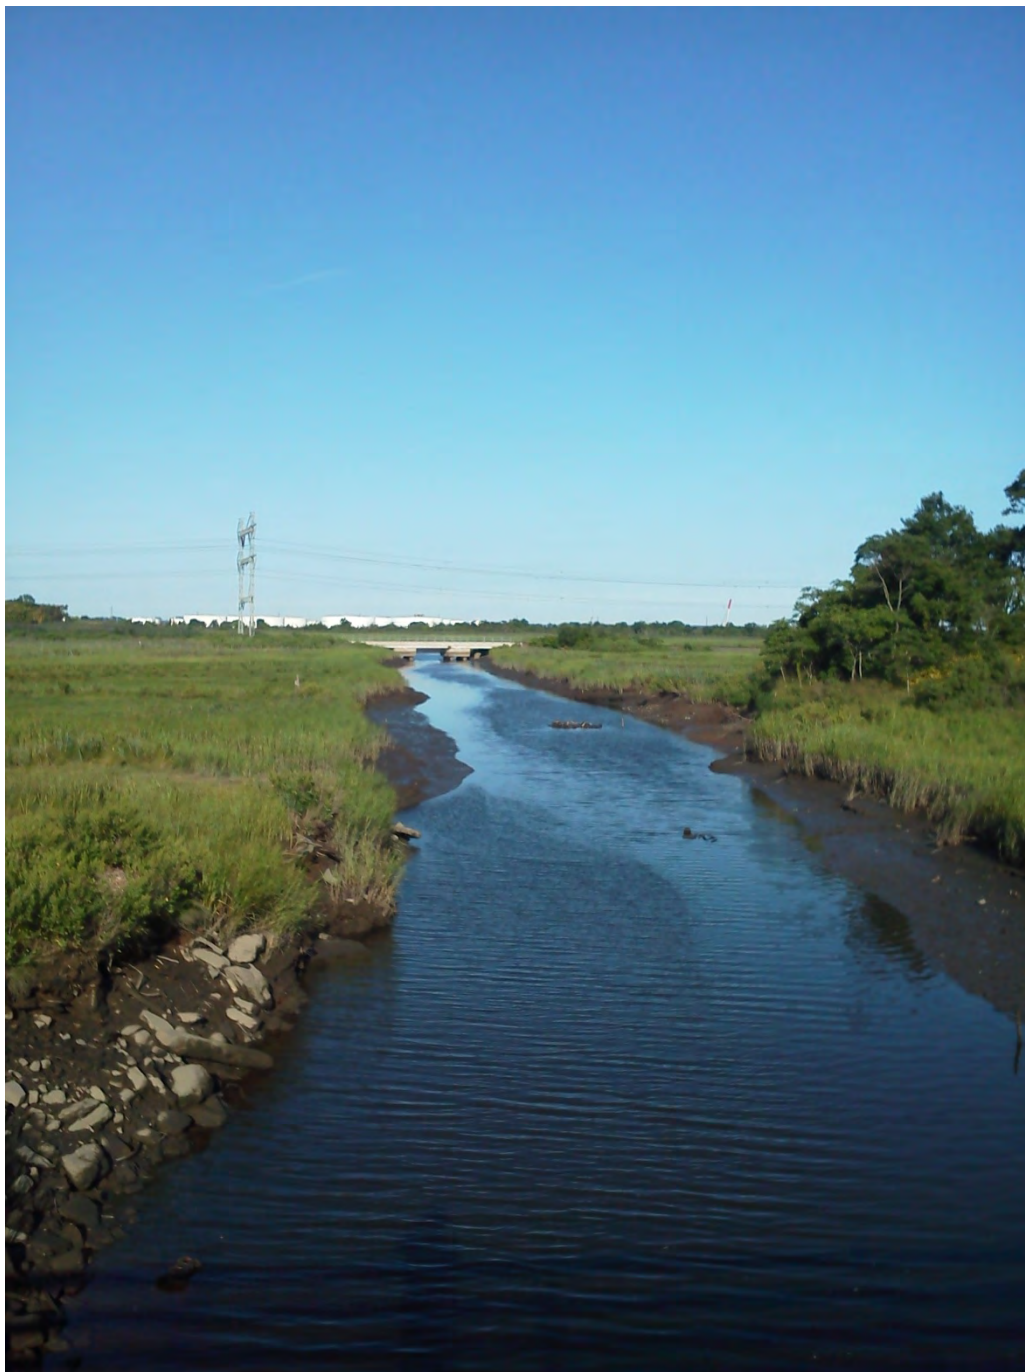
Photo 3: Looking west along Saw Mill Creek from Chelsea Road bridge.

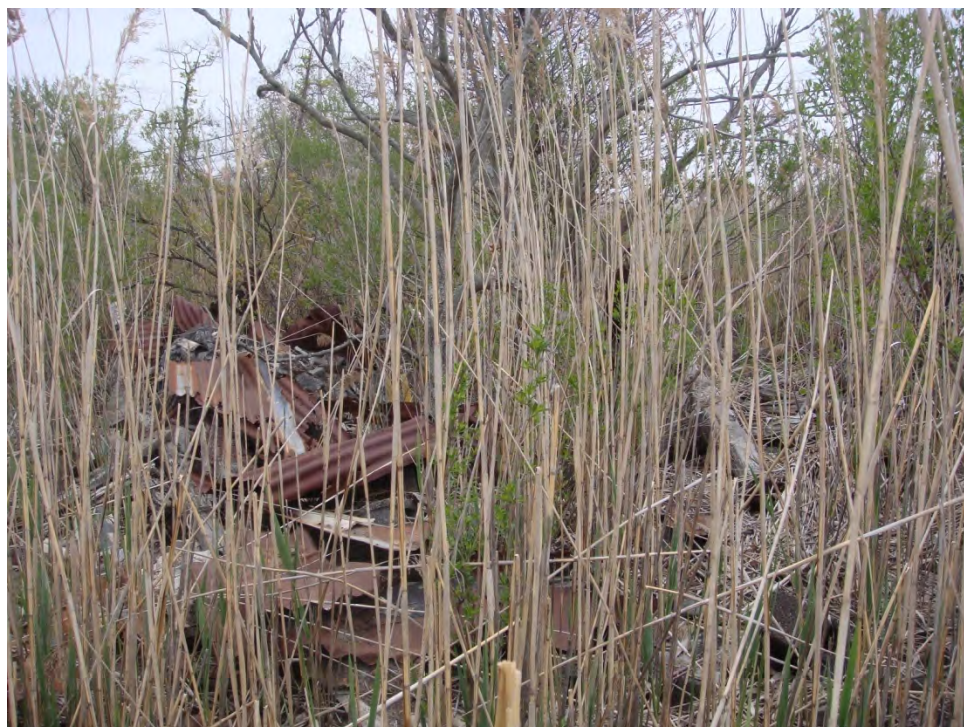
Photo 11: Wood and metal debris dumped near wetland/upland boundary – west of Chelsea Road.

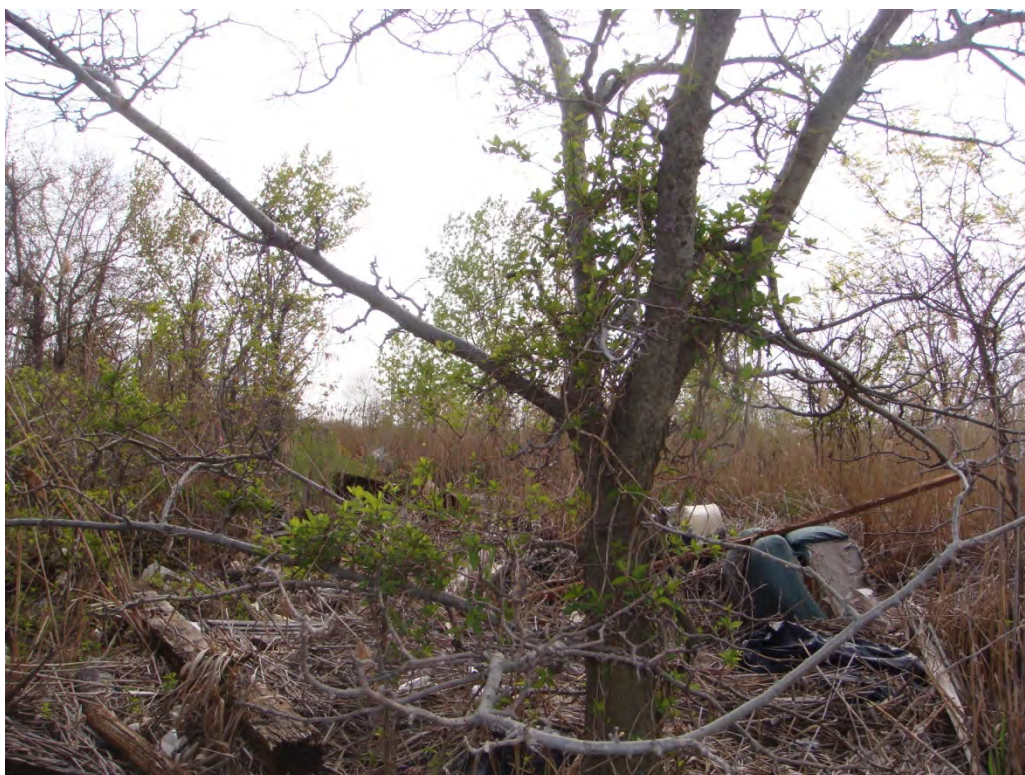
Photo 16: Storm surge debris – west of Chelsea Road.

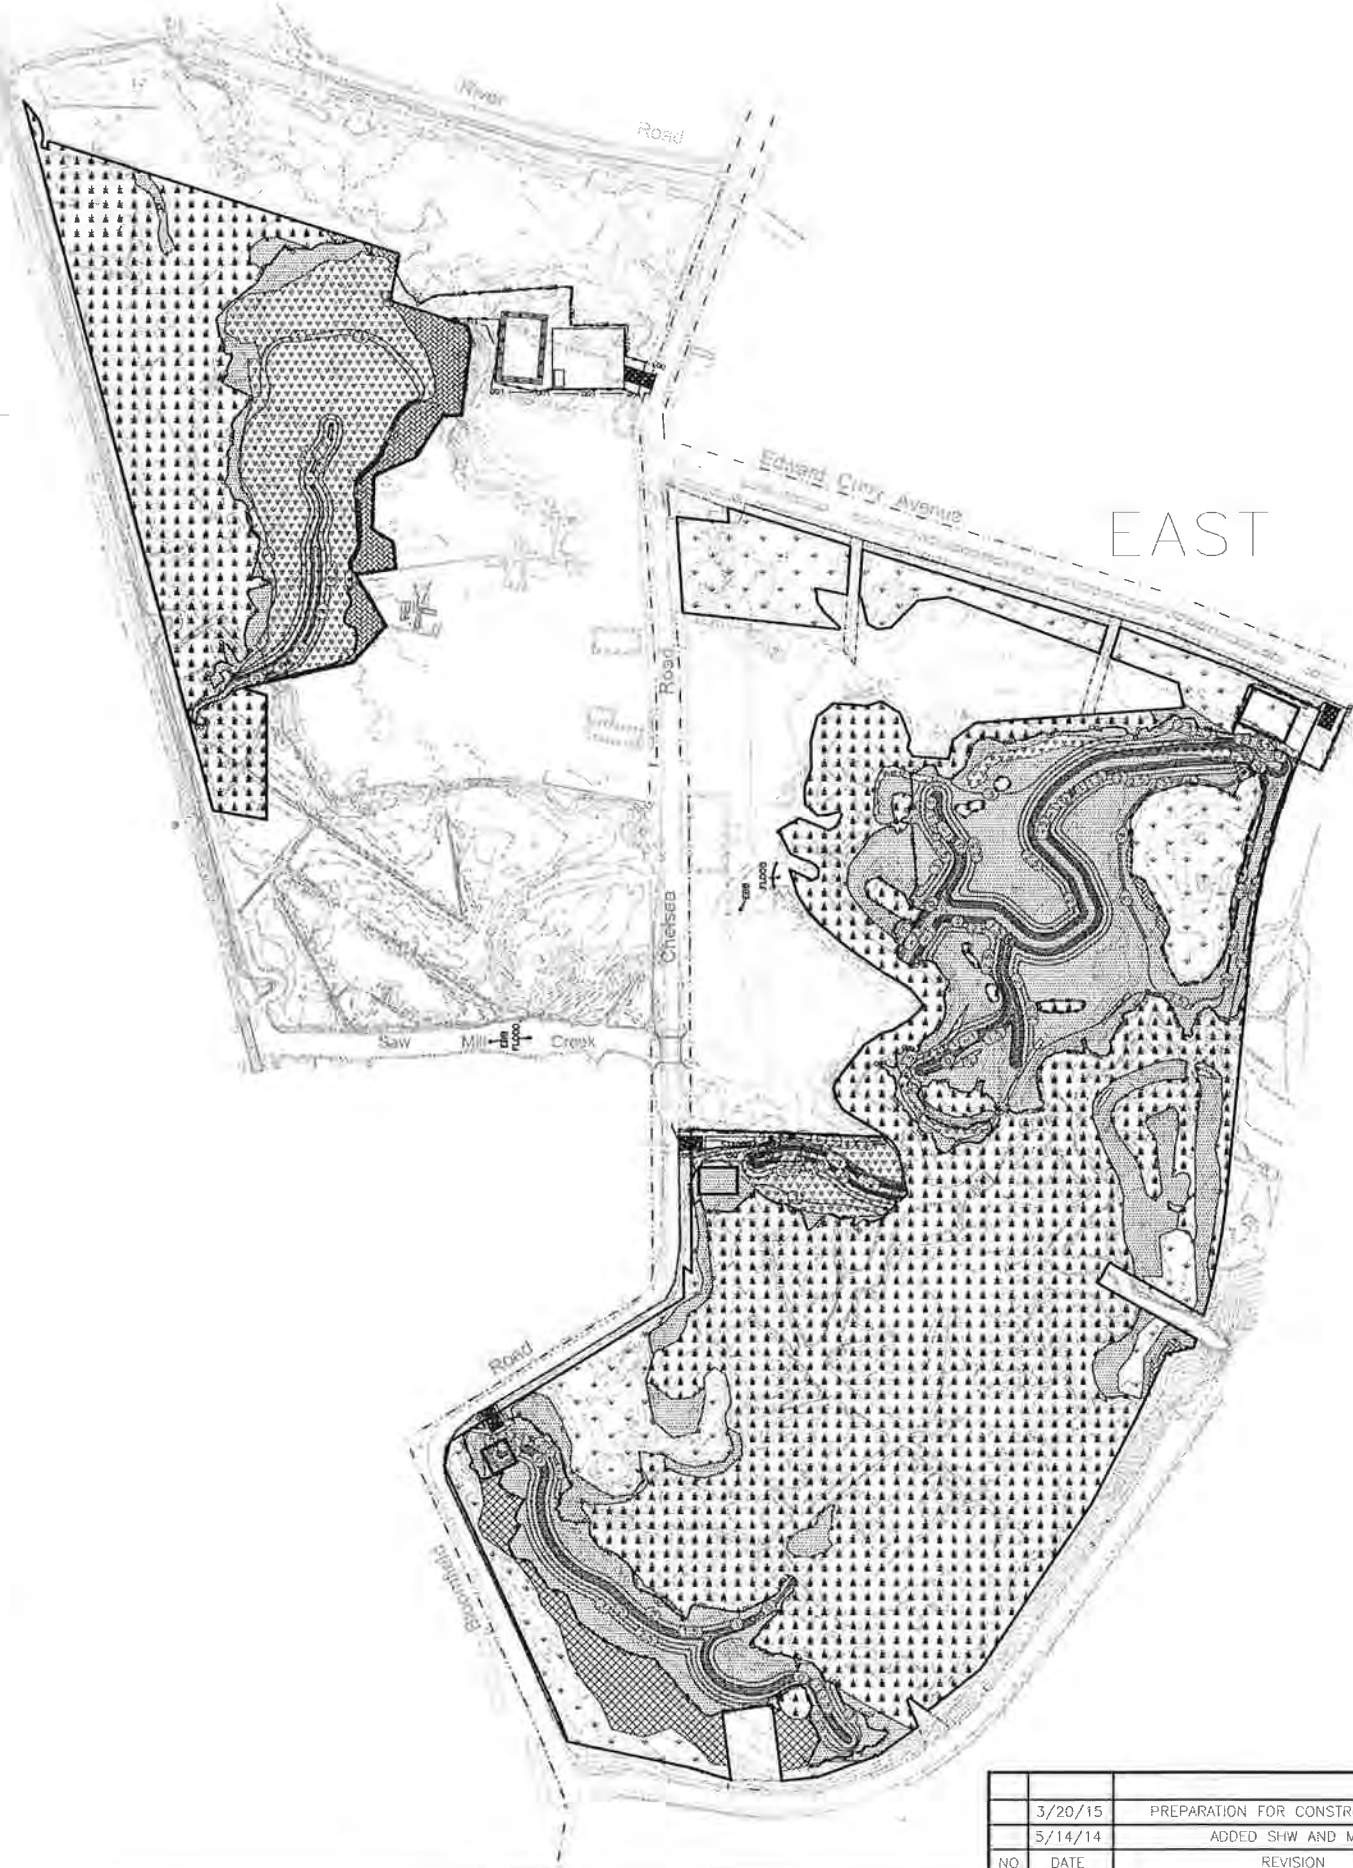
HABITAT AREAS				
TYPE	SYMBOLS	WEST	EAST	TOTAL
WETLAND RESTORATION (REHABILITATION)		1.02 ACRES	15.70 ACRES	16.72 ACRES
WETLAND RESTORATION (RE-ESTABLISHMENT)		5.17 ACRES	1.87 ACRES	7.04 ACRES
TIDAL WETLAND ENHANCEMENT		7.69 ACRES	26.03 ACRES	33.72 ACRES
FORESTED WETLAND ENHANCEMENT		0.00 ACRES	1.52 ACRES	1.52 ACRES
UPLAND SLOPE		1.12 ACRES	0.33 ACRES	1.45 ACRES
BUFFER REHABILITATION		0.00 ACRES	8.49 ACRES	8.49 ACRES
TOTAL		15.00 ACRES	53.94 ACRES	68.94 ACRES

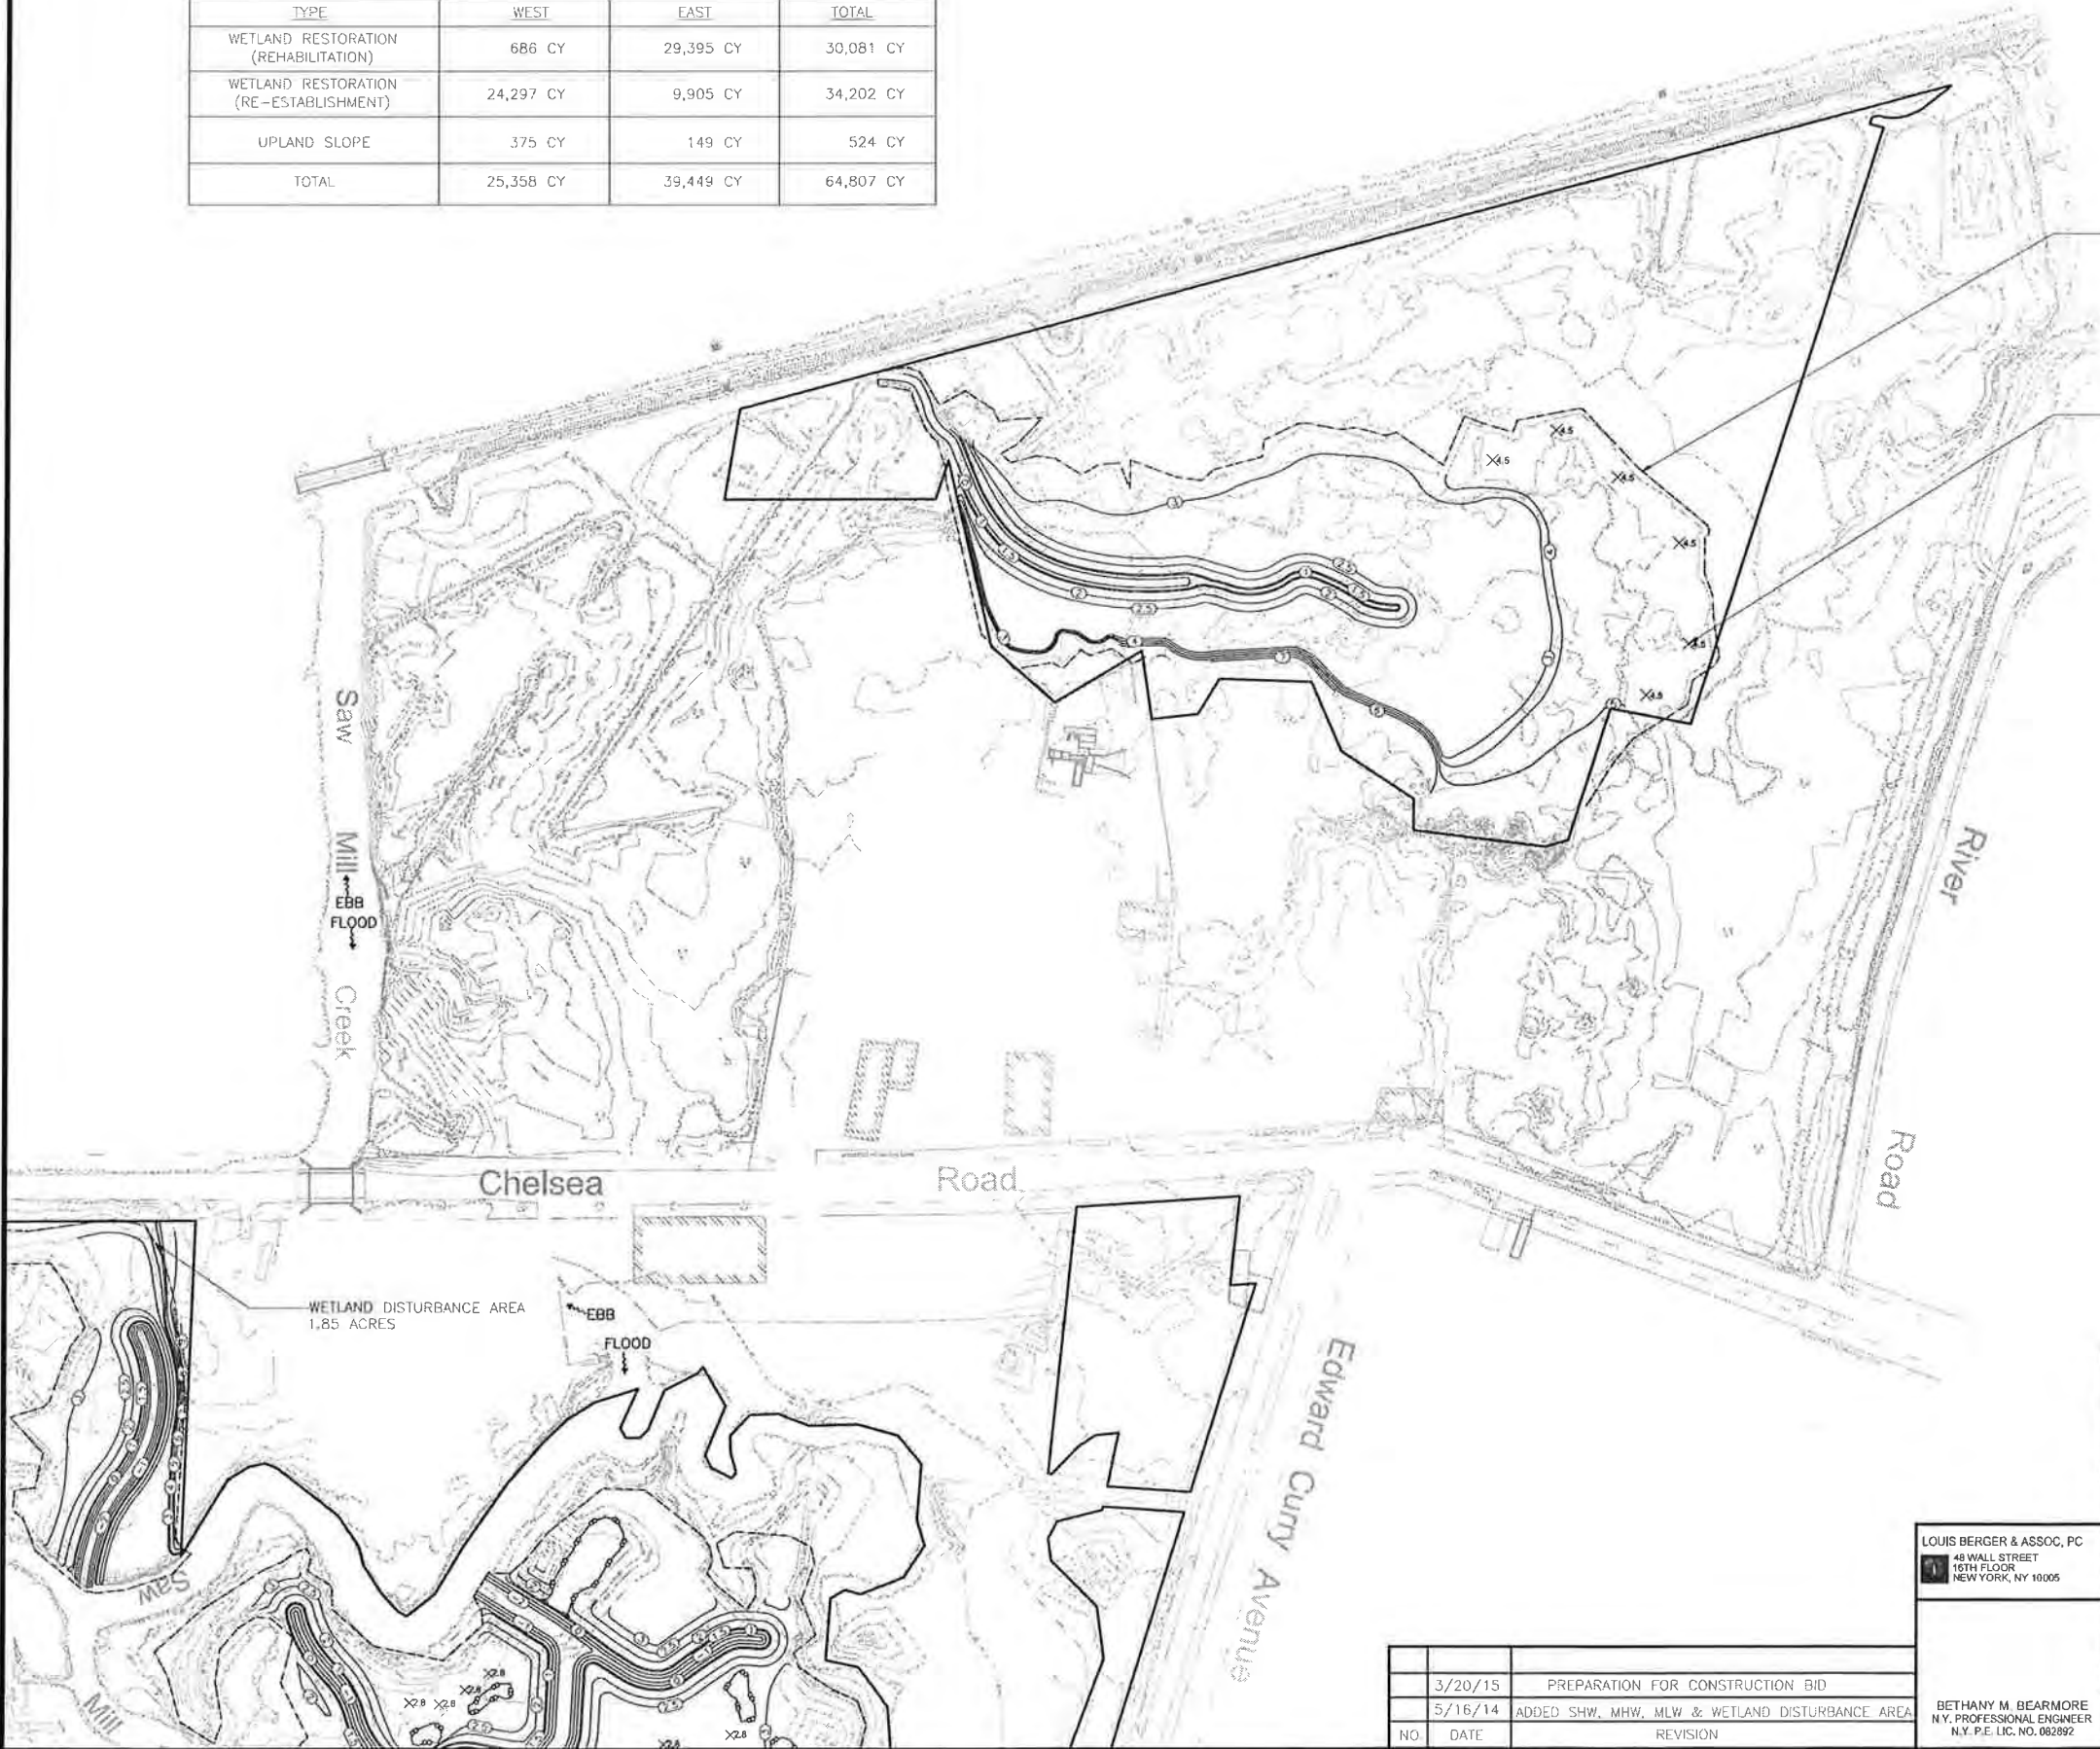
EXCAVATION BY HABITAT AREAS			
TYPE	WEST	EAST	TOTAL
WETLAND RESTORATION (REHABILITATION)	686 CY	29,395 CY	30,081 CY
WETLAND RESTORATION (RE-ESTABLISHMENT)	24,297 CY	9,905 CY	34,202 CY
UPLAND SLOPE	375 CY	149 CY	524 CY
TOTAL	25,358 CY	39,449 CY	64,807 CY

WETLAND DISTURBANCE AREA  
0.34 ACRES

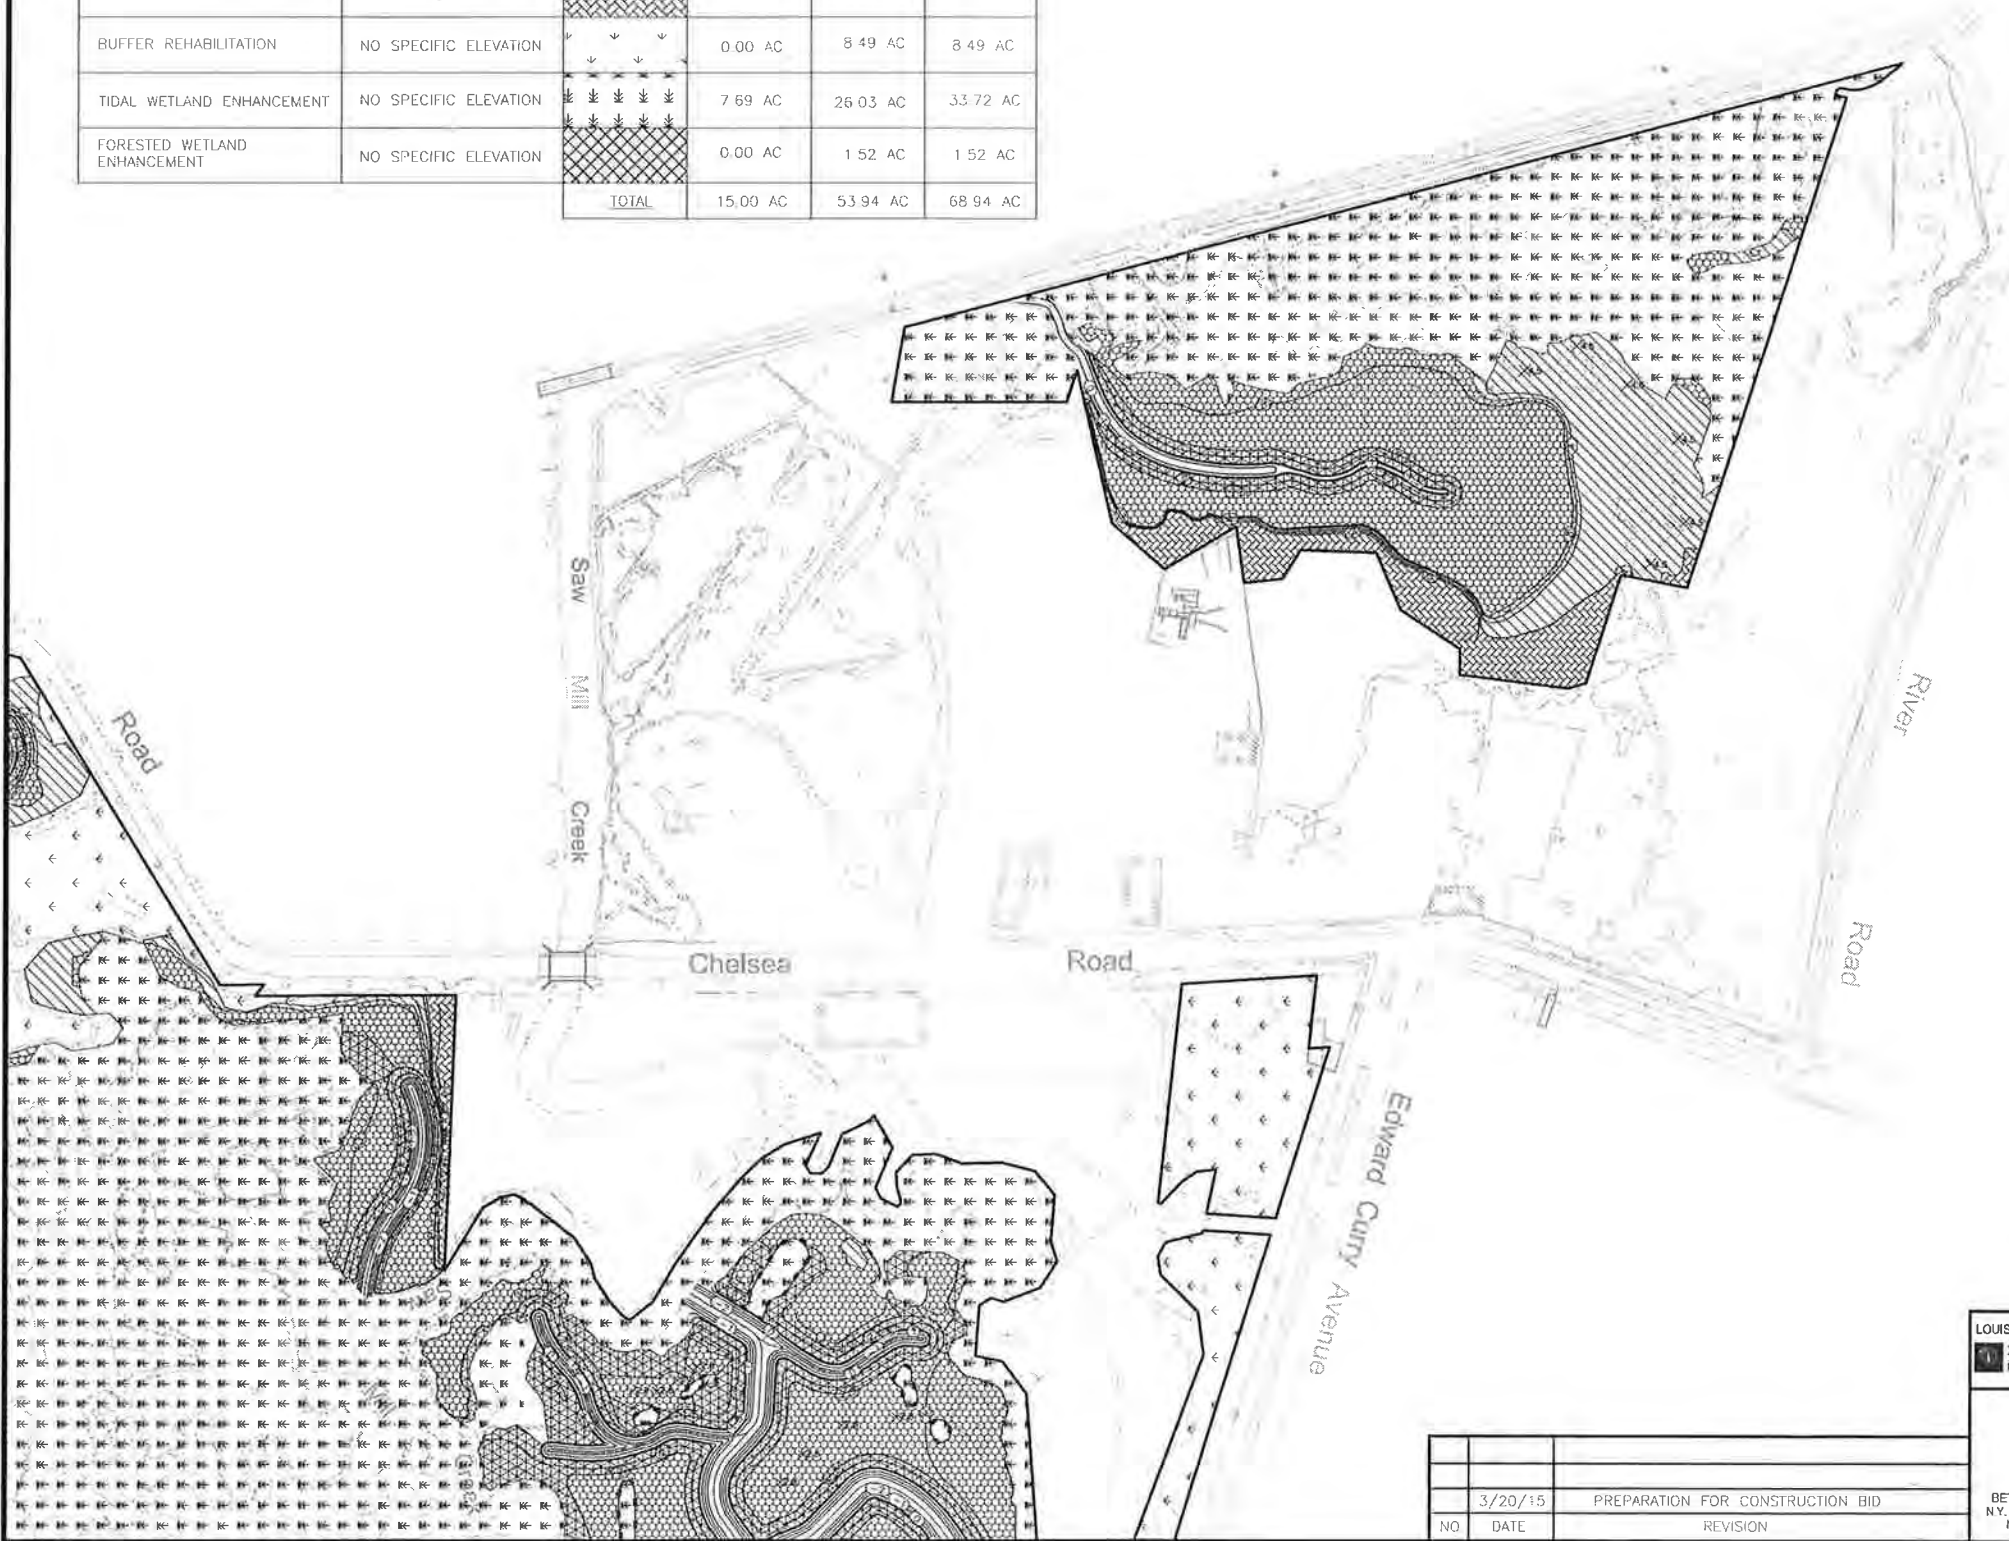
HABITAT ZONES					
HABITAT_ZONE	HABITAT ELEVATION RANGE	HATCHING	WEST	EAST	TOTAL
WETLAND RESTORATION OPEN WATER/MUDFLAT	< 1.5 FEET		0.26 AC	2.79 AC	3.05 AC
WETLAND RESTORATION LOW MARSH	1.5 FEET - 2.5 FEET		0.58 AC	5.21 AC	5.79 AC
WETLAND RESTORATION HIGH MARSH	2.5 FEET - 3.5 FEET		3.41 AC	7.95 AC	11.36 AC
WETLAND RESTORATION SCRUB SHRUB	3.5 FEET - 5.0 FEET		1.94 AC	1.62 AC	3.56 AC
UPLAND SLOPE	> 5.0 FEET		1.12 AC	0.33 AC	1.45 AC
BUFFER REHABILITATION	NO SPECIFIC ELEVATION		0.00 AC	8.49 AC	8.49 AC
TIDAL WETLAND ENHANCEMENT	NO SPECIFIC ELEVATION		7.69 AC	26.03 AC	33.72 AC
FORESTED WETLAND ENHANCEMENT	NO SPECIFIC ELEVATION		0.00 AC	1.52 AC	1.52 AC
TOTAL			15.00 AC	53.94 AC	68.94 AC

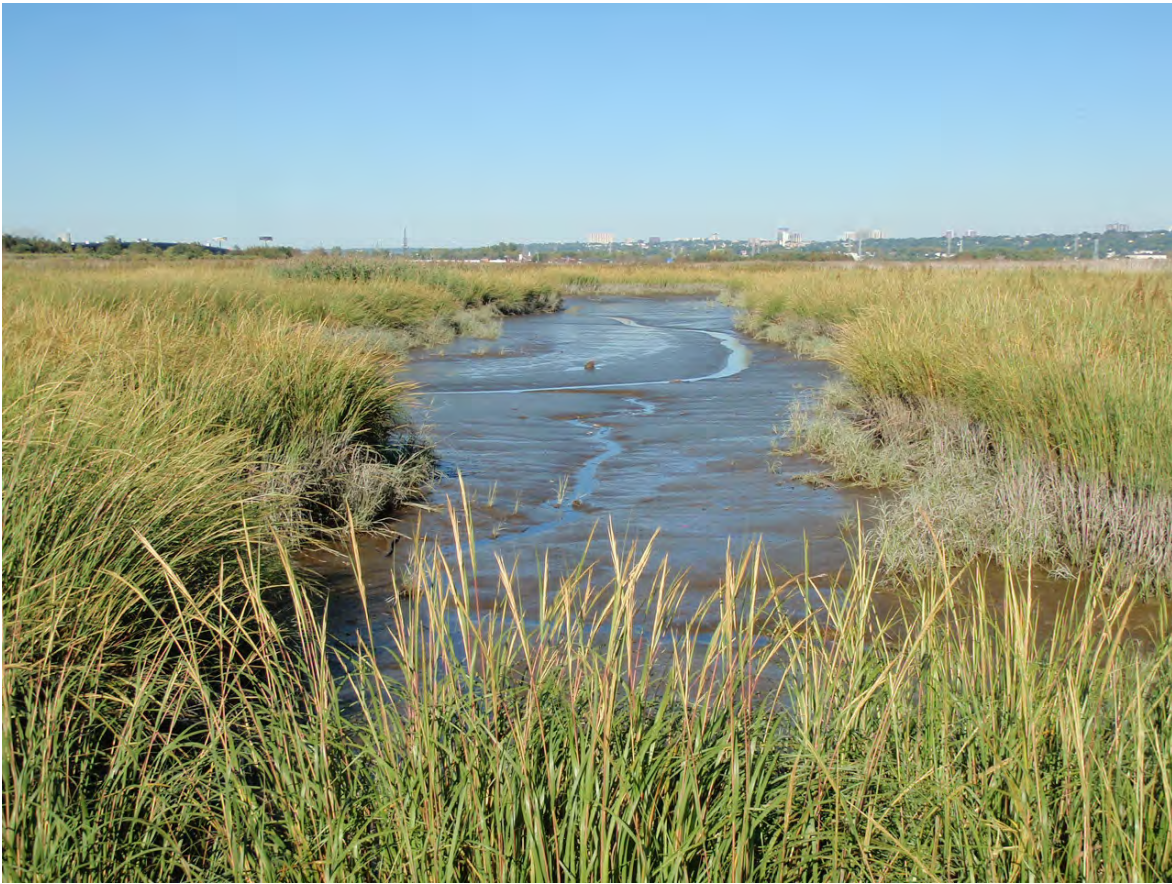
Figure 2. 2013 photograph of the Marsh Resources, Inc (MRI) Wetland Mitigation Bank that was constructed in 1999 and 2002. The photo shows the tidal channels and marsh 10+ years after construction (and after Hurricanes Irene & Sandy).

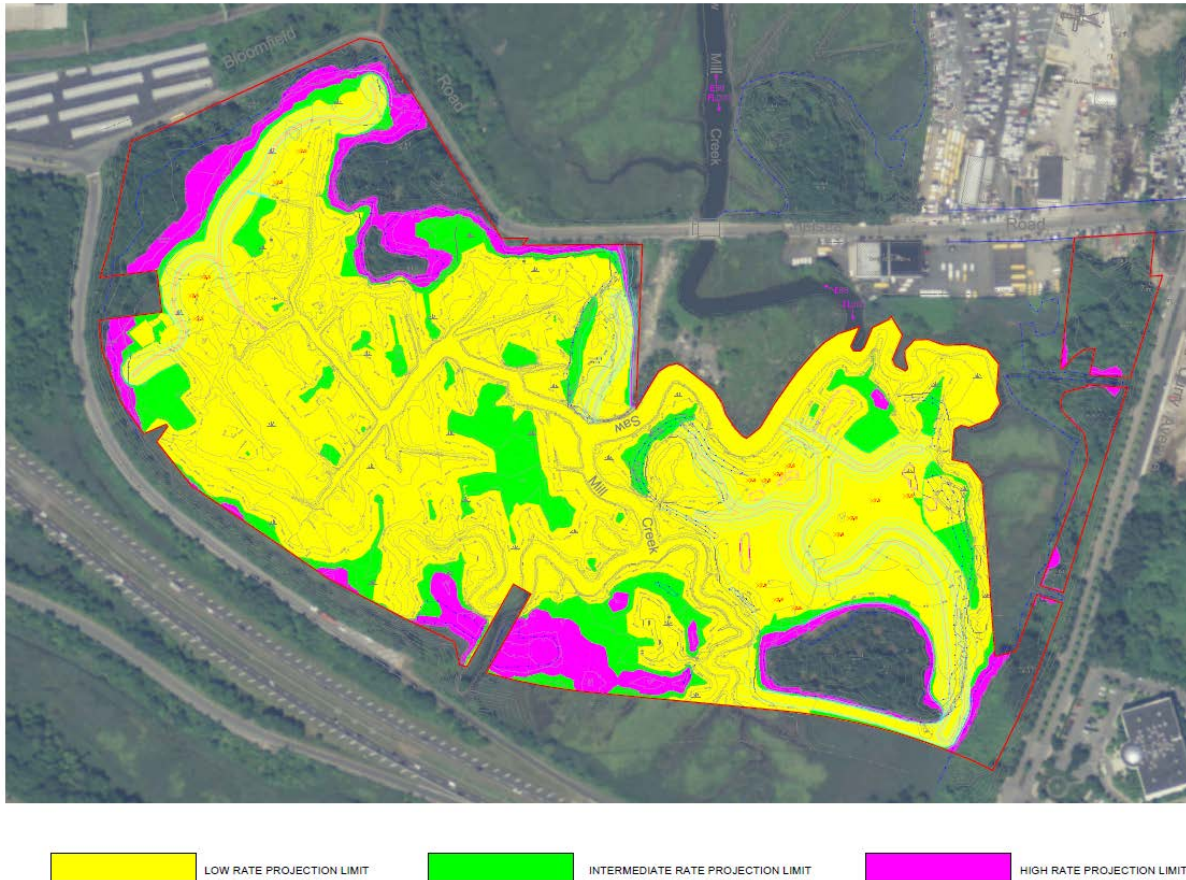
**Figure 5: Projected sea level rise extent in eastern marsh**
