Project #11750  
Addendum #3  
Date 9/18/26

**TABLE E-1**  
**SUMMARY OF THE OVERALL CONDITION RATINGS AND COSTS**  
**AT HUNTS POINT CORRECTIONS BULKHEAD AND VERNON C. BAINE**  
**CORRECTIONS CENTER FLOATING DETENTION BARGE**

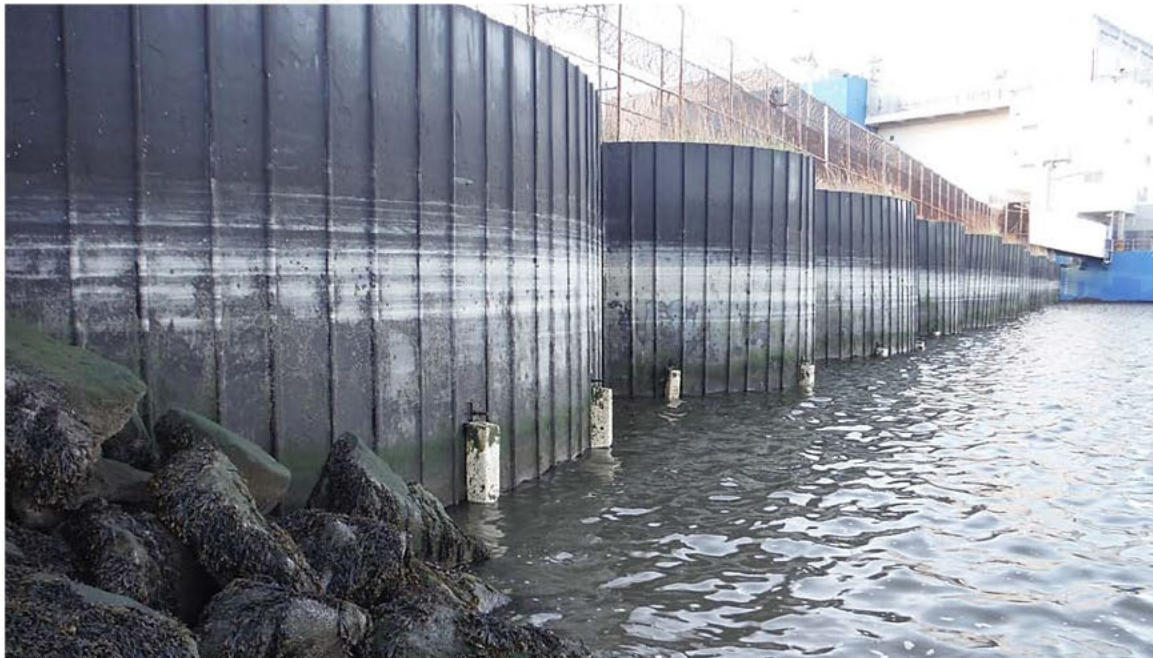
**Photo 3.1-1:** Overall view of the cellular steel sheet pile cofferdam (west leg) as viewed from Cell 25 looking south. Note the anodes above the water's surface.

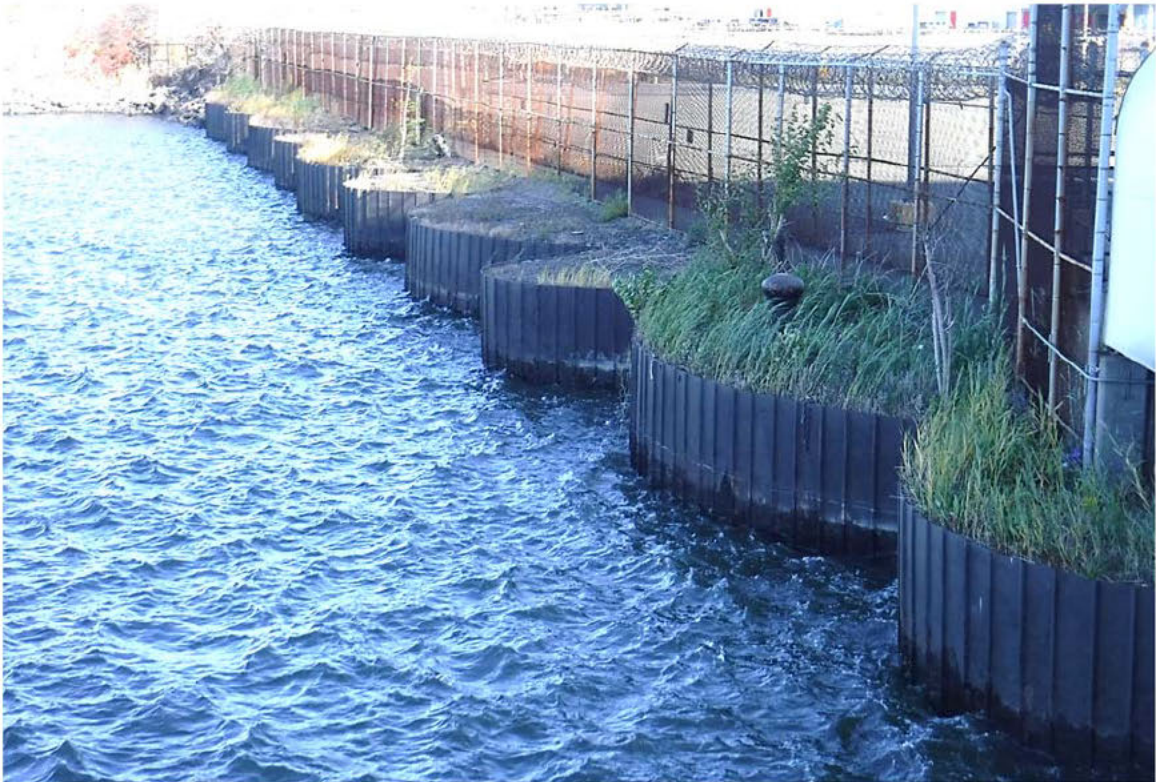
**Photo 3.1-2:** Overall view of the cellular steel sheet pile cofferdam (west leg) as viewed from Cell 15 looking north.

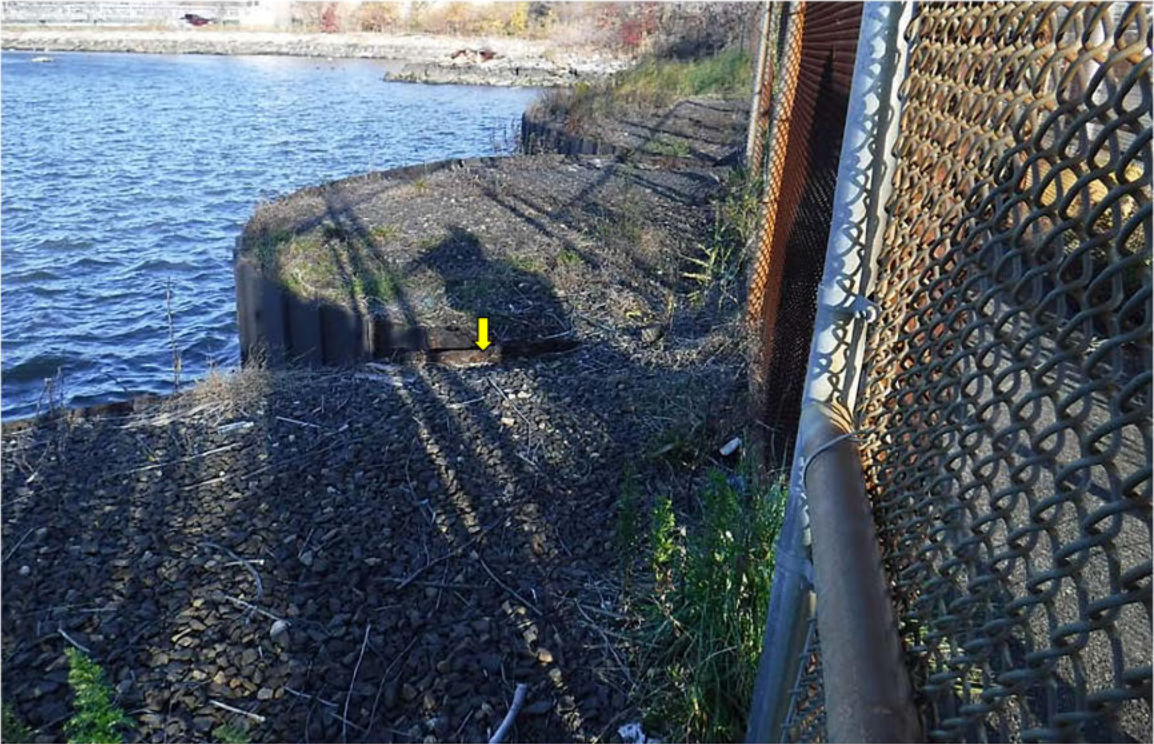
**Photo 3.1-9:** Subsidence at the north side of Cell 21 at approximately Sta. 1+22.

In general, the steel components comprising each of the systems exhibit coating loss with varying degrees of corrosion. The cellular cofferdam and transition bulkhead exhibit coating failure with corrosion throughout exposed surfaces above mean low water. In addition, where sinkholes and subsided areas exist, these should be filled and graded. The topside is overgrown and should be cleared.

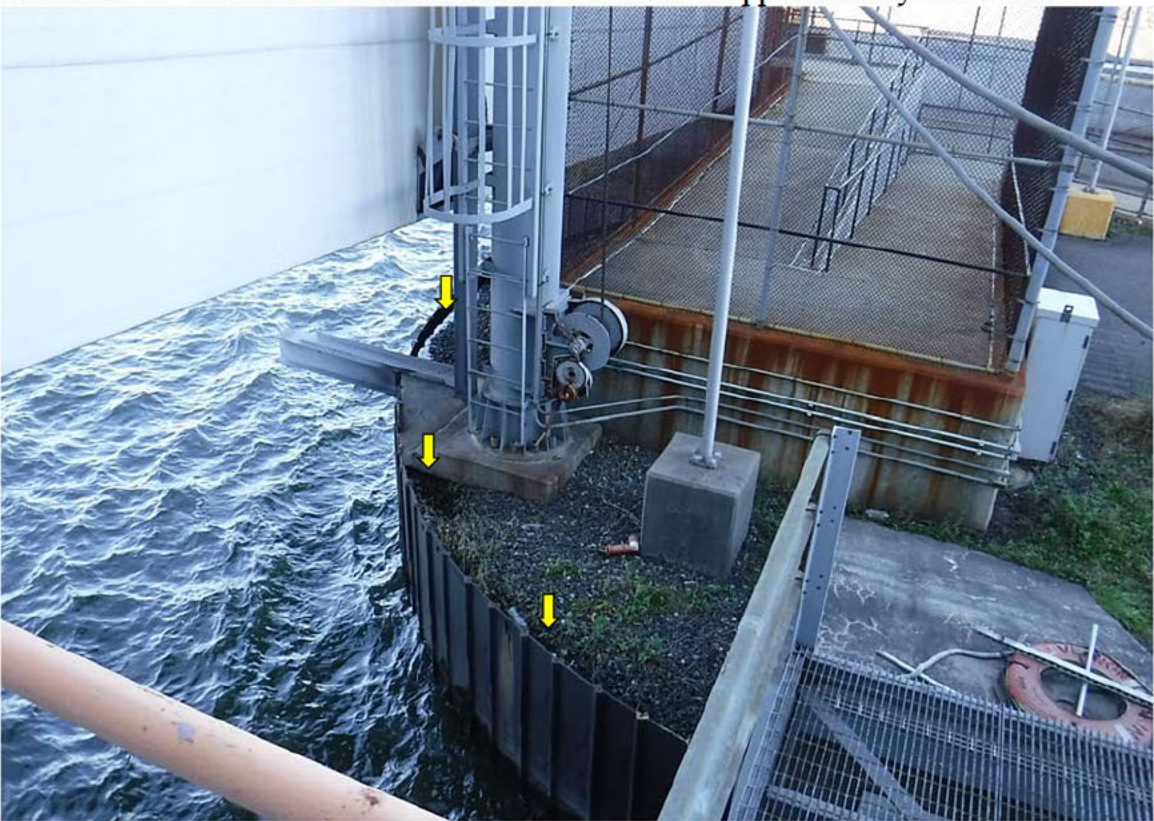
**Photo 3.1-10:** Various sinkholes along the sheet piles at Cell 15.

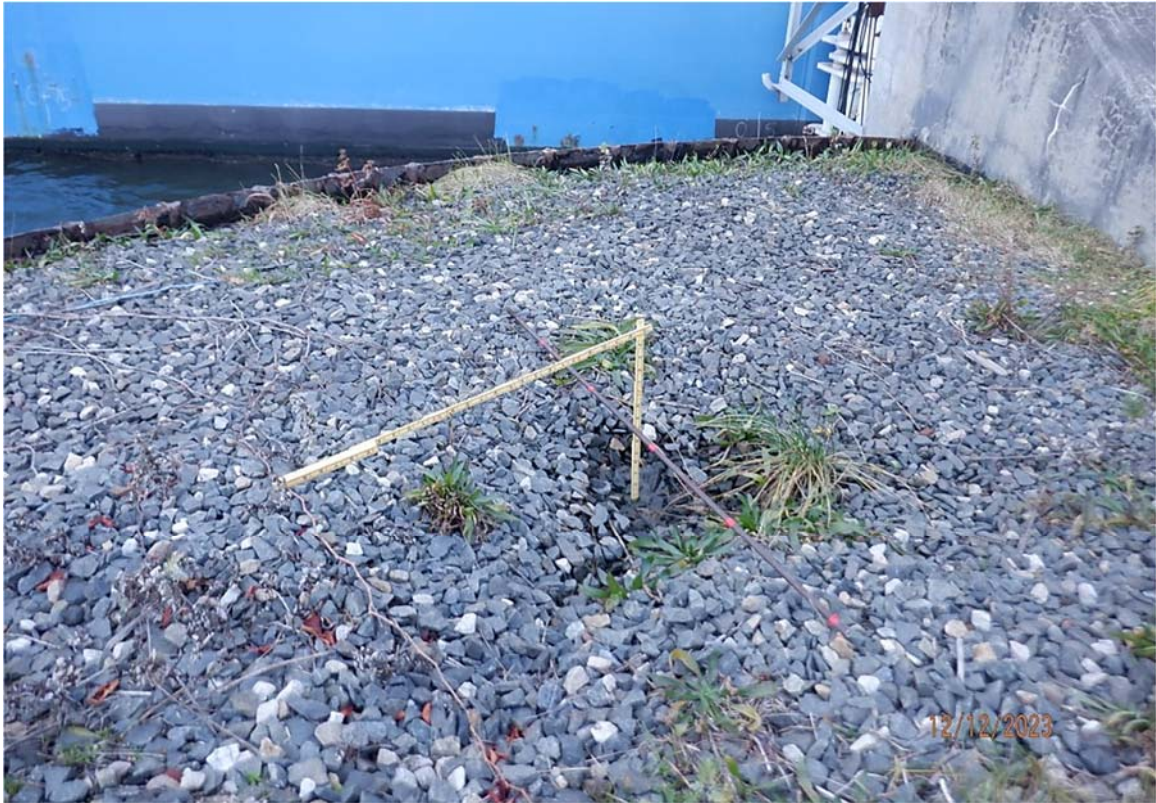
**Photo 3.1-11:** Minor sinkhole at Cell 15.

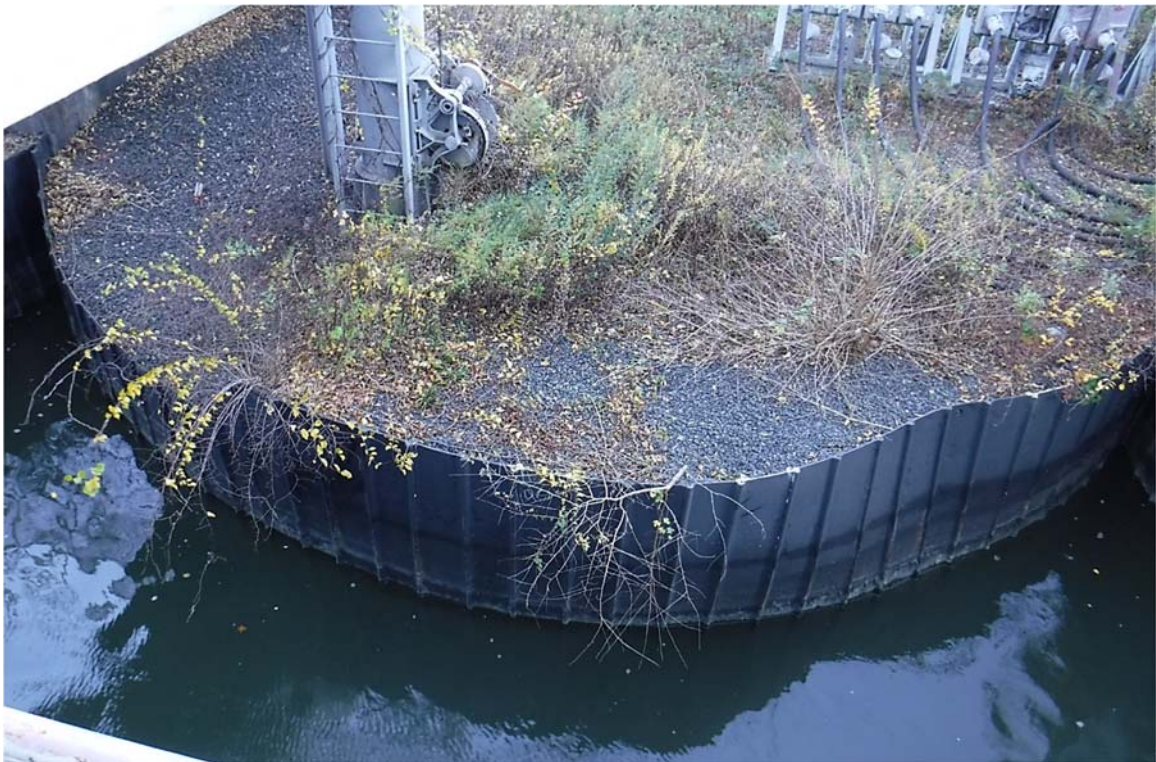
**Photo 3.1-12:** East side of Cell 3 is deformed, likely due to barge impact during installation.

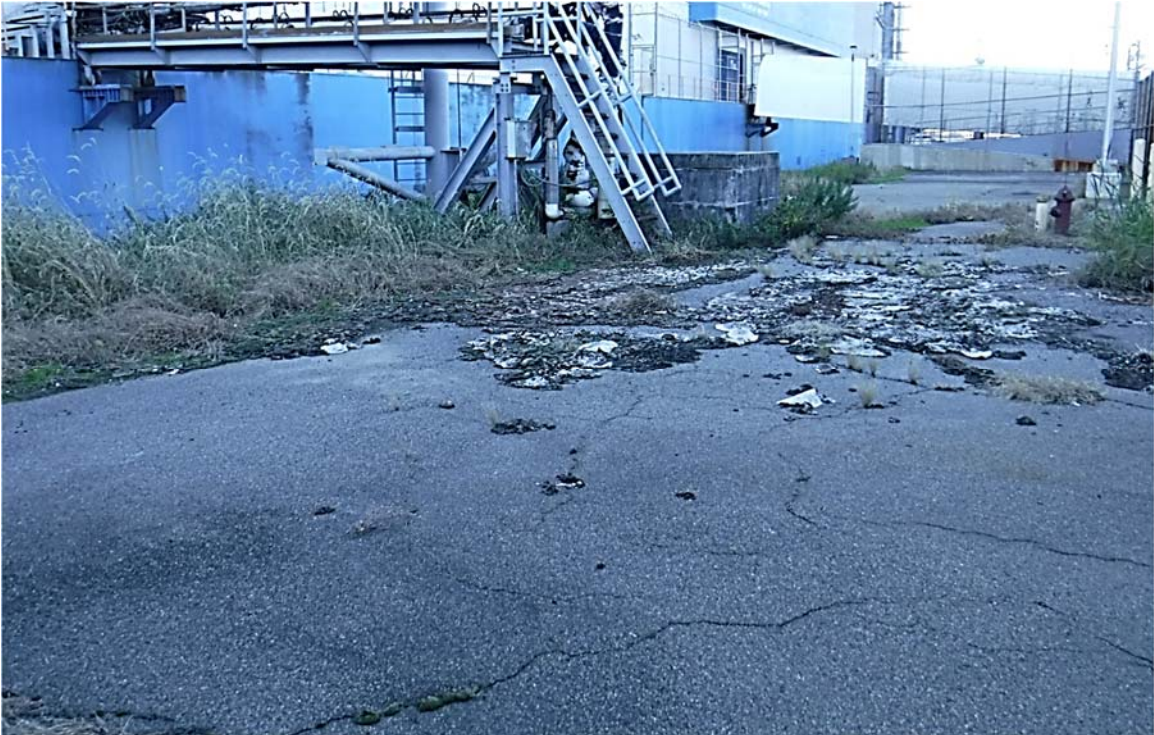
**Photo 3.1-13:** General view of the topside looking west of Cell 4. Note the remnant sanitary waste. The asphalt pavement is generally worn, uneven and contains many cracks. Also note the heavy overgrowth.

| Action Type | Description | Implementation Date | Total Cost (2024 USD) |
|---|---|---|---|
| | Repave worn/damaged pavement surfaces | FY 2027 | \$304,112 |

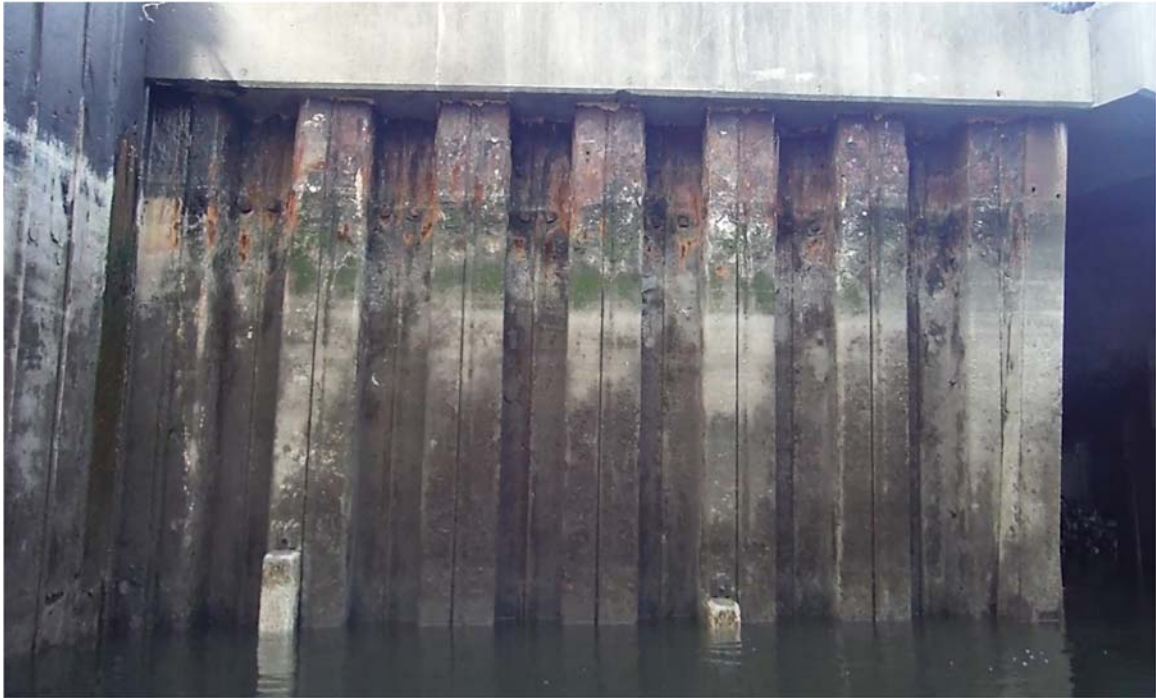
In the splash zone above MHW, the coating has completely failed and exhibits moderate to advanced corrosion. This zone is highly susceptible to regular continuous cyclical wetting and oxidation that promotes more aggressive corrosion. Table 3.2-2 summarizes the observed conditions. Photo 3.2-1 depicts an overall view of the Transition Bulkhead at MLW, and Photo 3.2-2 provides a closeup of the steel corrosion in the splash zone above MHW.

**Photo 3.2-1:** Overall view of the Transition Bulkhead sheet piles at MLW. Note two anodes protrude above the waterline.

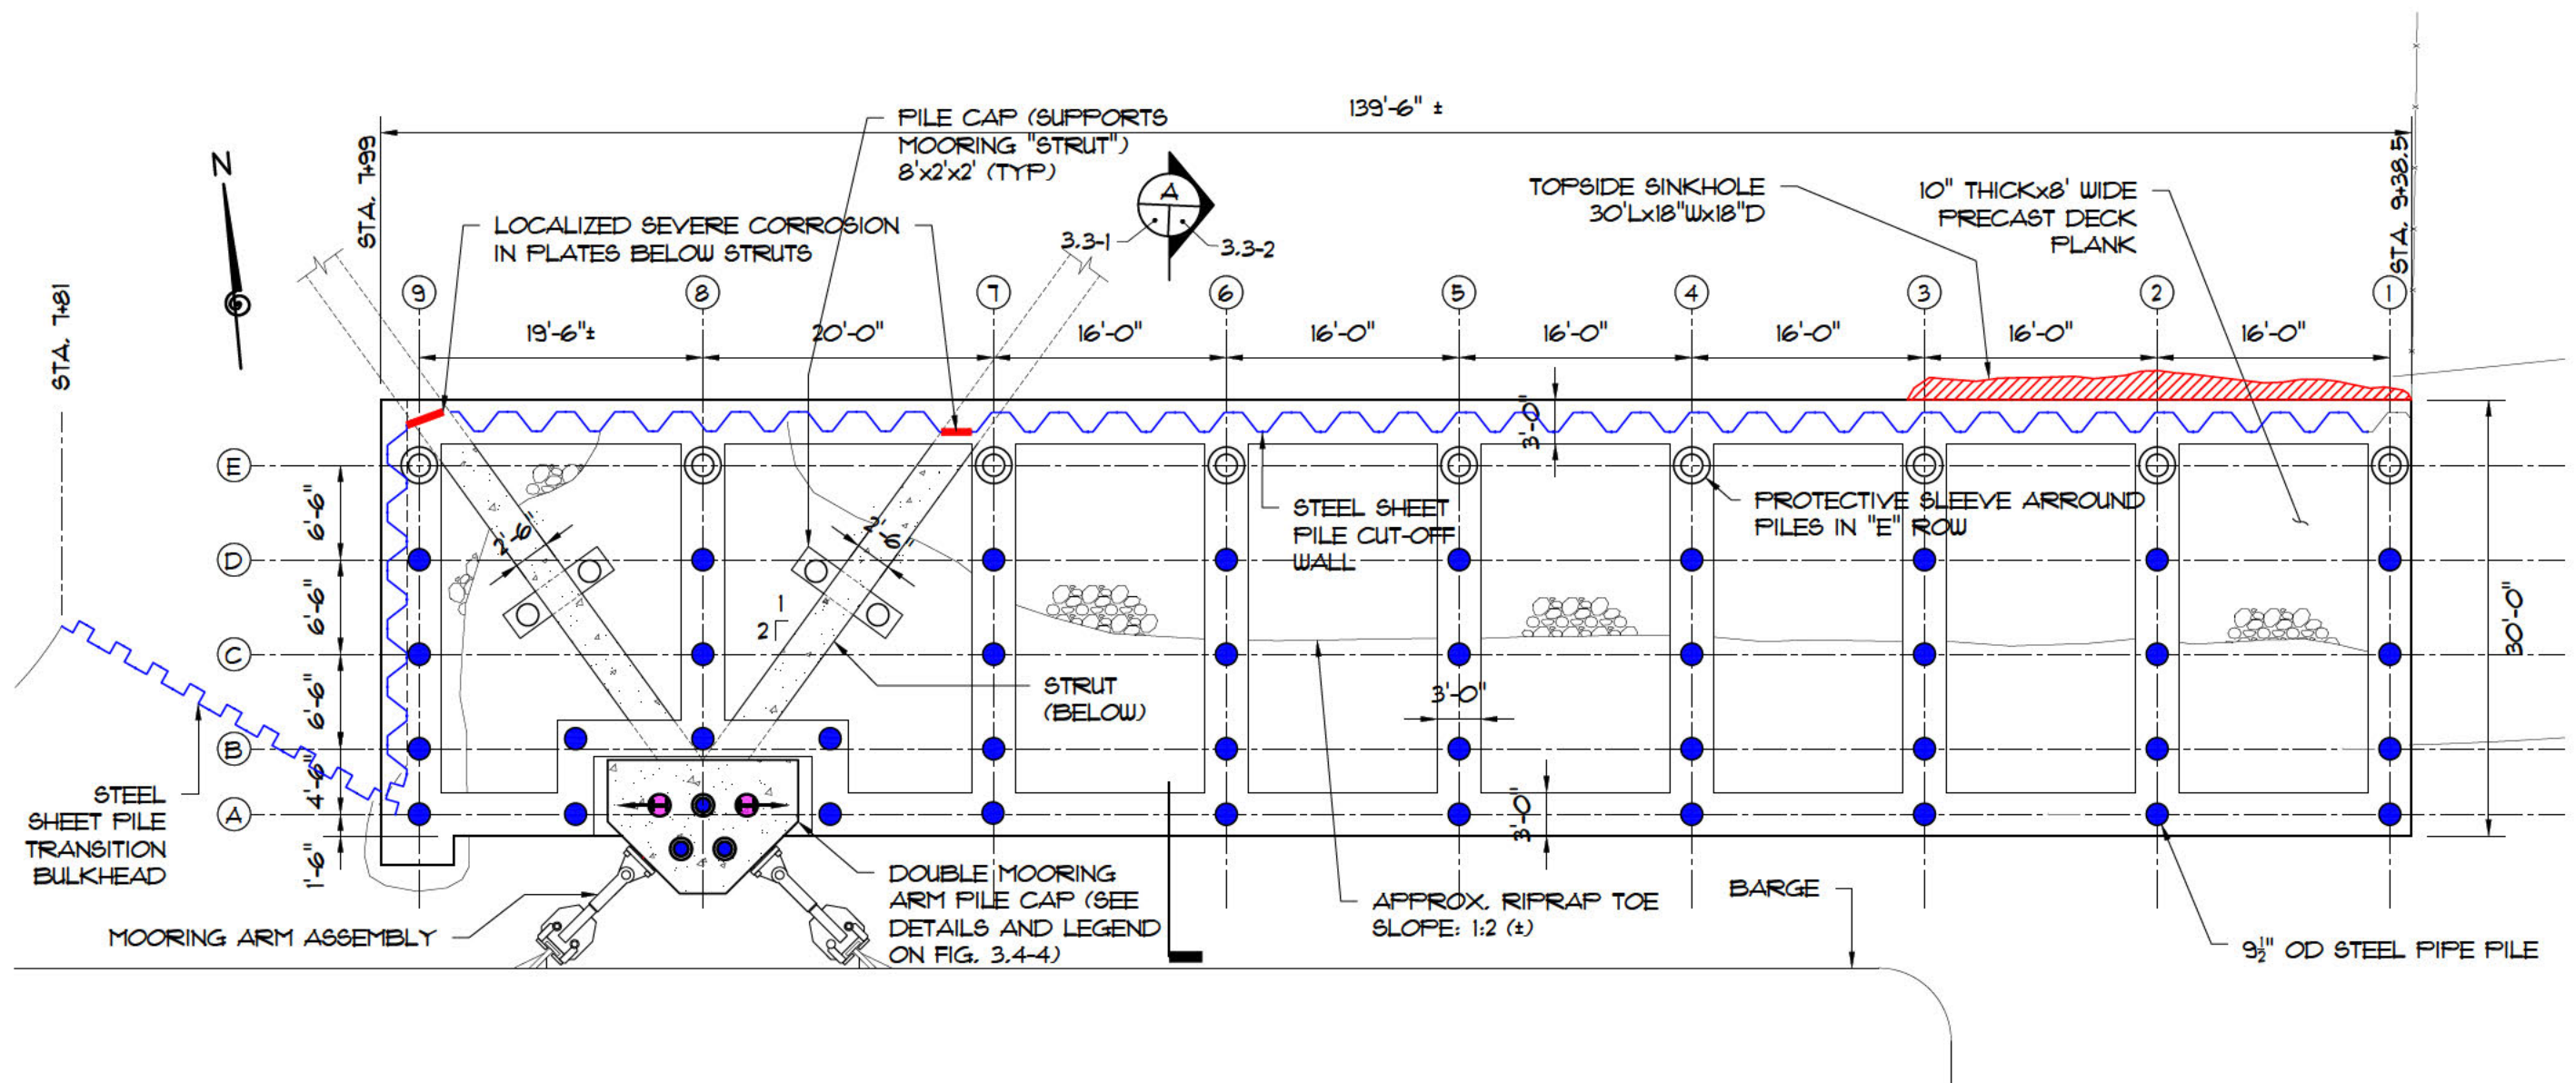
1  
3.3-1  
FILE AND PILE CAP PLAN  
HIGH-LEVEL PLATFORM

- SEVERE COATING LOSS WITH MINOR TO MODERATE CORROSION OF STEEL IN TOP 3 FT TO 4 FT OF PILE.

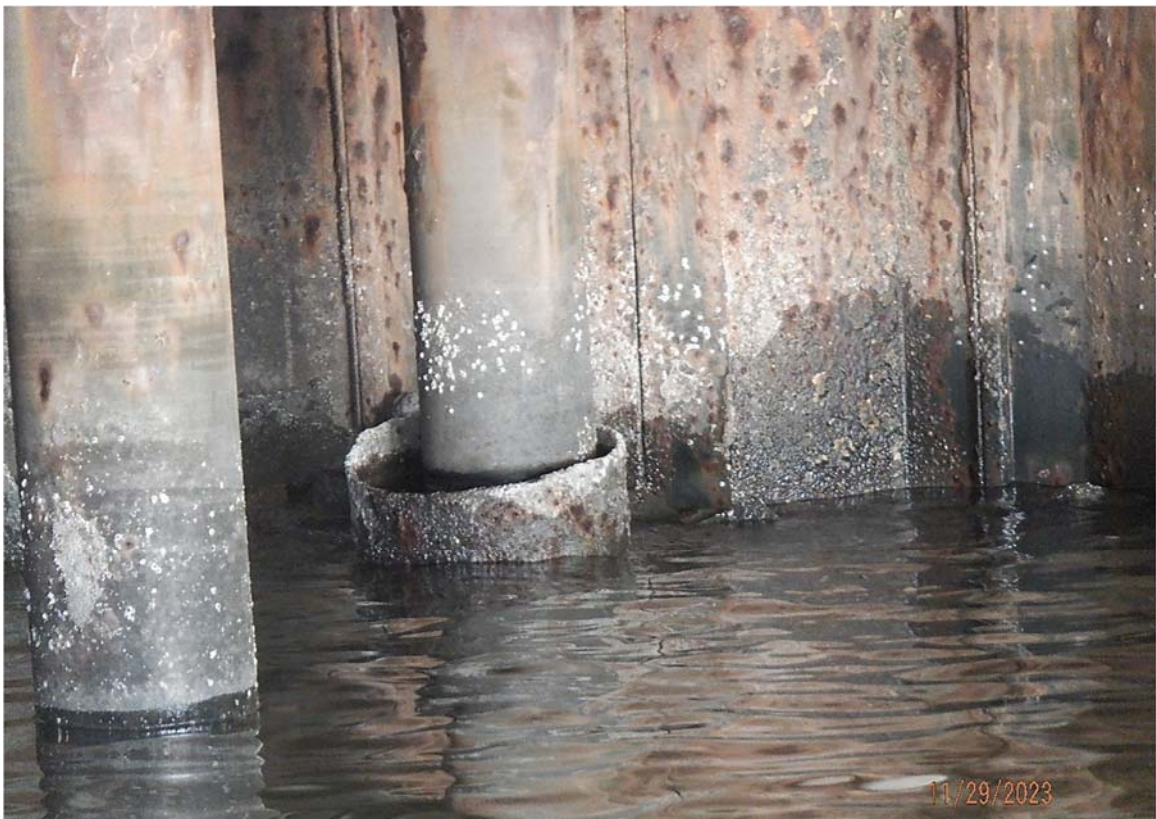
**Photo 3.3-2:** Example of a protective pile sleeve along the "E" row.

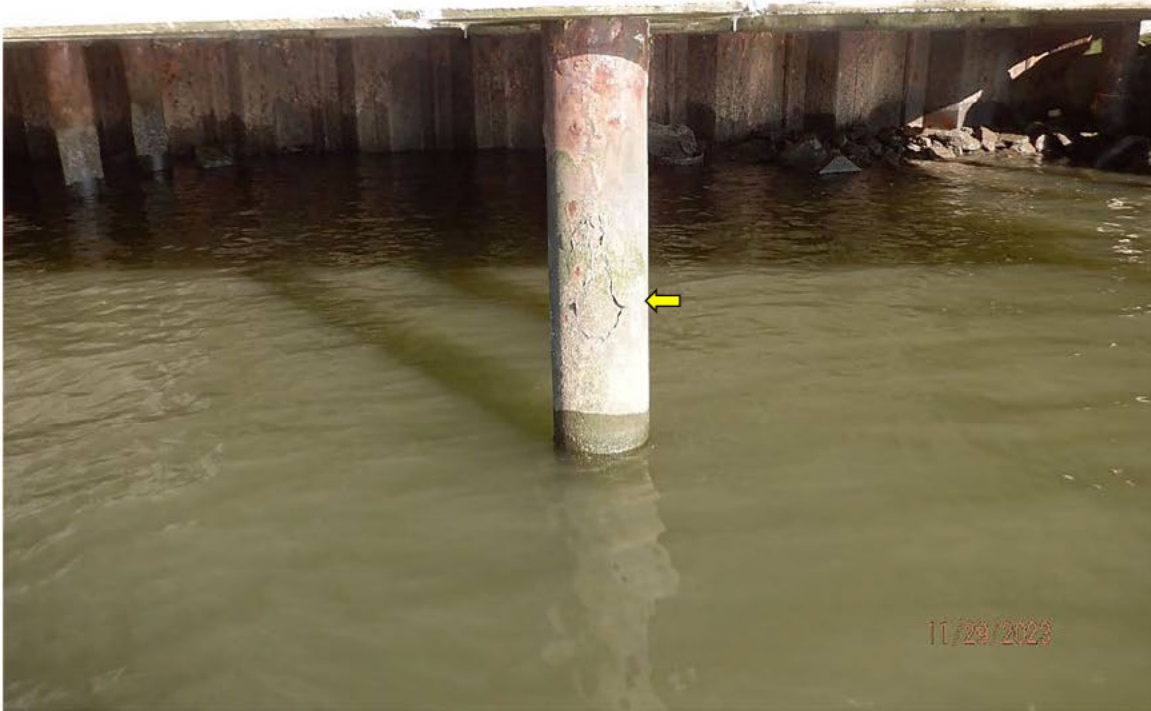
**Photo 3.3-3:** Typical minor coating loss in the tidal zone.

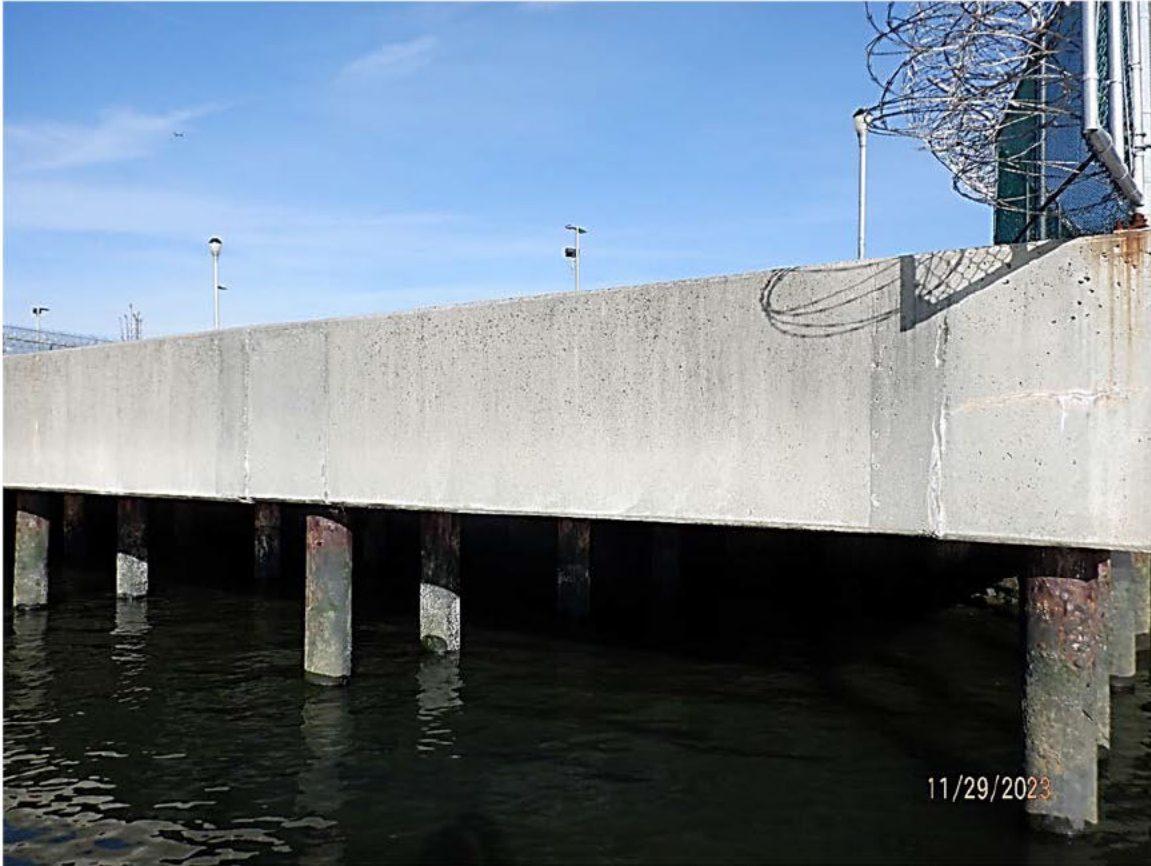
**Photo 3.3-4:** Elevation view of the edge beam along the High-Level Platform.

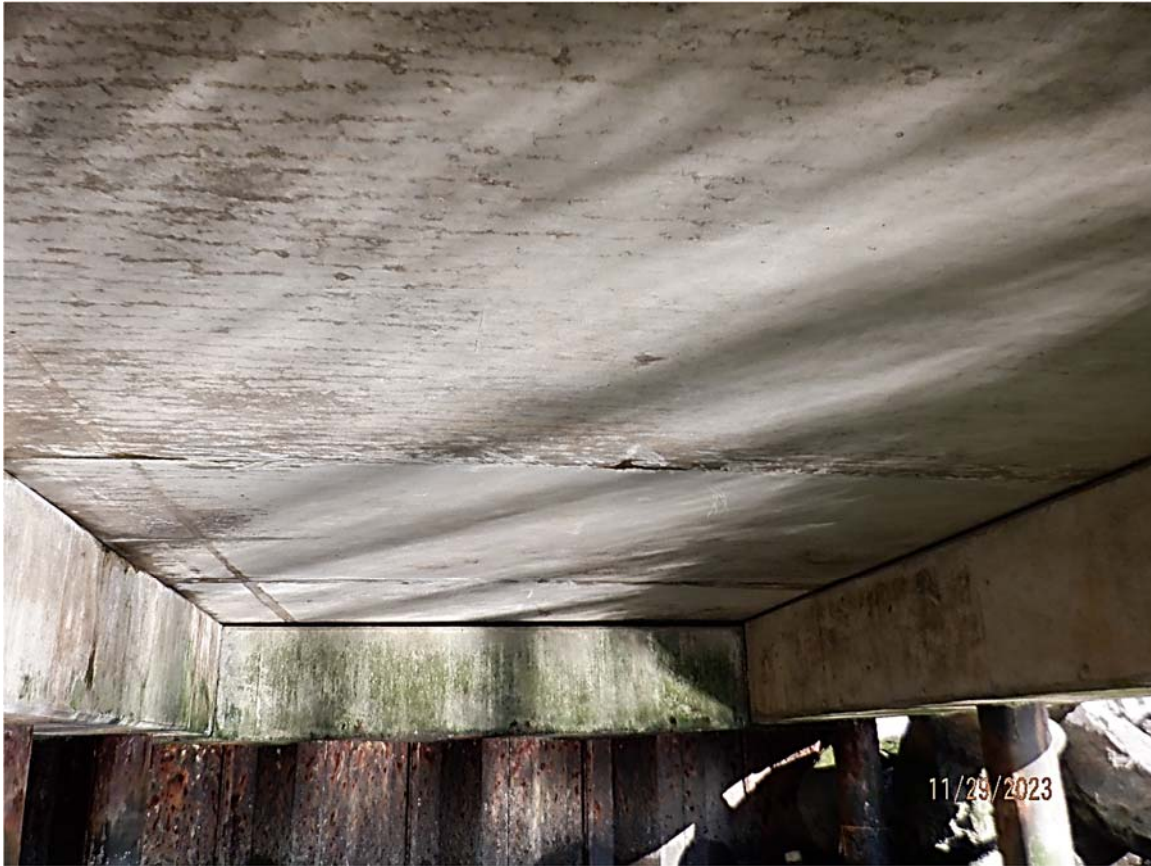
**Photo 3.3-5:** Typical condition of the precast concrete deck underside.

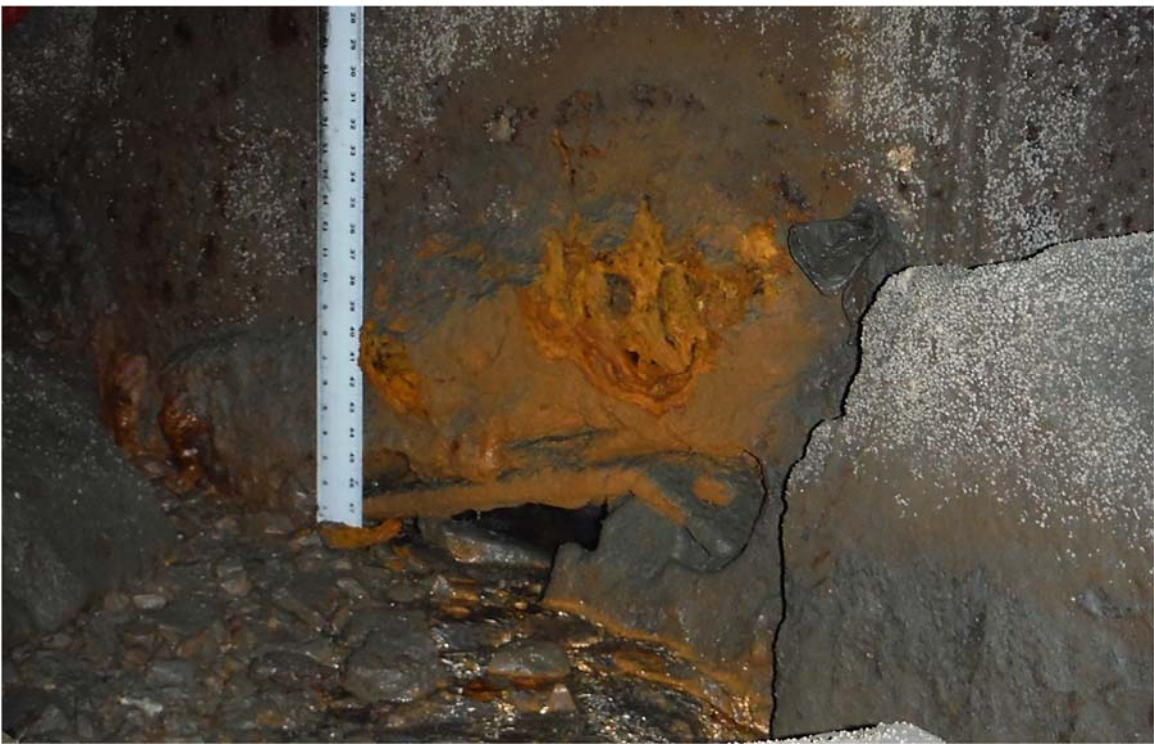
The steel pipe piles supporting High-Level Platform exhibit moderate corrosion above mean low water. Similarly, the steel sheet pile cutoff wall exhibits coating failure and corrosion. Where the mooring arm struts penetrate the cutoff wall, the steel contains severe corrosion and voids behind the sheet piles. These areas should

**Photo 3.3-7:** Severe localized corrosion and corrosion hole in steel plate below the west strut of the double-bit mooring arm. Note the void through the hole.

| Action Type | Description | Implementation Date | Total Cost (2024 USD) |
|---|---|---|---|
| | Clean and recoat the steel sheet pile cut-off wall above the riprap and patch the corrosion holes at the strut penetrations. | FY 2027 | \$345,481 |

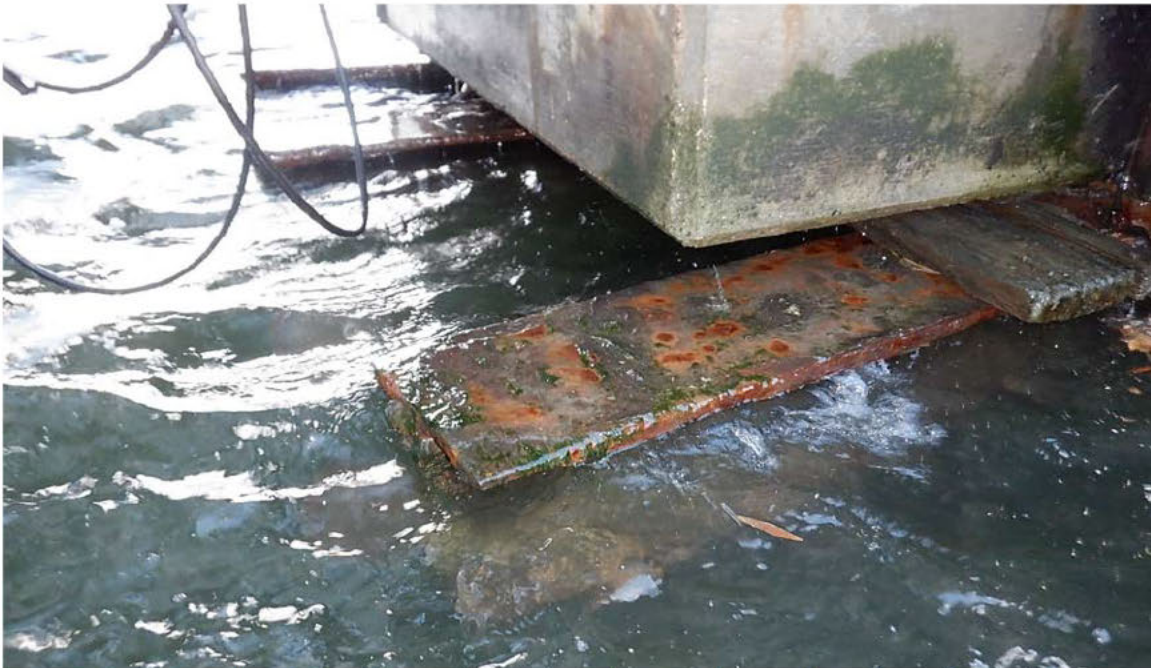
| Element | Description of Observed Conditions | Unit | Quantity |
|---|---|---|---|
| Support Bracket at the West Mooring Arm | All three knee-brackets supporting the overhanging edge of the cap exhibit moderate to advanced corrosion on the cantilevered beams extending out from the bulkhead, and on the diagonal knee braces. The western knee brace contains a corrosion hole through the web. The function of the brackets, however, is uncertain since there exists a 4" to 6" gap between the top of the steel bracket and the underside of the concrete cap. Timber shims have dislodged and a load path to the bracket is no longer possible. | EA | 1 |

**Photo 3.4-4:** Coating loss with moderate corrosion on the steel bracket. Timber shims are missing between the steel bracket and the underside of the concrete.

The steel support bracket for the west mooring arm support cap is severely corroded and the shims between the bracket and the cap are no longer present. The brackets should be cleaned, reinforced, recoated, and shimmed. The steel pipe piles supporting the east mooring arm pile cap are mostly encased. However, the encasements do not extend to the underside of the cap, nor do they extend down to the mudline. The exposed steel exhibits corrosion and should be cleaned and encased in concrete. New encasements should be installed at the mudline also. The concrete pile cap for the east mooring arm contains excessive map cracks, and two approximately ¼" wide cracks that may be stress related, possibly due to the barge bottoming out on the mudline at mean low water. These cracks should be repaired using low-pressure injection of epoxy grout.

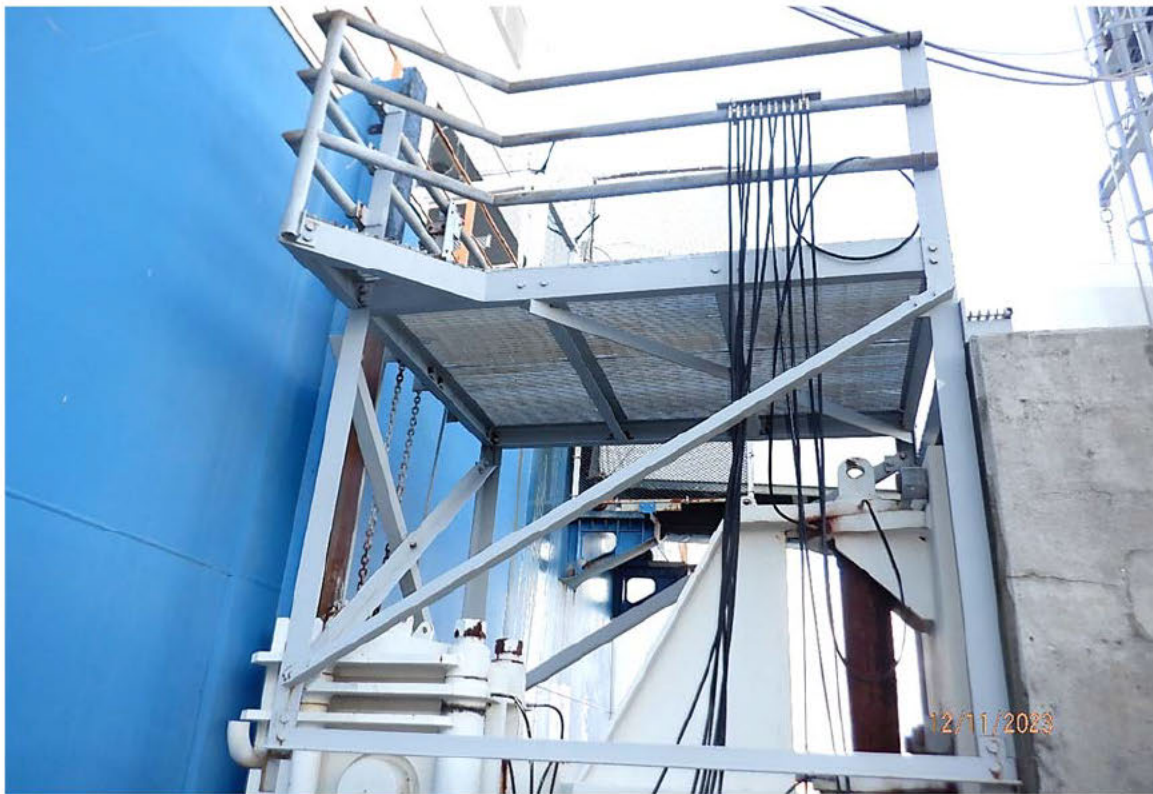
| Element | Description of Observed Conditions | Unit | Quantity |
|---|---|---|---|
| Catwalk at the West Mooring Arm | The components remain functional and the coating remains largely intact. The framing members and connections are satisfactorily attached and stable | EA | 1 |

**Photo 3.4-6:** Overall view of the catwalk at the West Mooring Arm.

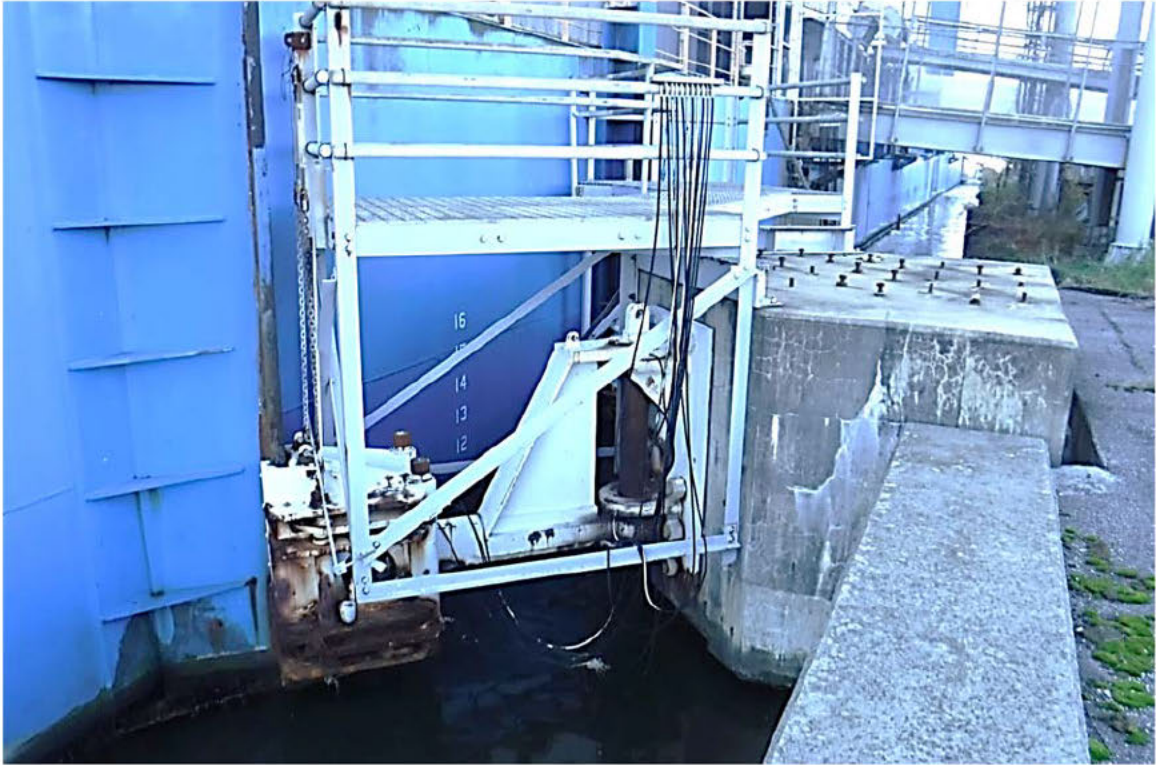
The double-leg mooring arm is located at the High-Level Platform (Sta. 8+21). The overall condition of the mooring arm is **Fair**. The steel elements exhibit coating failure with minor to moderate corrosion along the bottom of the assemblies immediately above the water surface. Affected components include the gripper clamps, pins, and stiffener plates. All grease fittings remain attached although the hoses dangle in the water at high tide. The steel anchor plates and anchor bolts mounted to the vertical face of the concrete support cap exhibit minor coating failure with corrosion at the bottom ends of the assemblies. All anchor bolts remain in place. The chain lift rod on both legs are detached and hanging on top of mooring arm and the gripper clamp on east leg is shifted northeast by approximately 3/4". However, the T-guides and clamps appear fully engaged and functional and the arms continue to operate as intended by design. Table 3.5-2 summarizes the observed conditions for the double-arm mooring assembly. Photos 3.5-1 and 3.5-2 depict the east elevation, and Photo 3.5-3 depicts the west elevation of the mooring arm.

| Element | Description of Observed Conditions | Unit | Quantity |
|---|---|---|---|
| Double-Leg Mooring Arm Assembly | The steel elements exhibit coating failure with minor to moderate corrosion along the bottom of the assemblies immediately above the water surface. Affected components include the gripper clamps, pins, and stiffener plates. All grease fittings remain attached although the hoses dangle in the water at high tide. The steel anchor plates and anchor bolts mounted to the vertical face of the concrete support cap exhibit minor coating failure with corrosion at the bottom ends of the assemblies. All anchor bolts remain in place. The chain lift rod on both legs are detached and hanging on top of mooring arm and the gripper clamp on east leg is shifted northeast by approximately 3/4". However, the T-guides and clamps appear fully engaged and functional and the arms continue to operate as intended by design. | EA | 1 |

**Photo 3.5-1:** Overall view of the east leg of the East Mooring Arm.

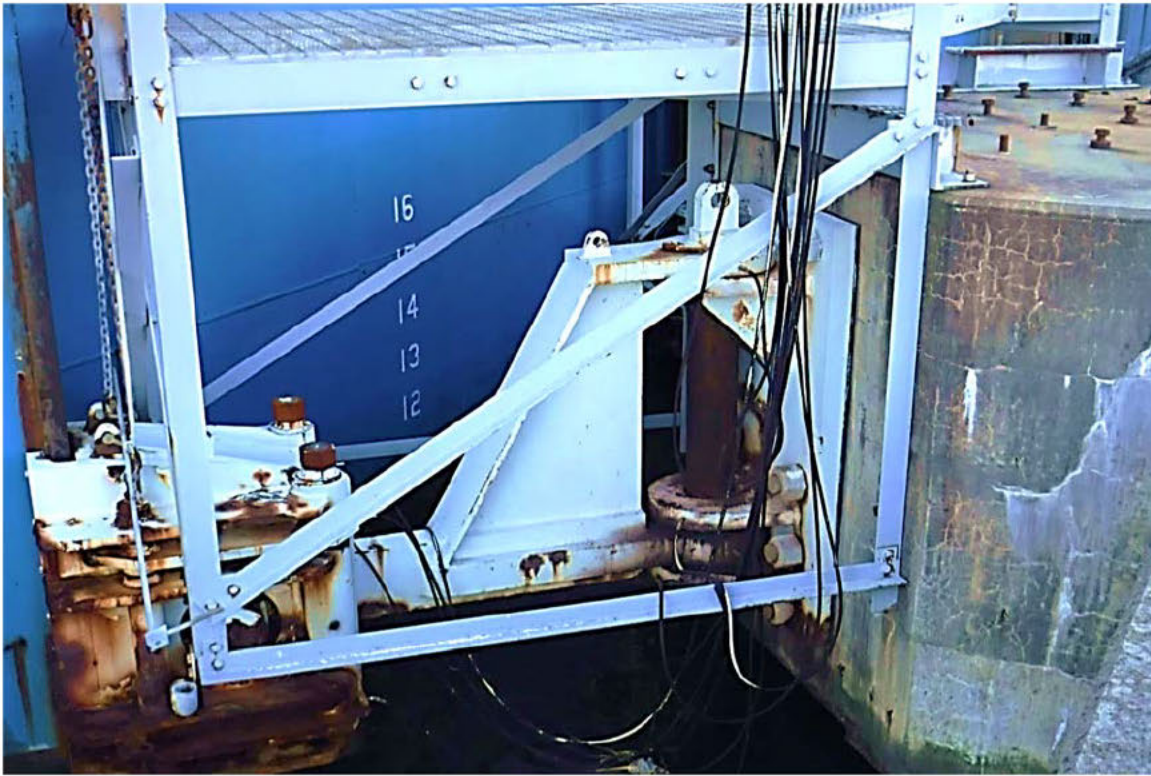
**Photo 3.5-3:** Overall view of the west leg of the East Mooring Arm.

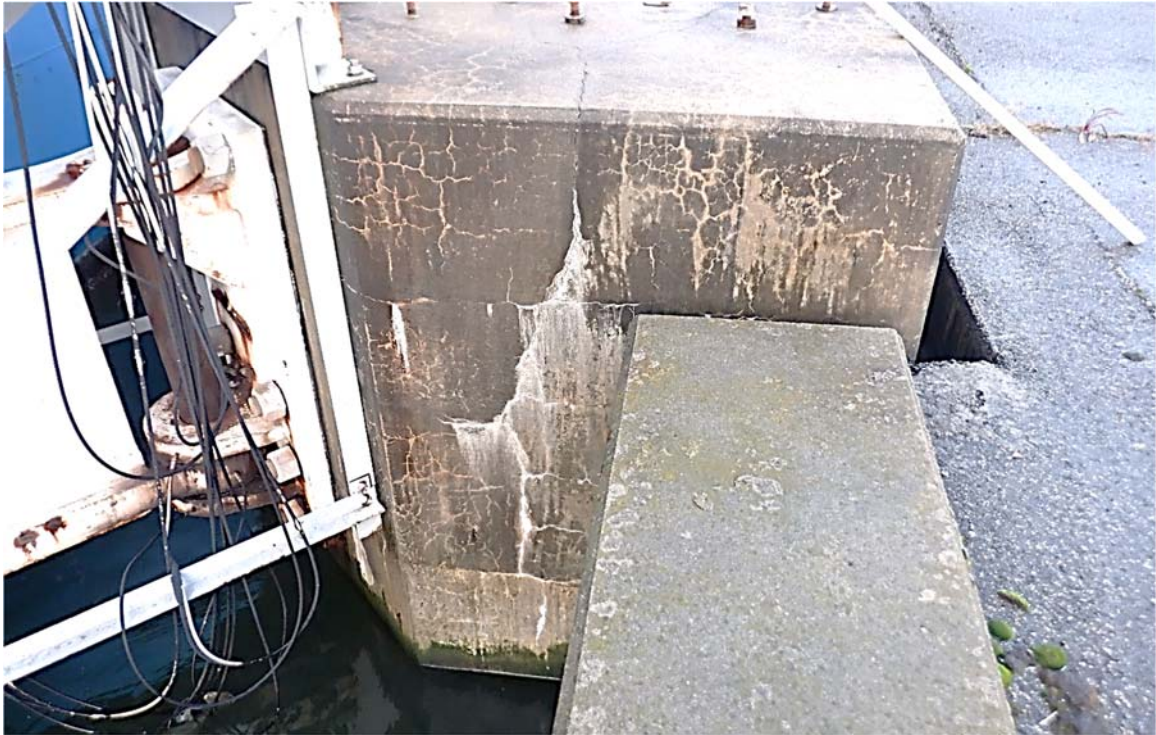
The condition of the concrete pile cap supporting the double-leg mooring arms is **Fair**. The concrete is generally smooth and exhibits evidence of minor structural distress. The top face of the cap contains numerous cracks with efflorescence ranging in width from hairline up to approximately 1/16". An approximately 1/16" wide by 8 ft long crack is located 5 ft away from the northwest top face. An approximately 1/16" wide crack is located 5 ft away from the northeast top face. It runs diagonally 6 ft, then proceeds down vertically down the side approximately 4 ft. Table 3.5-3 summarizes the observed conditions of the pile cap. Photos 3.5-4 and 3.5-5 depict the various cracks on the pile cap.

| Element | Description of Observed Conditions | Unit | Quantity |
|---|---|---|---|
| Pile Cap at the East Mooring Arm | The concrete is generally smooth and exhibits evidence of minor structural distress. The top face of the cap contains numerous cracks with efflorescence ranging in width from hairline up to approximately 1/16". An approximately 1/16" wide crack is located 5 ft away from the top northwest and northeast faces. | EA | 1 |

**Photo 3.5-4:** General view of cracks with efflorescence on the east face of the cap varying in width from general hairline map cracks up to 1/16".

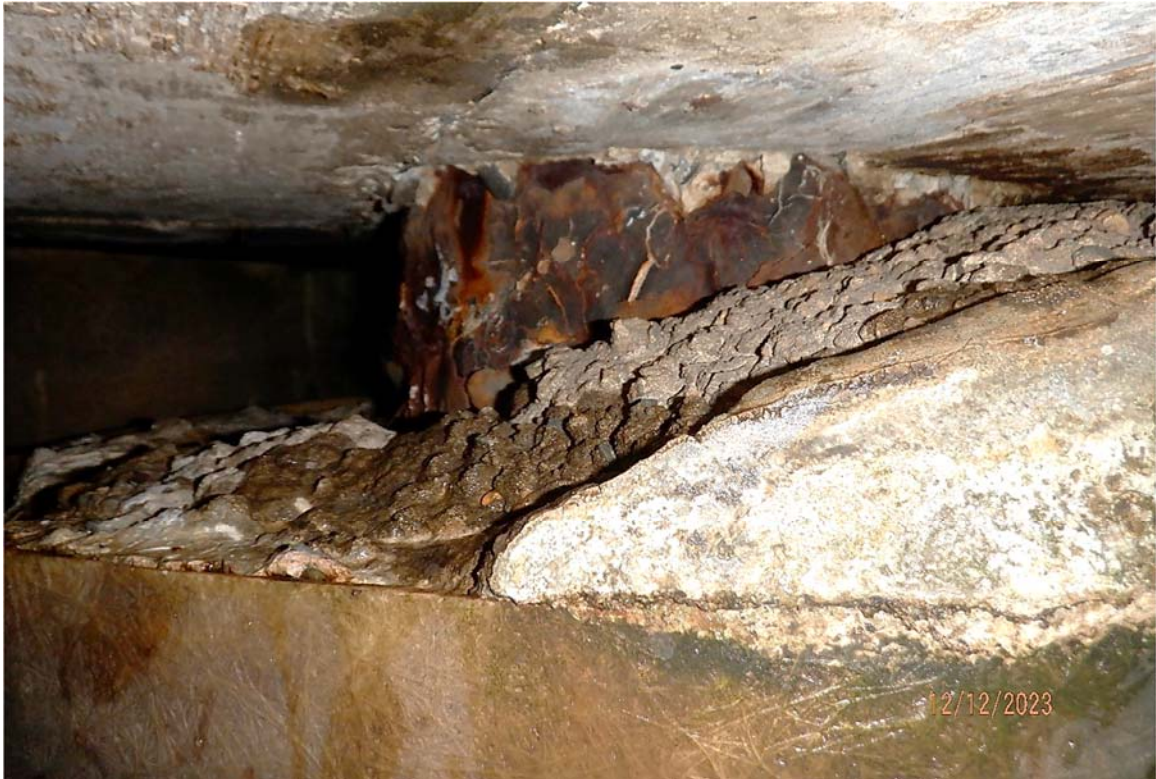
The condition of the piles supporting the double-leg mooring arm pile cap is **Fair**. All five piles are encased in concrete. However, the encasements do not extend along the full height of the piles. The piles are generally exposed above and below the encasement. The exposed portions between the bottom of the pile cap and the top of the encasements exhibit coating failure with minor to moderate corrosion. The three central pipe piles contain an approximately 2 in. to 8 in. gap above the encasements with coating failure and minor to moderate corrosion. The encasement for the inboard central pipe pile is hollow in the top 18 in of the form. The two battered H-piles contain gaps varying from 2 in. to 8 in. and exhibit moderate to advanced corrosion.

The pile encasement no longer extend to the mudline, possibly due to scour. The steel piles are exposed between the bottom of the encasements and the mudline in varying heights ranging from 1 ft to 3 ft. The bottom of the form has failed on the east batter H-pile. Table 3.5-4 summarizes the observed conditions of the pile cap. Photos 3.5-6 and 3.5-7 illustrate the exposed portions of the piles between the bottom of the pile cap and the top of the encasements for each of the steel pipe and H-piles.

**Photo 3.5-6:** View of the southeast steel pipe pile between the bottom of the pile cap and the top of the encasement.
