Project #11750  
Addendum #3  
Date 9/18/26

**TABLE E-1**  
**SUMMARY OF THE OVERALL CONDITION RATINGS AND COSTS**  
**AT HUNTS POINT CORRECTIONS BULKHEAD AND VERNON C. BAINE**  
**CORRECTIONS CENTER FLOATING DETENTION BARGE**

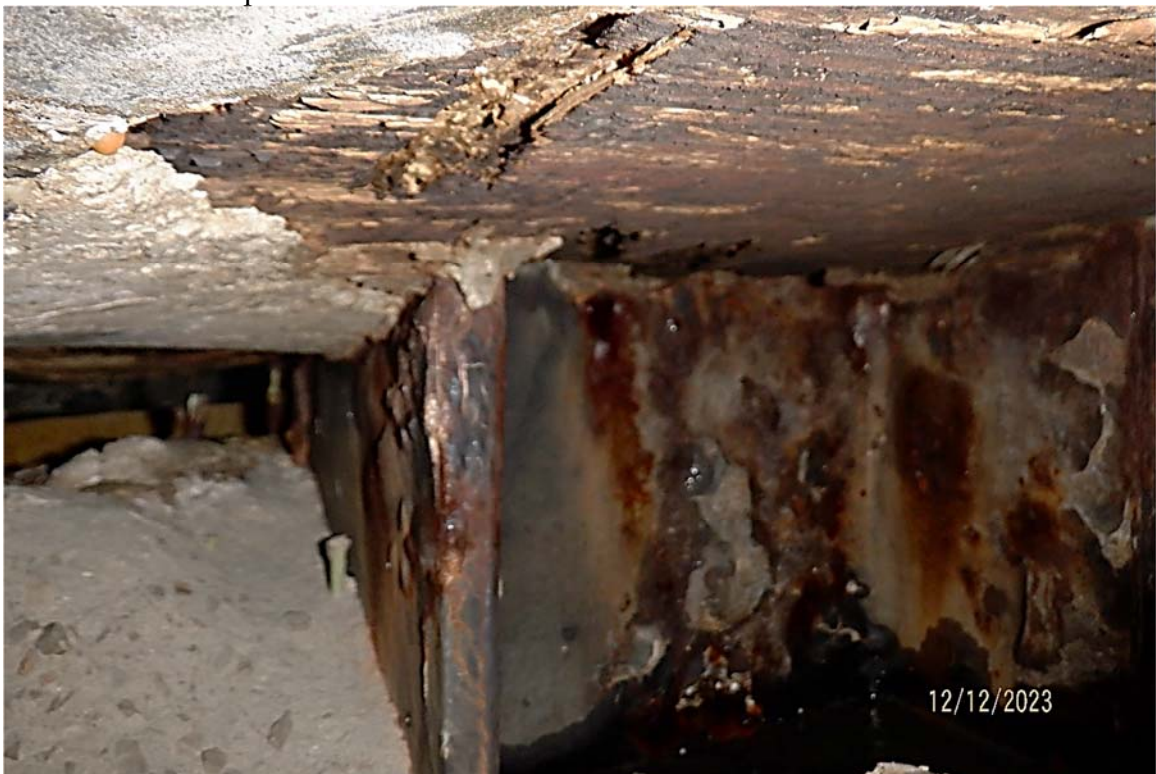
The condition of the piles supporting the double-leg mooring arm pile cap is **Fair**. All five piles are encased in concrete. However, the encasements do not extend along the full height of the piles. The piles are generally exposed above and below the encasement. The exposed portions between the bottom of the pile cap and the top of the encasements exhibit coating failure with minor to moderate corrosion. The three central pipe piles contain an approximately 2 in. to 8 in. gap above the encasements with coating failure and minor to moderate corrosion. The encasement for the inboard central pipe pile is hollow in the top 18 in of the form. The two battered H-piles contain gaps varying from 2 in. to 8 in. and exhibit moderate to advanced corrosion.

The pile encasement no longer extend to the mudline, possibly due to scour. The steel piles are exposed between the bottom of the encasements and the mudline in varying heights ranging from 1 ft to 3 ft. The bottom of the form has failed on the east batter H-pile. Table 3.5-4 summarizes the observed conditions of the pile cap. Photos 3.5-6 and 3.5-7 illustrate the exposed portions of the piles between the bottom of the pile cap and the top of the encasements for each of the steel pipe and H-piles.

**Photo 3.5-7:** View of the northwest steel batter H-pile between the bottom of the pile cap and the top of the encasement.

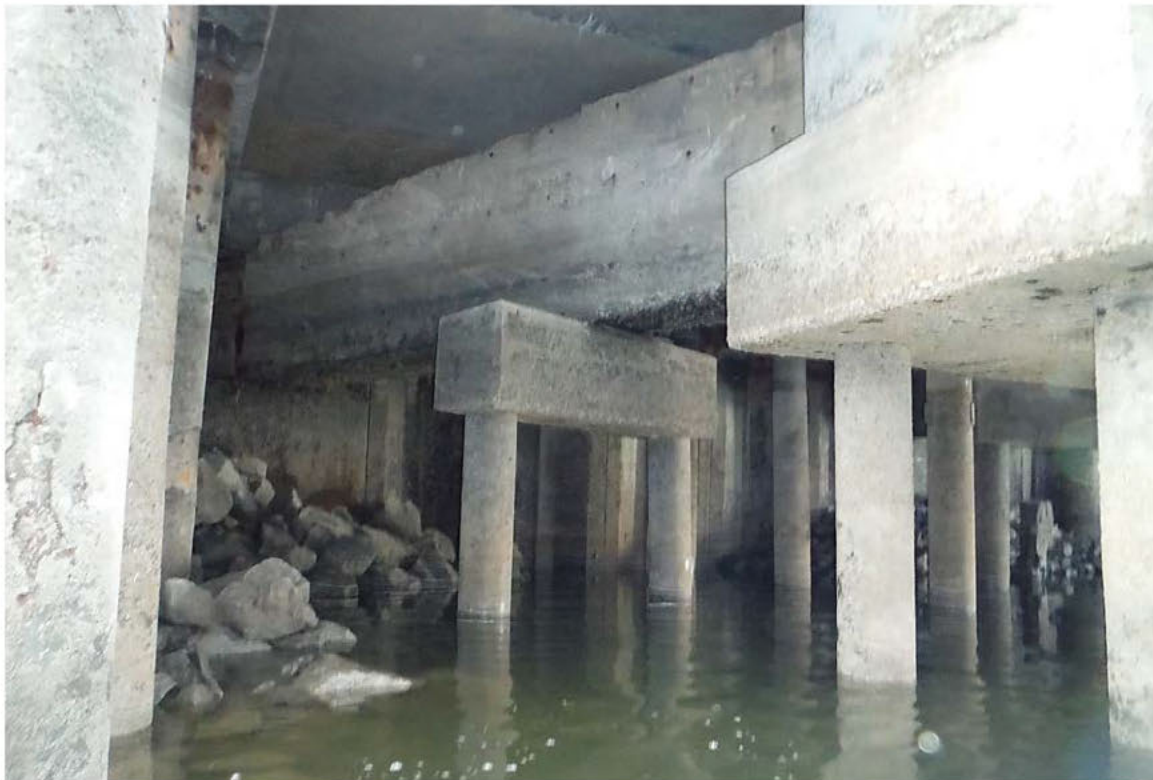
The condition of the two intermediate bench caps supporting the struts is **Satisfactory**. The concrete is solid, smooth and does not exhibit cracks, spalls, or other forms of distress. The condition of the four steel pipe piles supporting the two concrete bench caps is **Satisfactory**. The coating remains intact and does not exhibit damage. Table 3.5-6 summarizes the observed conditions and Photo 3.5-9 depicts the typical condition of the bench caps and the corresponding support piles.

**Photo 3.5-9:** Typical condition of diagonal strut that braces the double-leg mooring arm pile cap.

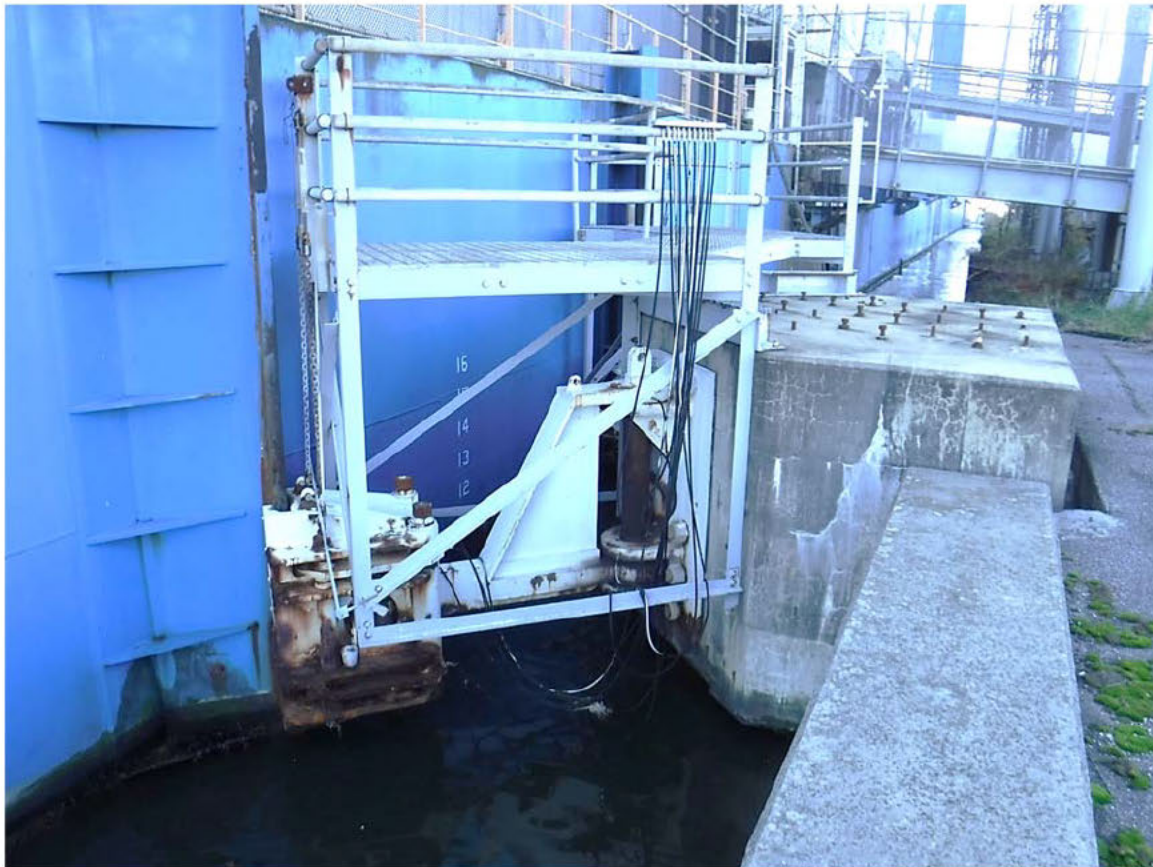
The condition of the steel catwalk framing above the pile cap is **Satisfactory**. The components remain functional, and the coating remains intact although some light surface rust is visible at isolated location. The framing members and connections are satisfactorily attached and stable. Table 3.4-7 summarizes the observed conditions. Photo 3.4-10 provides an overall view of the catwalk.

| Element | Description of Observed Conditions | Unit | Quantity |
|---|---|---|---|
| Catwalk at the East Mooring Arm | The components remain functional and the coating remains largely intact. The framing members and connections are satisfactorily attached and stable | EA | 1 |

**Photo 3.5-10:** Overall view of the catwalk at the East Mooring Arm.

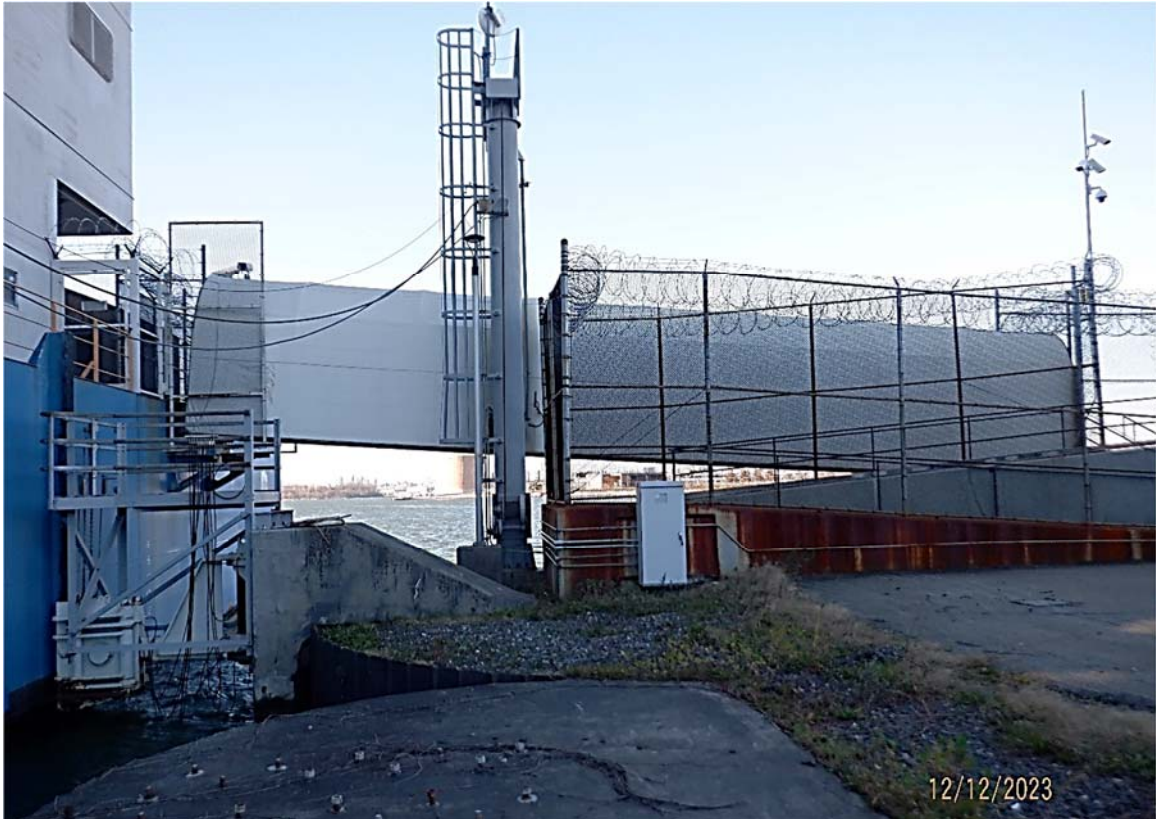
**Photo 3.6-1:** Overall east elevation view of the West Pedestrian Gangway A and the gangway support frame.

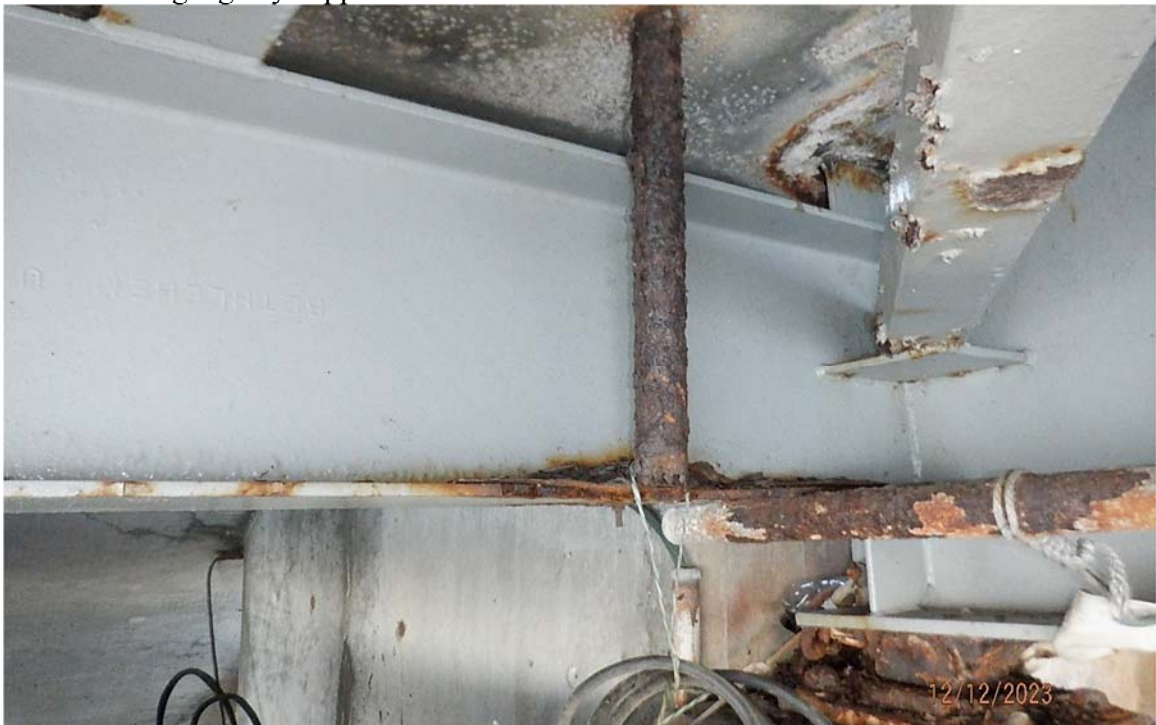
| Element | Description of Observed Conditions | Unit | Quantity |
|---|---|---|---|
| Gangway Framing at the West Pedestrian Gangway A | In general, the gangway framing does not exhibit significant corrosion, mechanical damage, or missing/inoperable components. The girder top flange at the deck interface contains minor corrosion over a length of approximately 56 ft. The cross-bracing contains approximately 10 percent coating loss with minor corrosion of the exposed steel. The bottom flange of the northernmost floor beam on its east side contains moderate corrosion and delamination, with approximately 5/16" remaining material (nominal 3/8"). The gangway functions as intended by design and can accommodate its full range of motion. | EA | 1 |

**Photo 3.6-2:** The bottom flange of the northernmost floor beam on its east side contains moderate corrosion and delamination. Also note the coating loss on the cross-bracing.

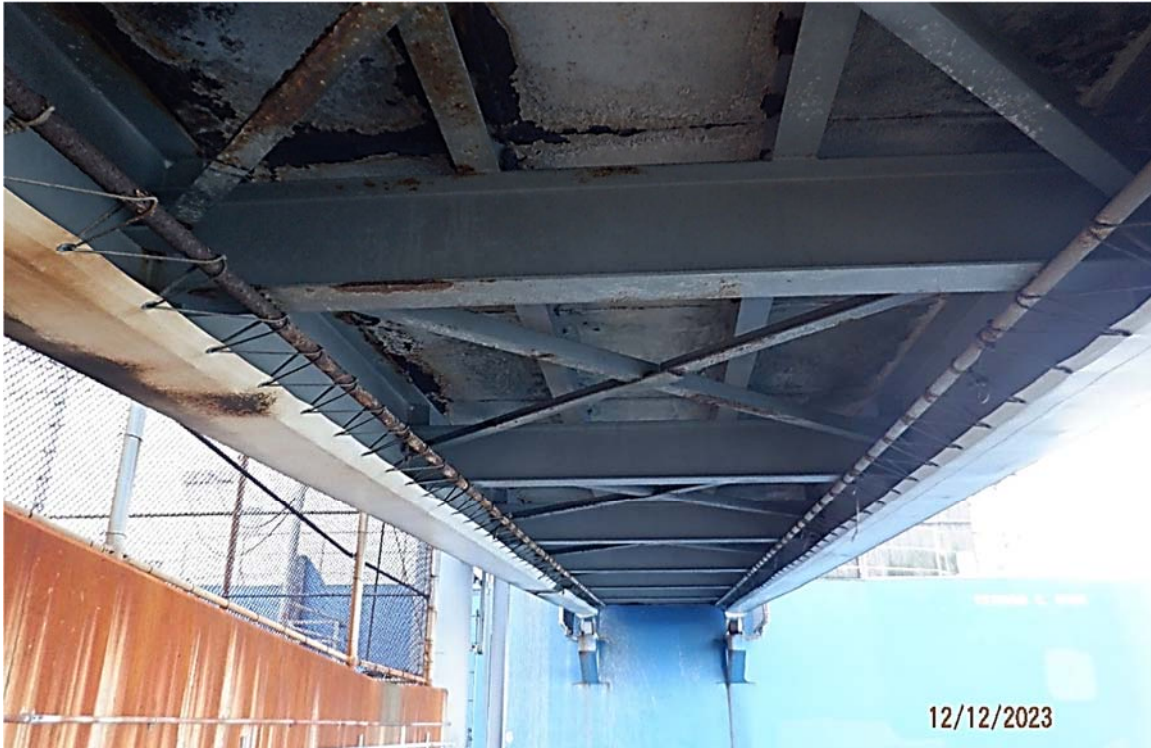
**Photo 3.6-3:** Overall view of the steel framing below the West Pedestrian Gangway A. Note the steel exhibits minor coating loss with corrosion at isolated locations on the floor beams and cross-braces.

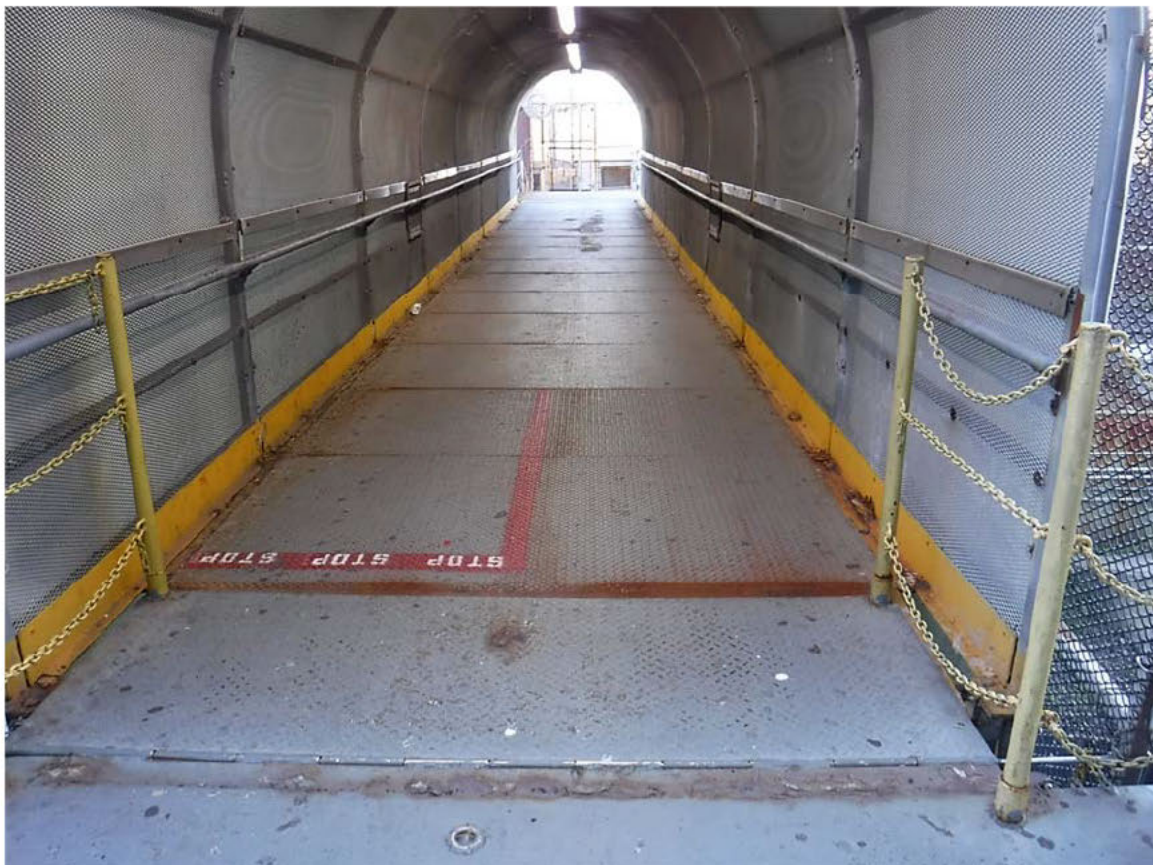
| Element | Description of Observed Conditions | Unit | Quantity |
|---|---|---|---|
| Gangway Deck, Railing and Canopy at the West Pedestrian Gangway A | The vinyl canopy on east and west sides of gangway limit ability to inspect various components. The steel diamond deck plate exhibits coating loss due to wear and abrasion with minor to moderate surface corrosion at isolated locations. The railing and canopy remain in place and are fully functional. | EA | 1 |

**Photo 3.6-5:** Overall view of the gangway interior of the West Pedestrian Gangway A.

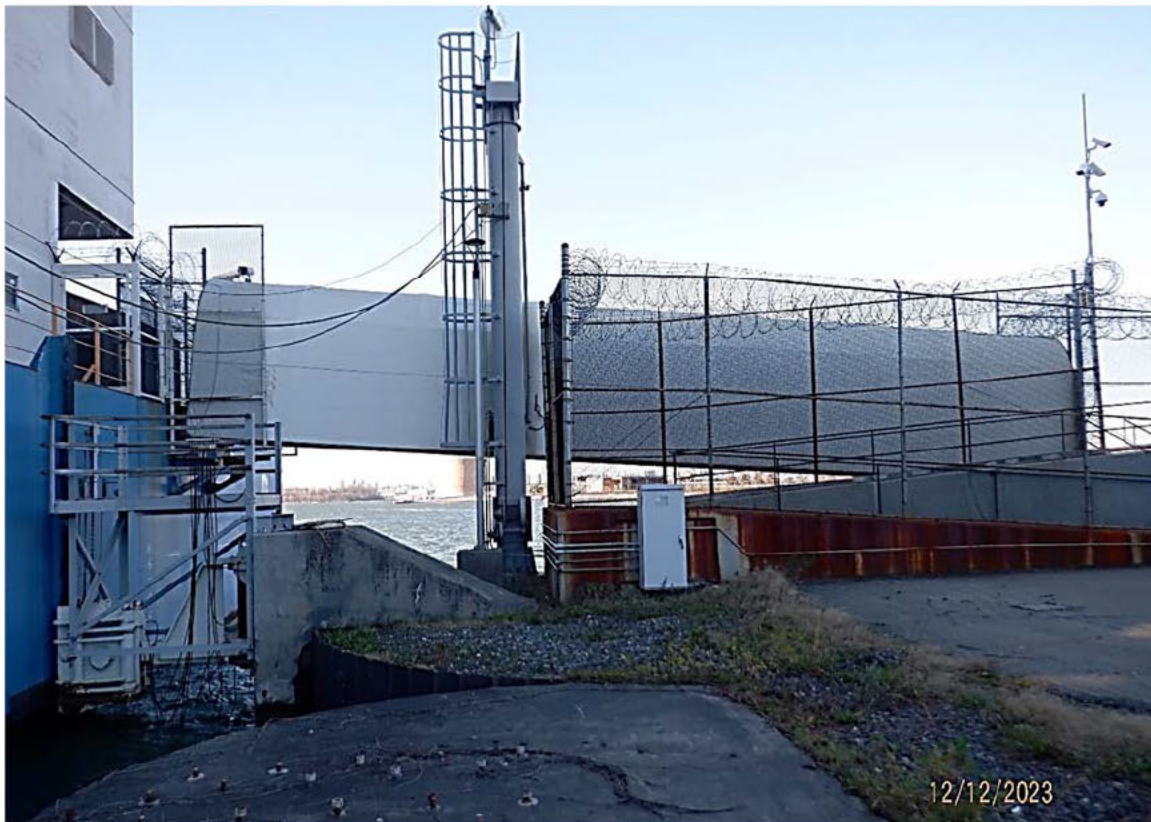
**Photo 3.6-7:** Overall east elevation view of the West Pedestrian Gangway A and the gangway support frame.

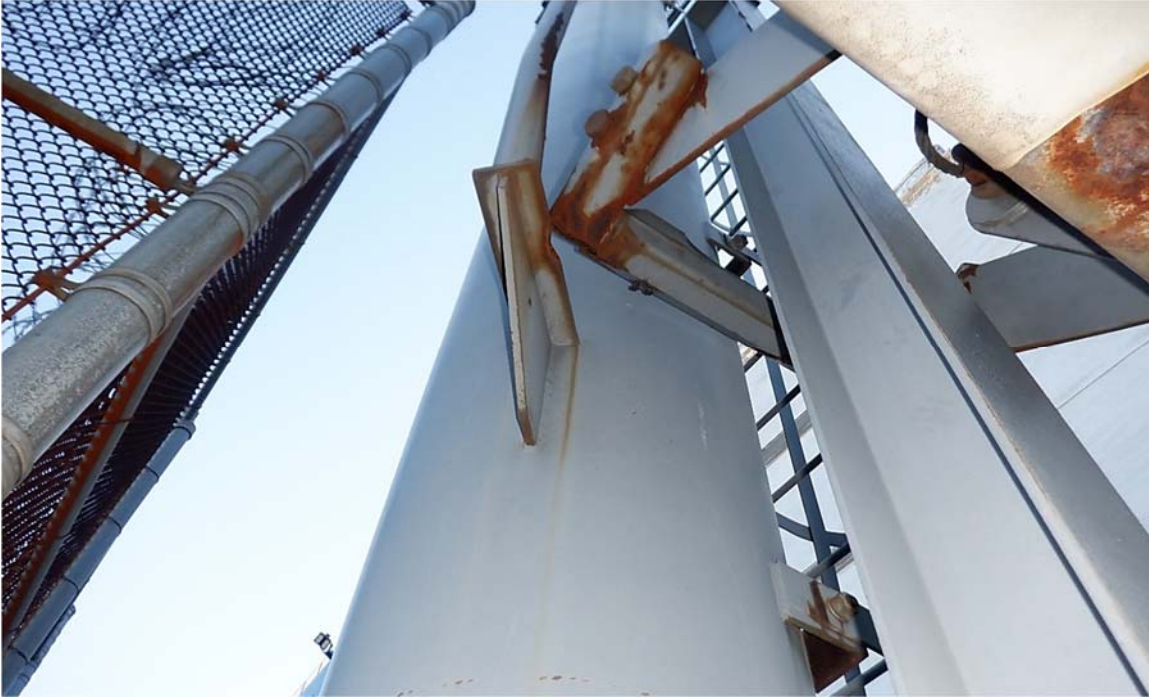
| Element | Description of Observed Conditions | Unit | Quantity |
|---|---|---|---|
| Gangway Support Frame at the West Pedestrian Gangway A | With the exception of the guide bar framing on the support frame, support frame components do not exhibit significant corrosion, mechanical damage, or missing/inoperable components. The mast is plumb and the foundation is secure. The structure does not indicate evidence of distress or significant deterioration. The guide bar framing interferes with a bracket appurtenance on the mast. The elements conflict during low tide cycles, and the appurtenance is slightly deformed as a result. The manual winch mechanism was not inspected for functionality; however no obvious damage, deterioration, or potential for dysfunction was observed. | EA | 1 |

**Photo 3.6-8:** Guide bar framing interferes with a bracket appurtenance on the main mast. These elements conflict during low tide cycles, and the appurtenance is slightly deformed as a result.

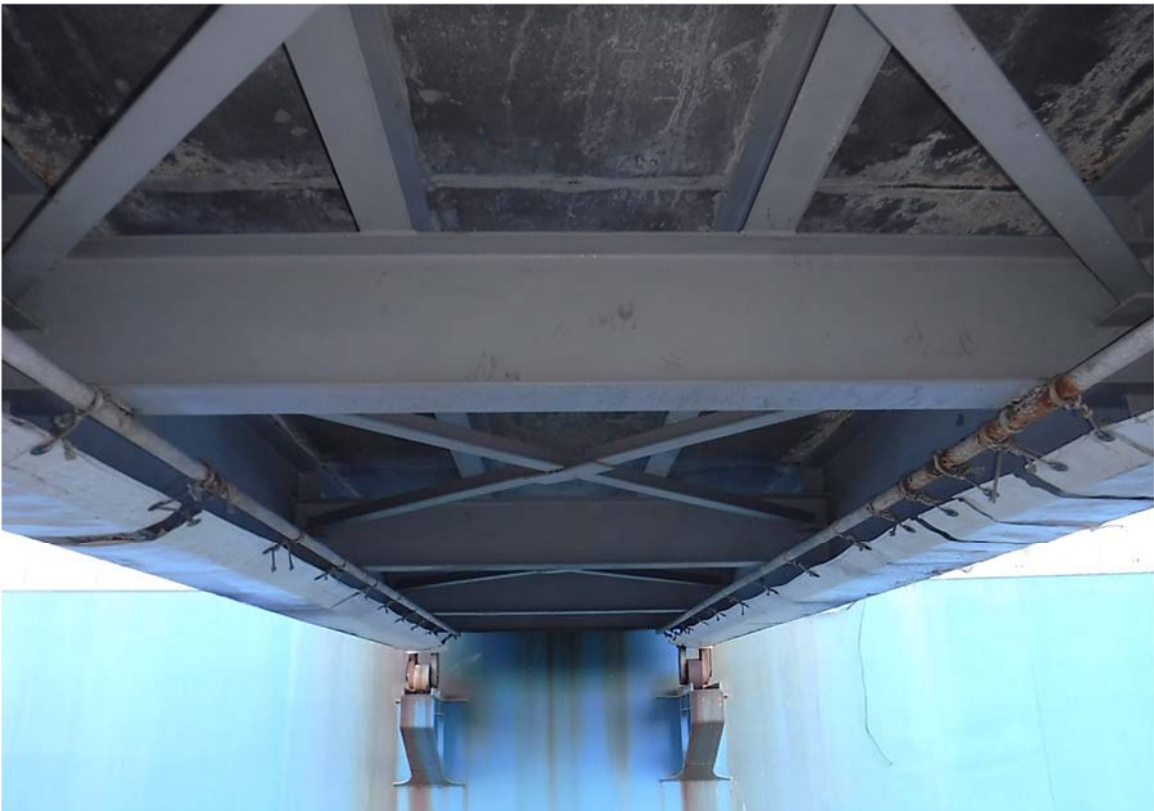
**Photo 3.7-2:** View of the Middle Pedestrian Gangway B framing looking south.

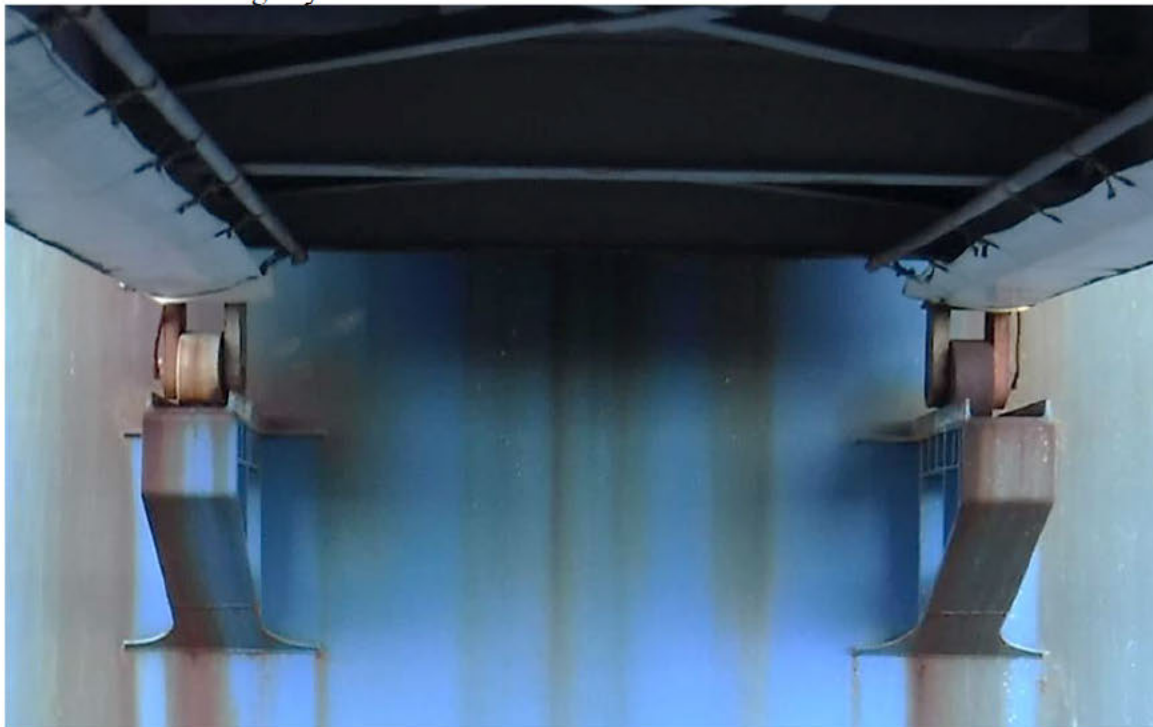
| Element | Description of Observed Conditions | Unit | Quantity |
|---|---|---|---|
| Gangway Bearings at the Middle Pedestrian Gangway B | The bearings typically exhibit minor coating loss and corrosion of the components. The safety/restraining chains and shackles exhibit moderate to advanced corrosion. The NE rocker bearing contains excessive debris accumulation. Anchor bolt nuts typically exhibit moderate to advanced corrosion with heavy delamination. However, the bearings function as intended by design and can accommodate their full range of motion. | EA | 4 |

**Photo 3.7-3:** Enlarged view of the roller bearings at the Middle Gangway B.

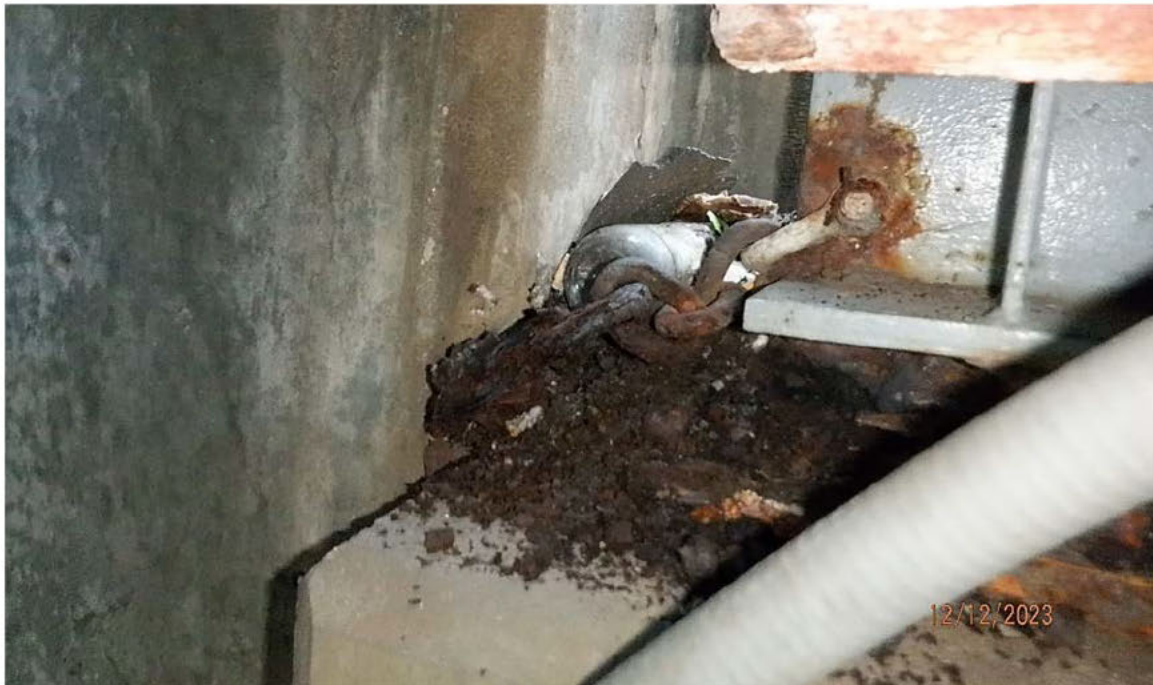
**Photo 3.7-4:** Closeup view of the northeast rocker bearing containing excessive debris accumulations at the Middle Gangway B.

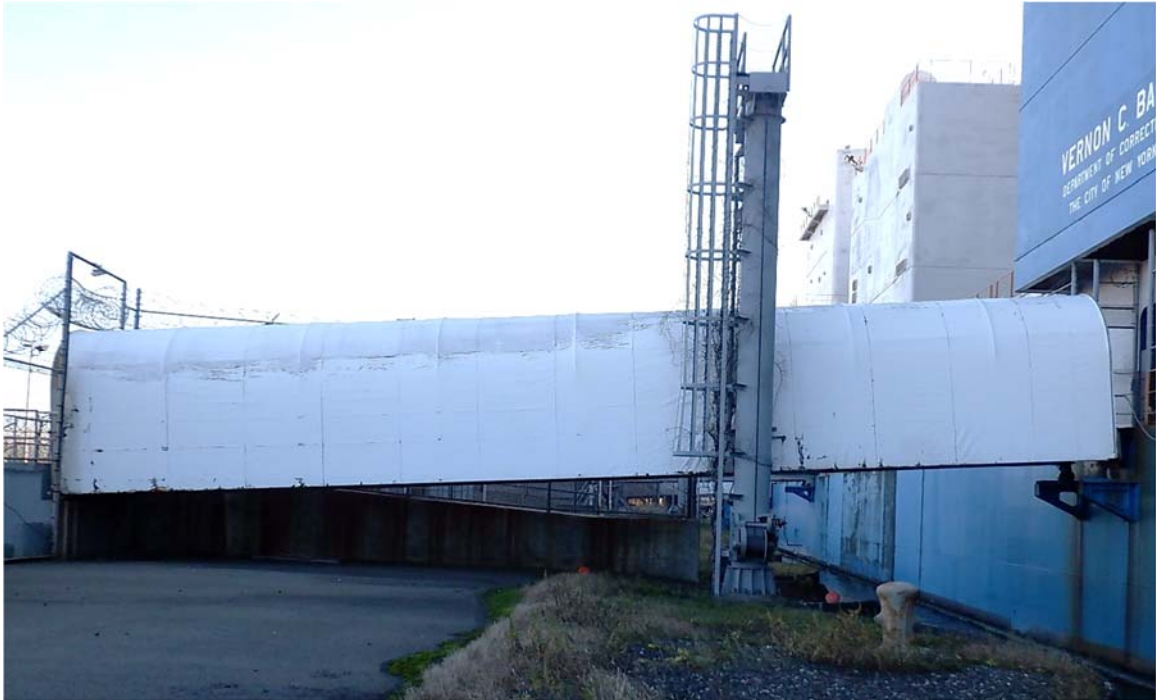
**Photo 3.7-5:** West elevation view of the Middle Gangway B and support frame. Note the vines growing on the support frame stairs.

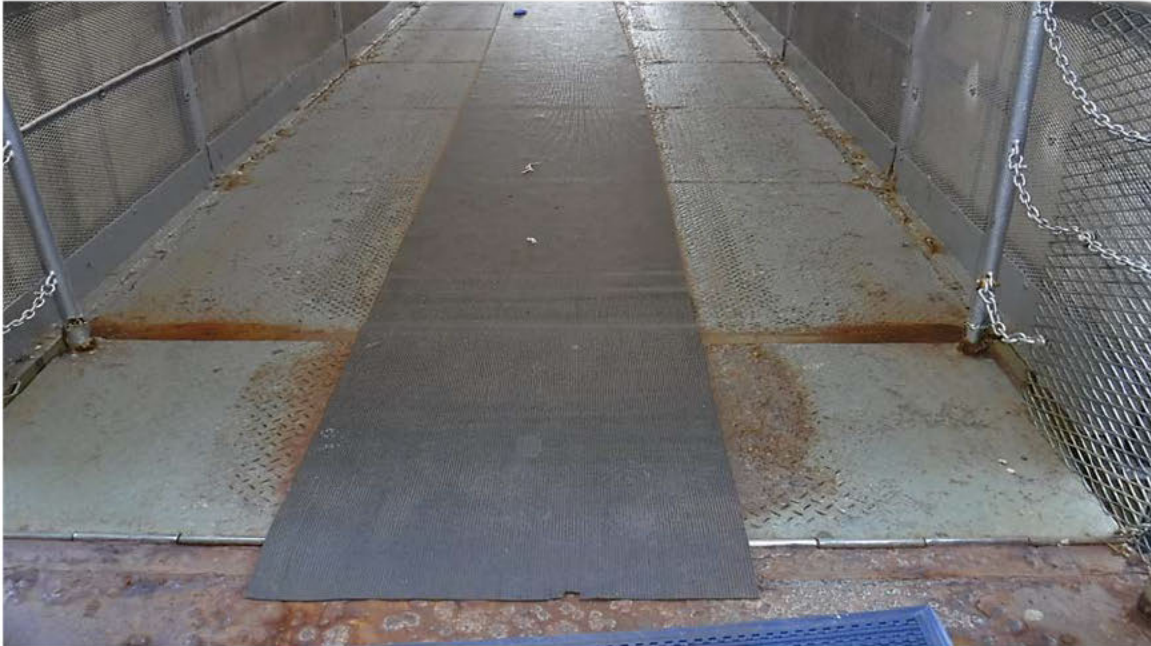
| Element | Description of Observed Conditions | Unit | Quantity |
|---|---|---|---|
| Gangway Deck, Railing and Canopy at the Middle Pedestrian Gangway B | The vinyl canopy on east and west sides of gangway limit ability to inspect various components. The vinyl canopy support pole at north abutment on east side is cracked through at bottom with heavy corrosion. The steel diamond deck plate exhibits wear with minor surface corrosion at various locations. The railing and canopy remain in place and are fully functional. | EA | 1 |

**Photo 3.7-7:** Interior view of the Middle Pedestrian Gangway B exhibiting wear with minor surface corrosion at various locations.

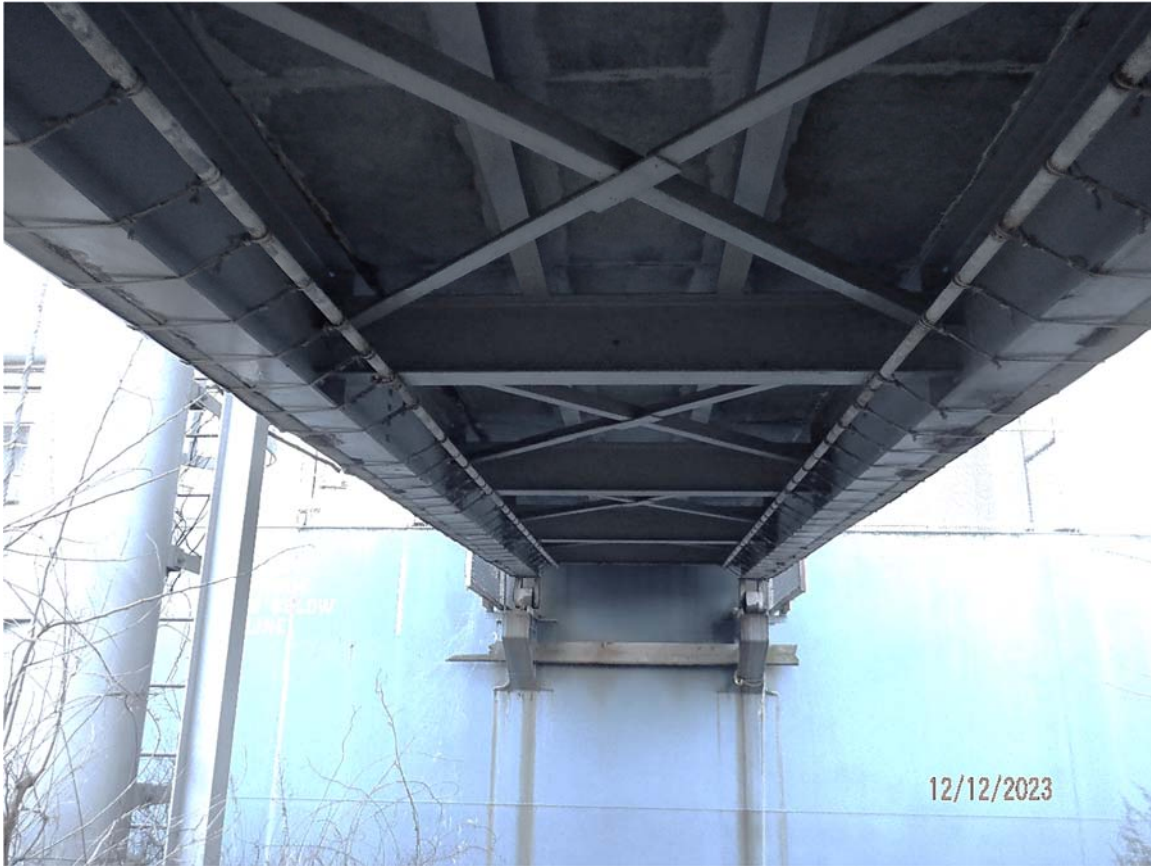
| Element | Description of Observed Conditions | Unit | Quantity |
|---|---|---|---|
| Gangway Framing at the East Pedestrian Gangway C | In general, the framing does not exhibit significant corrosion, mechanical damage, or missing/inoperable components. The steel girders, floor beams and cross-braces maintain their coating with only minor coating loss at isolated locations. However, the girder top flange at the deck interface contains minor corrosion over a length of approximately 40 ft, and the girder bottom flanges exhibit intermittent coating loss with minor corrosion over approximately 10 percent of its length at the interface with the vinyl canopy. The gangway functions as intended by design and can accommodate its full range of motion. | EA | 1 |

**Photo 3.8-1:** View of the framing underside and roller bearing supports at the East Pedestrian Gangway C.

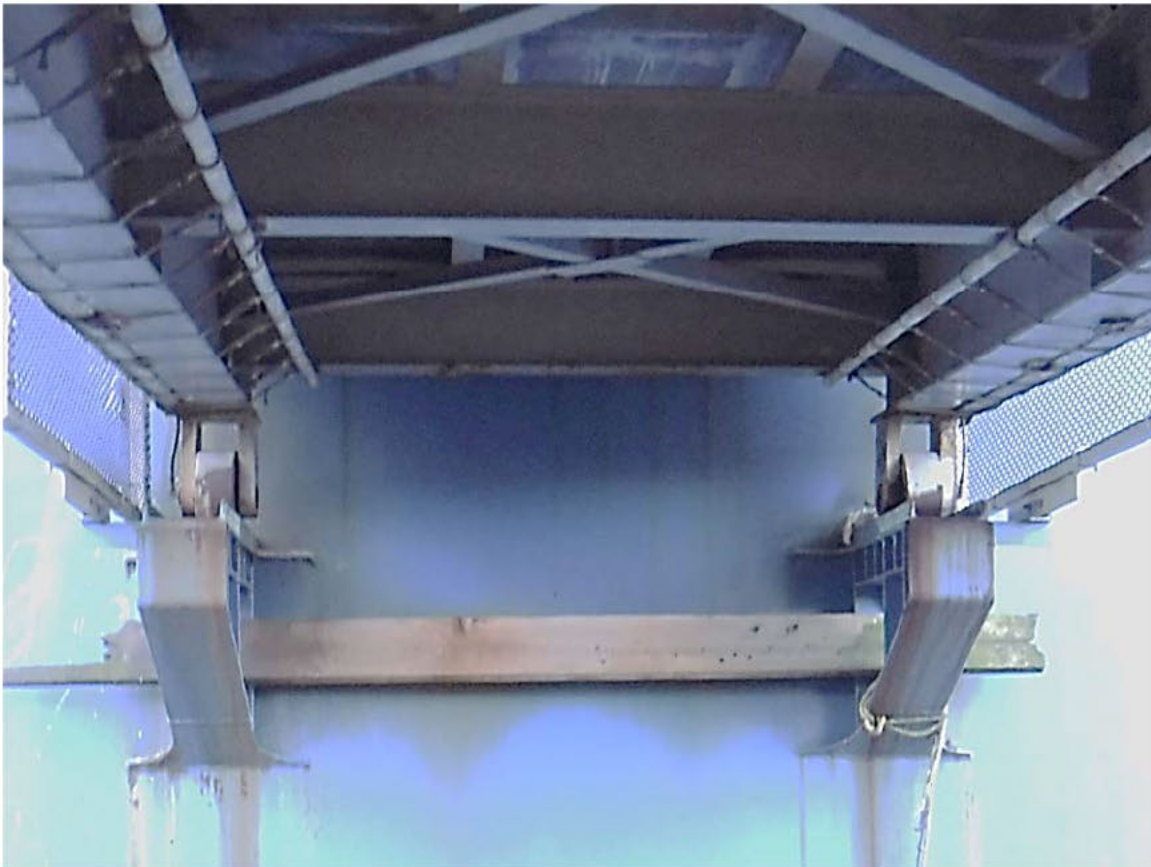
| Element | Description of Observed Conditions | Unit | Quantity |
|---|---|---|---|
| Gangway Bearings at the East Pedestrian Gangway C | The bearings typically exhibit minor coating loss and corrosion of the components. The safety/restraining chains and shackles exhibit moderate to advanced corrosion. The northeast rocker bearing safety chain is broken. Anchor bolt nuts typically exhibit moderate to advanced corrosion with heavy delamination. However, the bearings function as intended by design and can accommodate their full range of motion. | EA | 4 |

**Photo 3.8-2:** View of the roller bearings at East Pedestrian Gangway C.

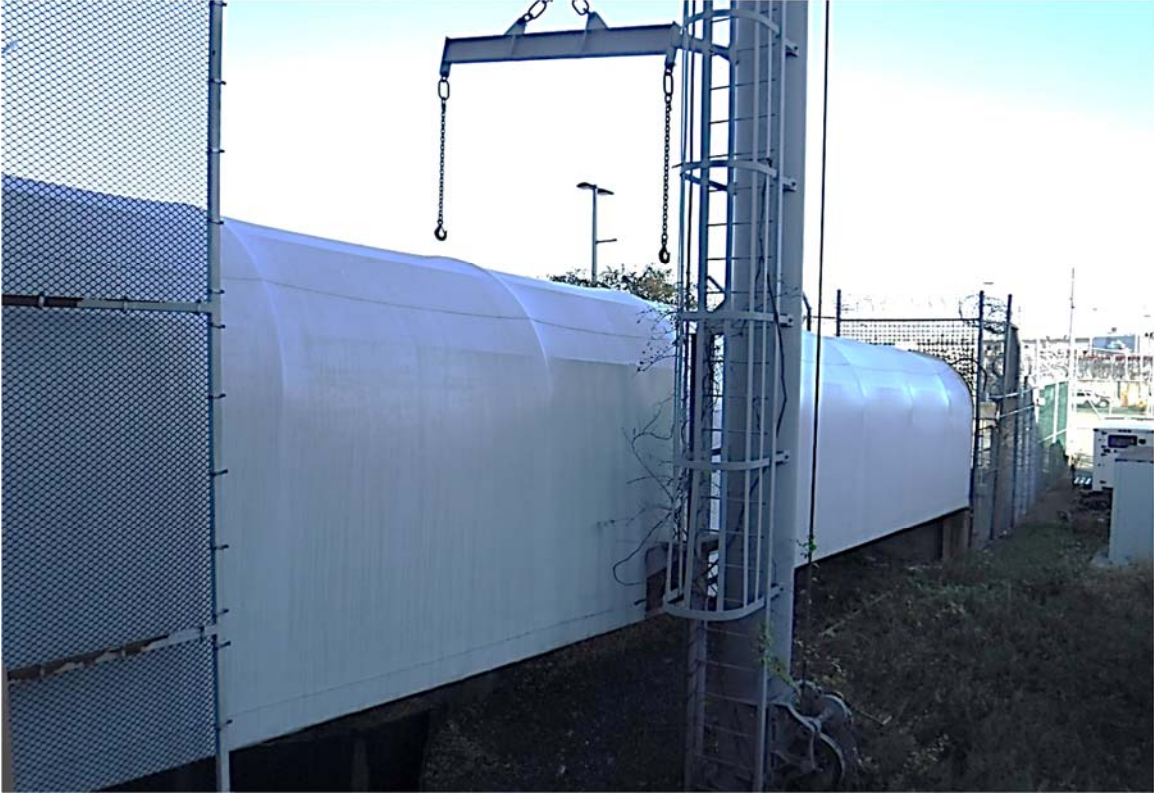
**Photo 3.8-4:** Overall east elevation view of the East Pedestrian Gangway C and the gangway support frame.

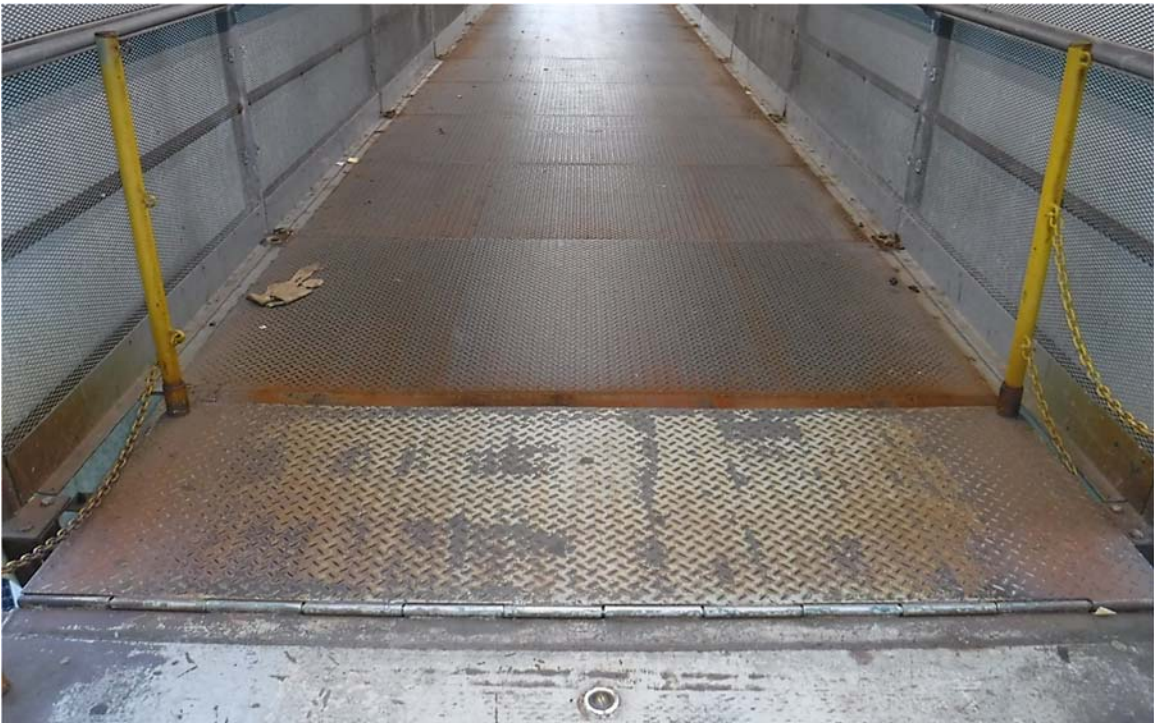
| Element | Description of Observed Conditions | Unit | Quantity |
|---|---|---|---|
| Gangway Deck, Railing and Canopy at the East Pedestrian Gangway C | The vinyl canopy on east and west sides of gangway limit ability to inspect various components. The steel diamond deck plate exhibits wear with minor surface corrosion at various locations. The railing and canopy remain in place and are fully functional. | EA | 1 |

**Photo 3.8-5:** Interior view of the East Pedestrian Gangway C. Note the wear and minor surface corrosion at various locations and at the transition plate.

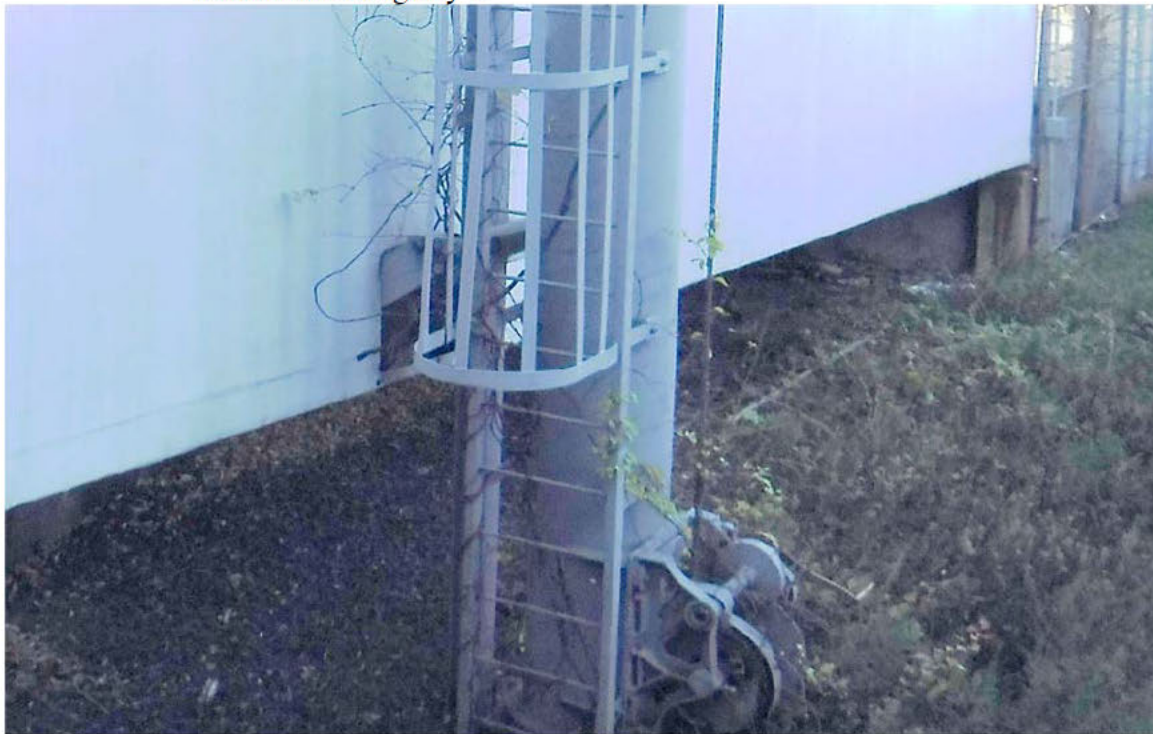
| Element | Description of Observed Conditions | Unit | Quantity |
|---|---|---|---|
| Gangway Support Frame at the East Pedestrian Gangway C | The support frame components do not exhibit significant corrosion, mechanical damage, or missing/inoperable components. The mast is plumb and the foundation is secure. Moderate to heavy vegetation (vines) growth on the steel cage ladder, mast, and mechanical winch inhibit access and restricts operation. | EA | 1 |

**Photo 3.8-6:** Moderate to heavy vegetation and vines growing on the support gangway cage ladder, mast, and winch restricting access and operation.

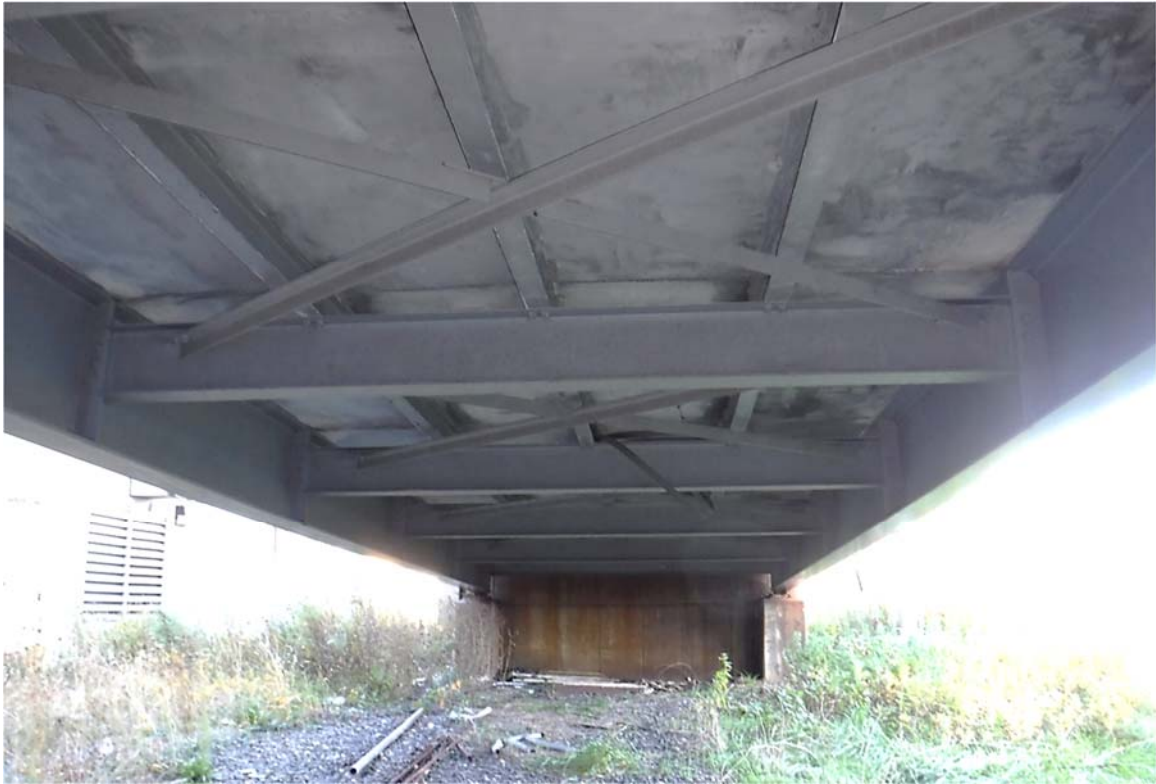
| Element | Description of Observed Conditions | Unit | Quantity |
|---|---|---|---|
| Gangway Framing at the Cargo Gangway | In general, the framing does not exhibit significant corrosion, mechanical damage, or missing/inoperable components. The steel girders, floor beams and cross-braces maintain their coating with only minor coating loss at isolated locations. The gangway functions as intended by design and can accommodate its full range of motion. | EA | 1 |

**Photo 3.9-1:** View of the Cargo Gangway framing looking north.

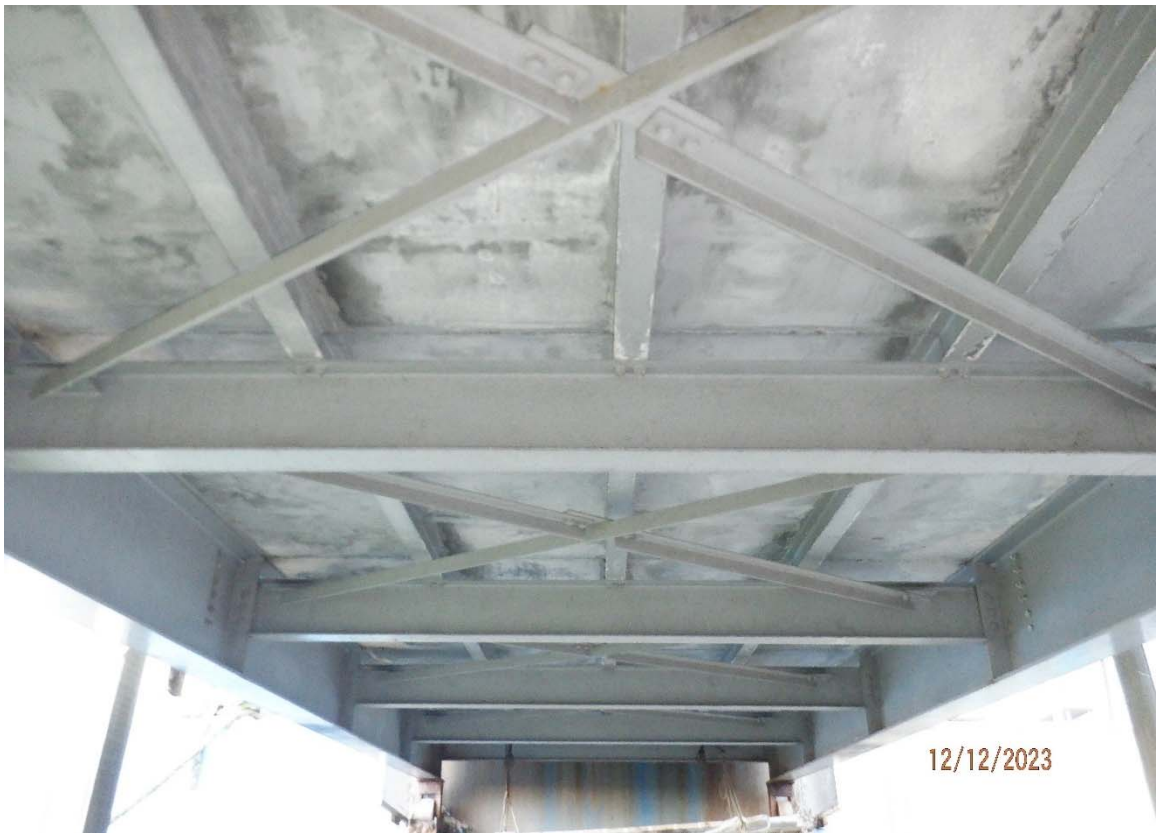
**Photo 3.9-2:** View of the Cargo Gangway framing looking south.

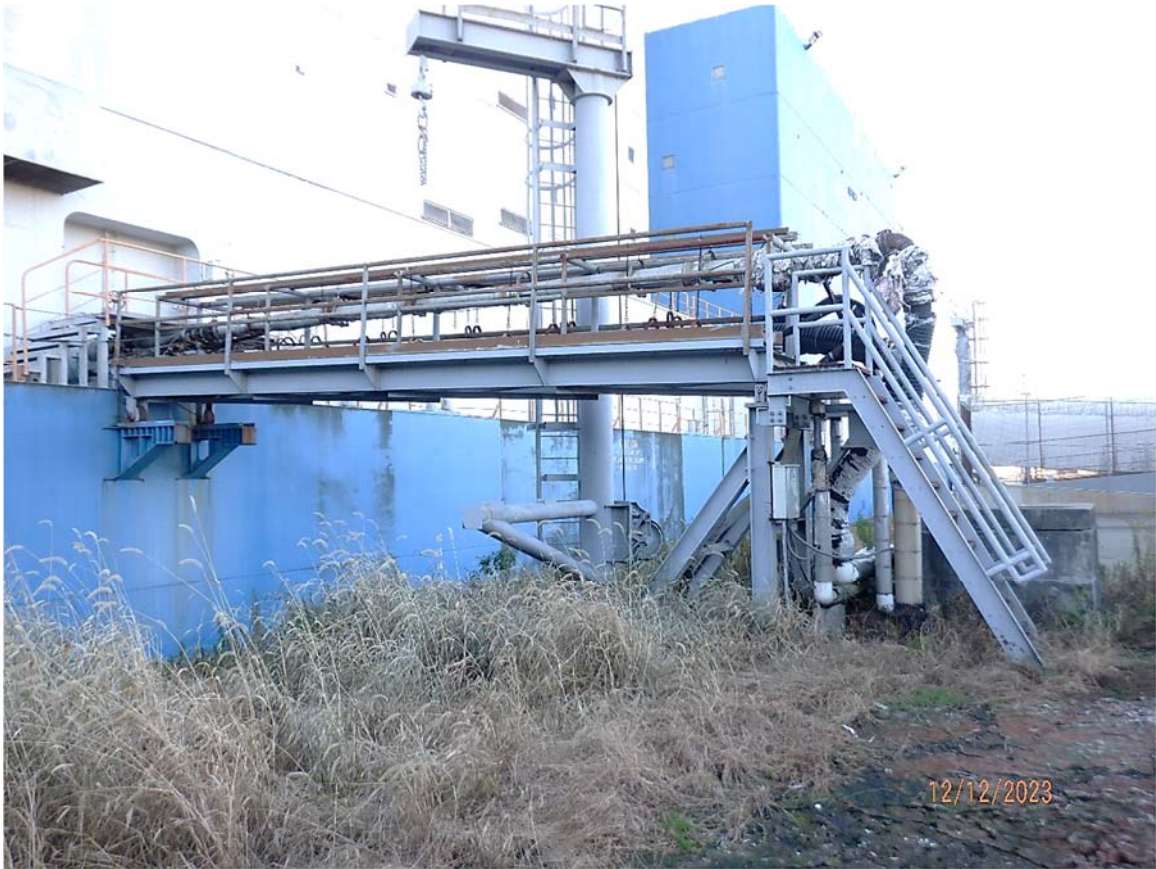
| Element | Description of Observed Conditions | Unit | Quantity |
|---|---|---|---|
| Gangway Framing at the Plumbing Gangway | In general, the framing does not exhibit significant corrosion, mechanical damage, or missing/inoperable components. The steel girders, floor beams and cross-braces maintain their coating with only minor coating loss at isolated locations. The gangway functions as intended by design and can accommodate its full range of motion. | EA | 1 |

**Photo 3.10-1:** Overall view of the Plumbing Gangway.
