Project #11750  
Addendum #3  
Date 9/18/26

**TABLE E-1**  
**SUMMARY OF THE OVERALL CONDITION RATINGS AND COSTS**  
**AT HUNTS POINT CORRECTIONS BULKHEAD AND VERNON C. BAINE**  
**CORRECTIONS CENTER FLOATING DETENTION BARGE**

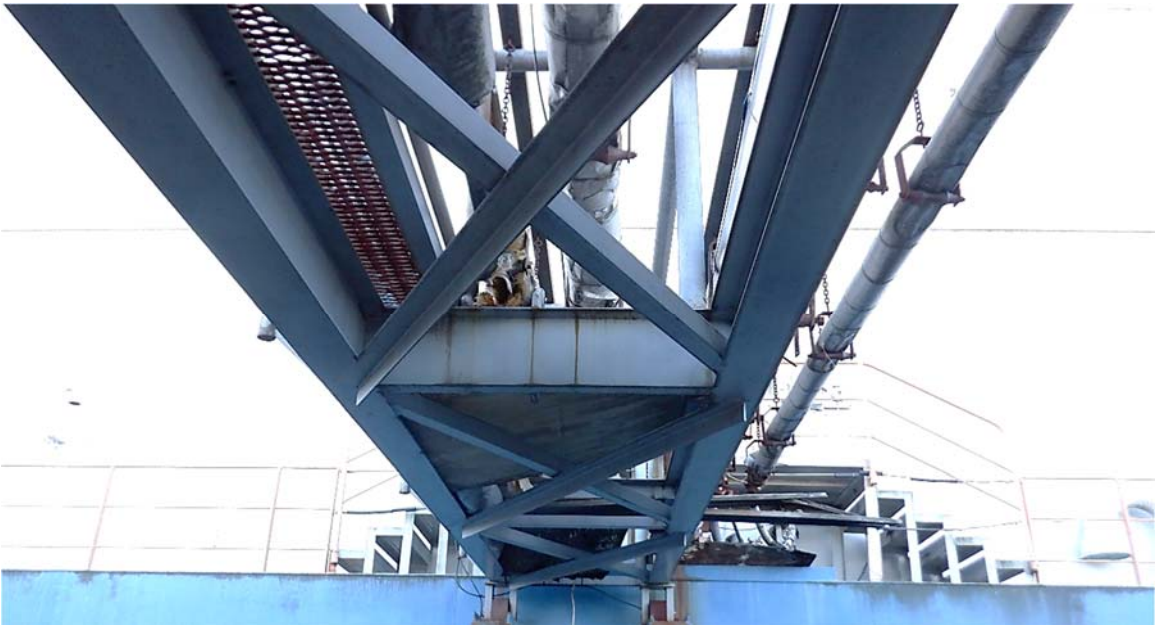
**Photo 3.10-2:** View of the Plumbing Gangway framing.

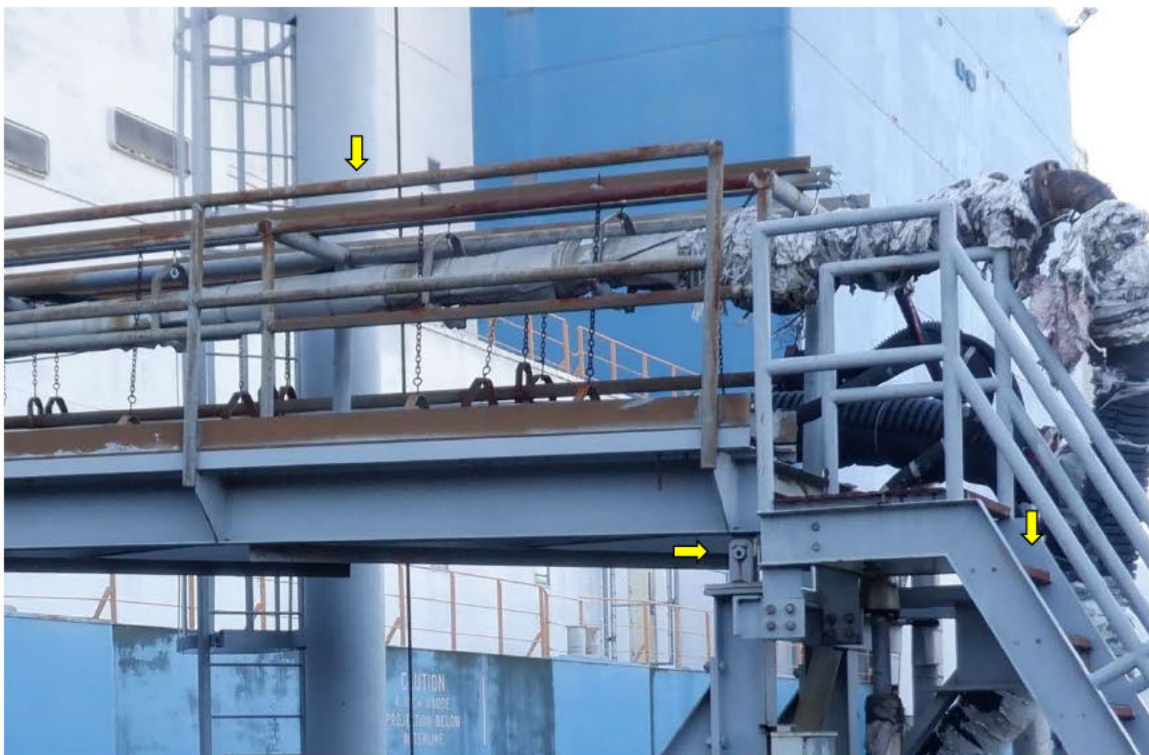
Framing members for the stairs and catwalk are coated and exhibit minor coating loss with surface corrosion at intermittent locations. The catwalk framing however, exhibits widespread coating failure with minor surface corrosion on all components including grate, steps, hand railing, and posts. The structure does not indicate evidence of distress or significant deterioration.

**Photo 3.10-4:** Enlarged view of the catwalk railing and steps.

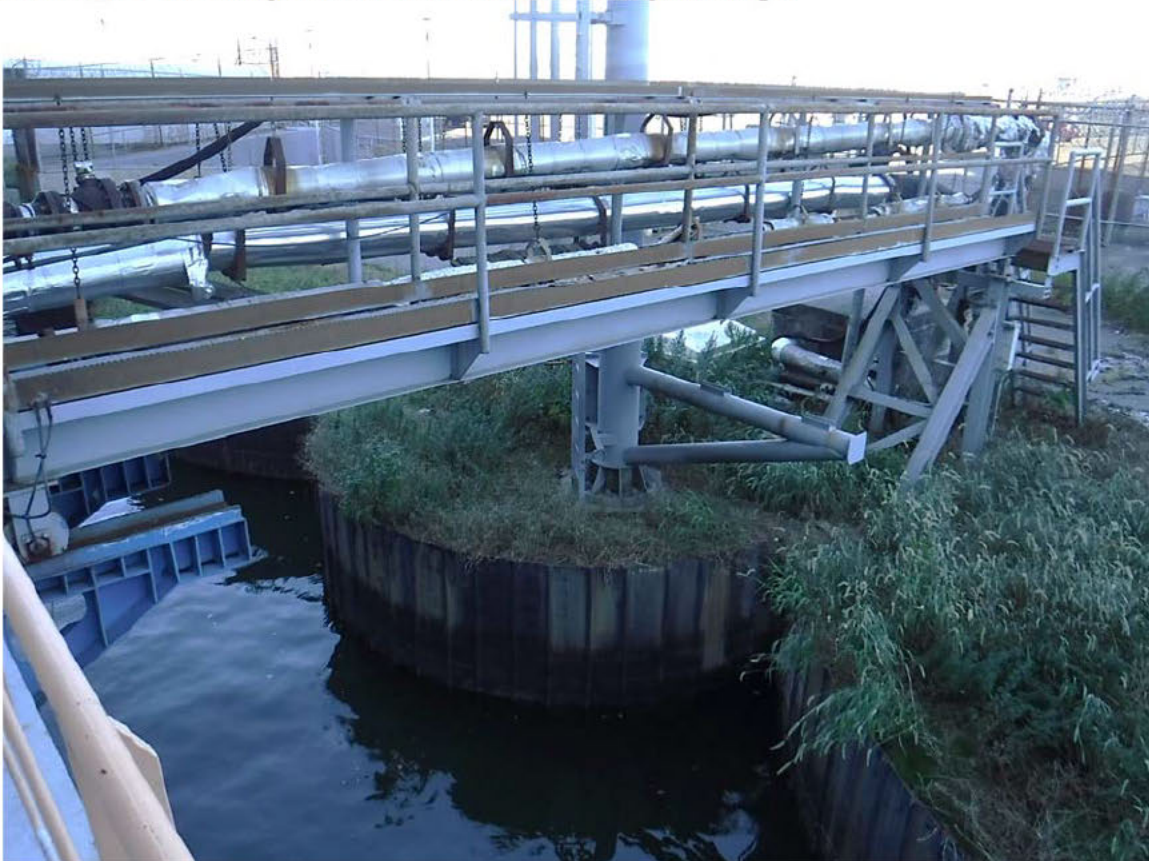
**Photo 3.10-5:** View of the catwalk railing and steps looking north.

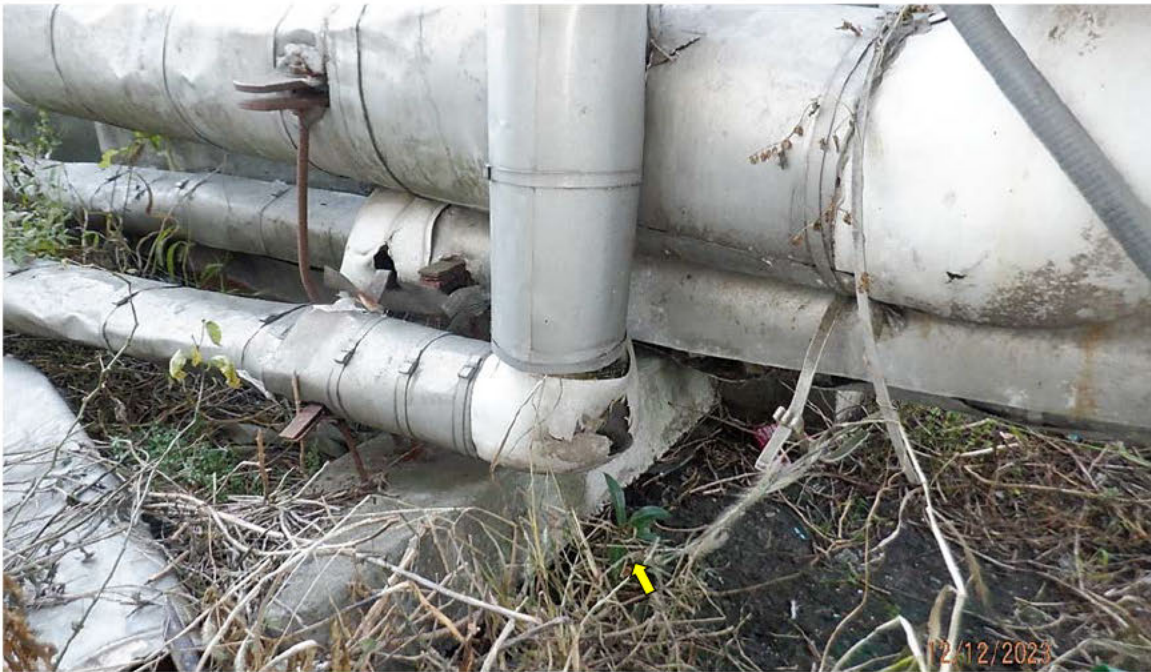
The utility lines draping from the gangway contain damaged insulation and perforations. One line exhibits corrosion holes. Other lines appear to be improperly patched and may contain leaks. In 2018 a sanitary sewer line contained a breach with leaking effluent. This leak appears to have been repaired.

**Photo 3.10-6:** Example of impacted insulated utility lines at the Plumbing Gangway.

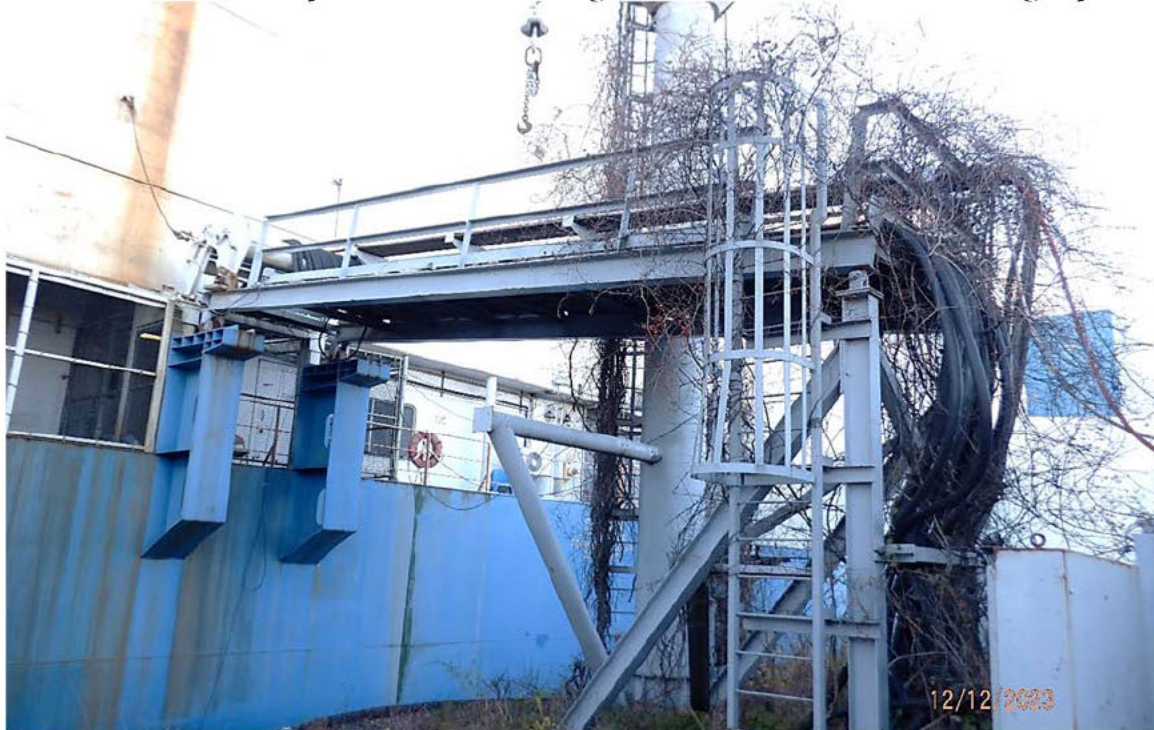
The overall condition of the framing at the Electrical Gangway is **Satisfactory**. In general, the framing does not exhibit significant corrosion, mechanical damage, or missing/inoperable components. The steel girders, floor beams and cross-braces maintain their coating with only minor coating loss at isolated locations. The gangway functions as intended by design and can accommodate its full range of motion. Table 3.11-2 below provides a summary of the observed conditions of the framing at the Electrical Gangway. Photo 3.11-1 provides an overall view of the gangway.

**Photo 3.11-1:** Overall view of the Electrical Gangway.

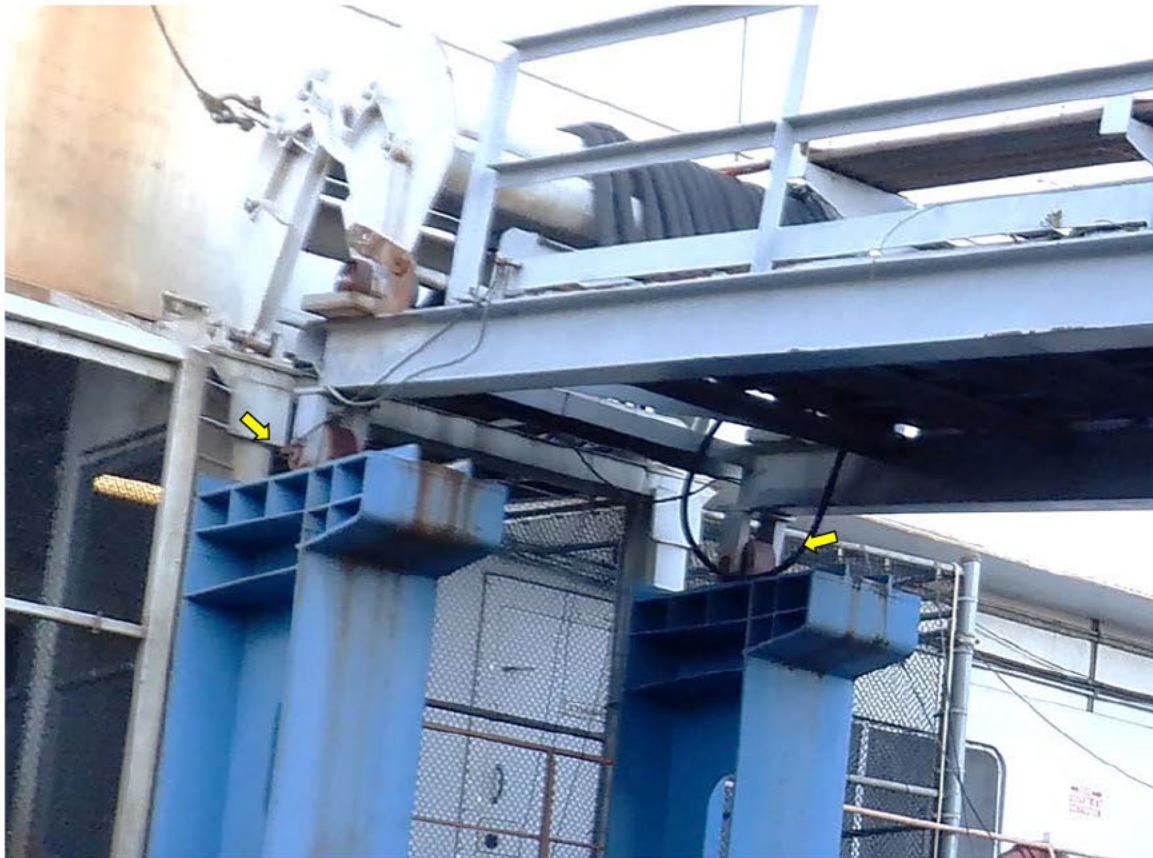
The overall condition of the roller bearing supports at the Electrical Gangway is **Satisfactory**. The bearings typically exhibit minor coating loss and corrosion of the components. The upland end of the gangway is supported by pins as part of the support frame. Table 3.11-3 below provides a summary of the observed conditions at the roller bearings of the Electrical Gangway. Photo 3.11-3 provides an enlarged view of the roller wheel bearings.

**Photo 3.11-2:** Enlarged view of the roller wheel bearings at the Electrical Gangway.

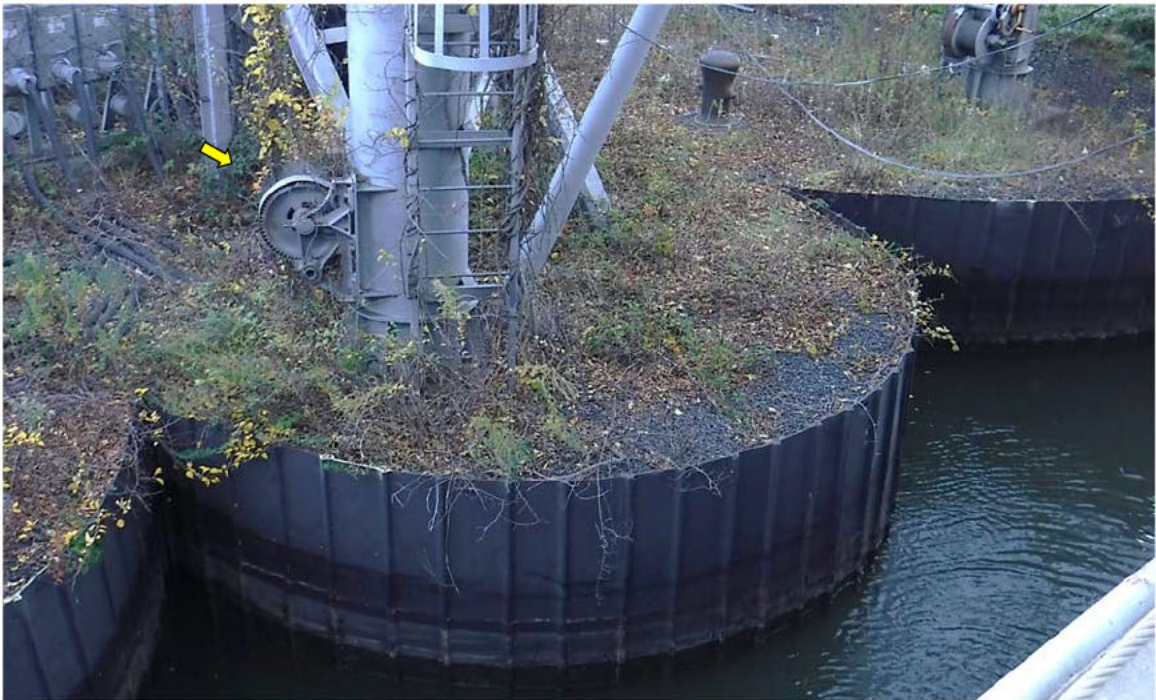
Table 3.11-5 below provides a summary of the observed conditions at the gangway support frame of the Electrical Gangway. Photo 3.11-3 provides an overall view of the gangway with excessive vegetation and vines, and Photo 3.11-4 illustrates vegetation growing into the winch mechanisms.

**Photo 3.11-4:** Excessive growth in the winch mechanisms at the Electrical Gangway.

The Plumbing Gangway and support frame does not exhibit evidence of structural distress and can continue to function as intended by design. Regular inspection and maintenance, including the removal of excessive growth on the support frame and mechanisms will ensure a state of good repair.

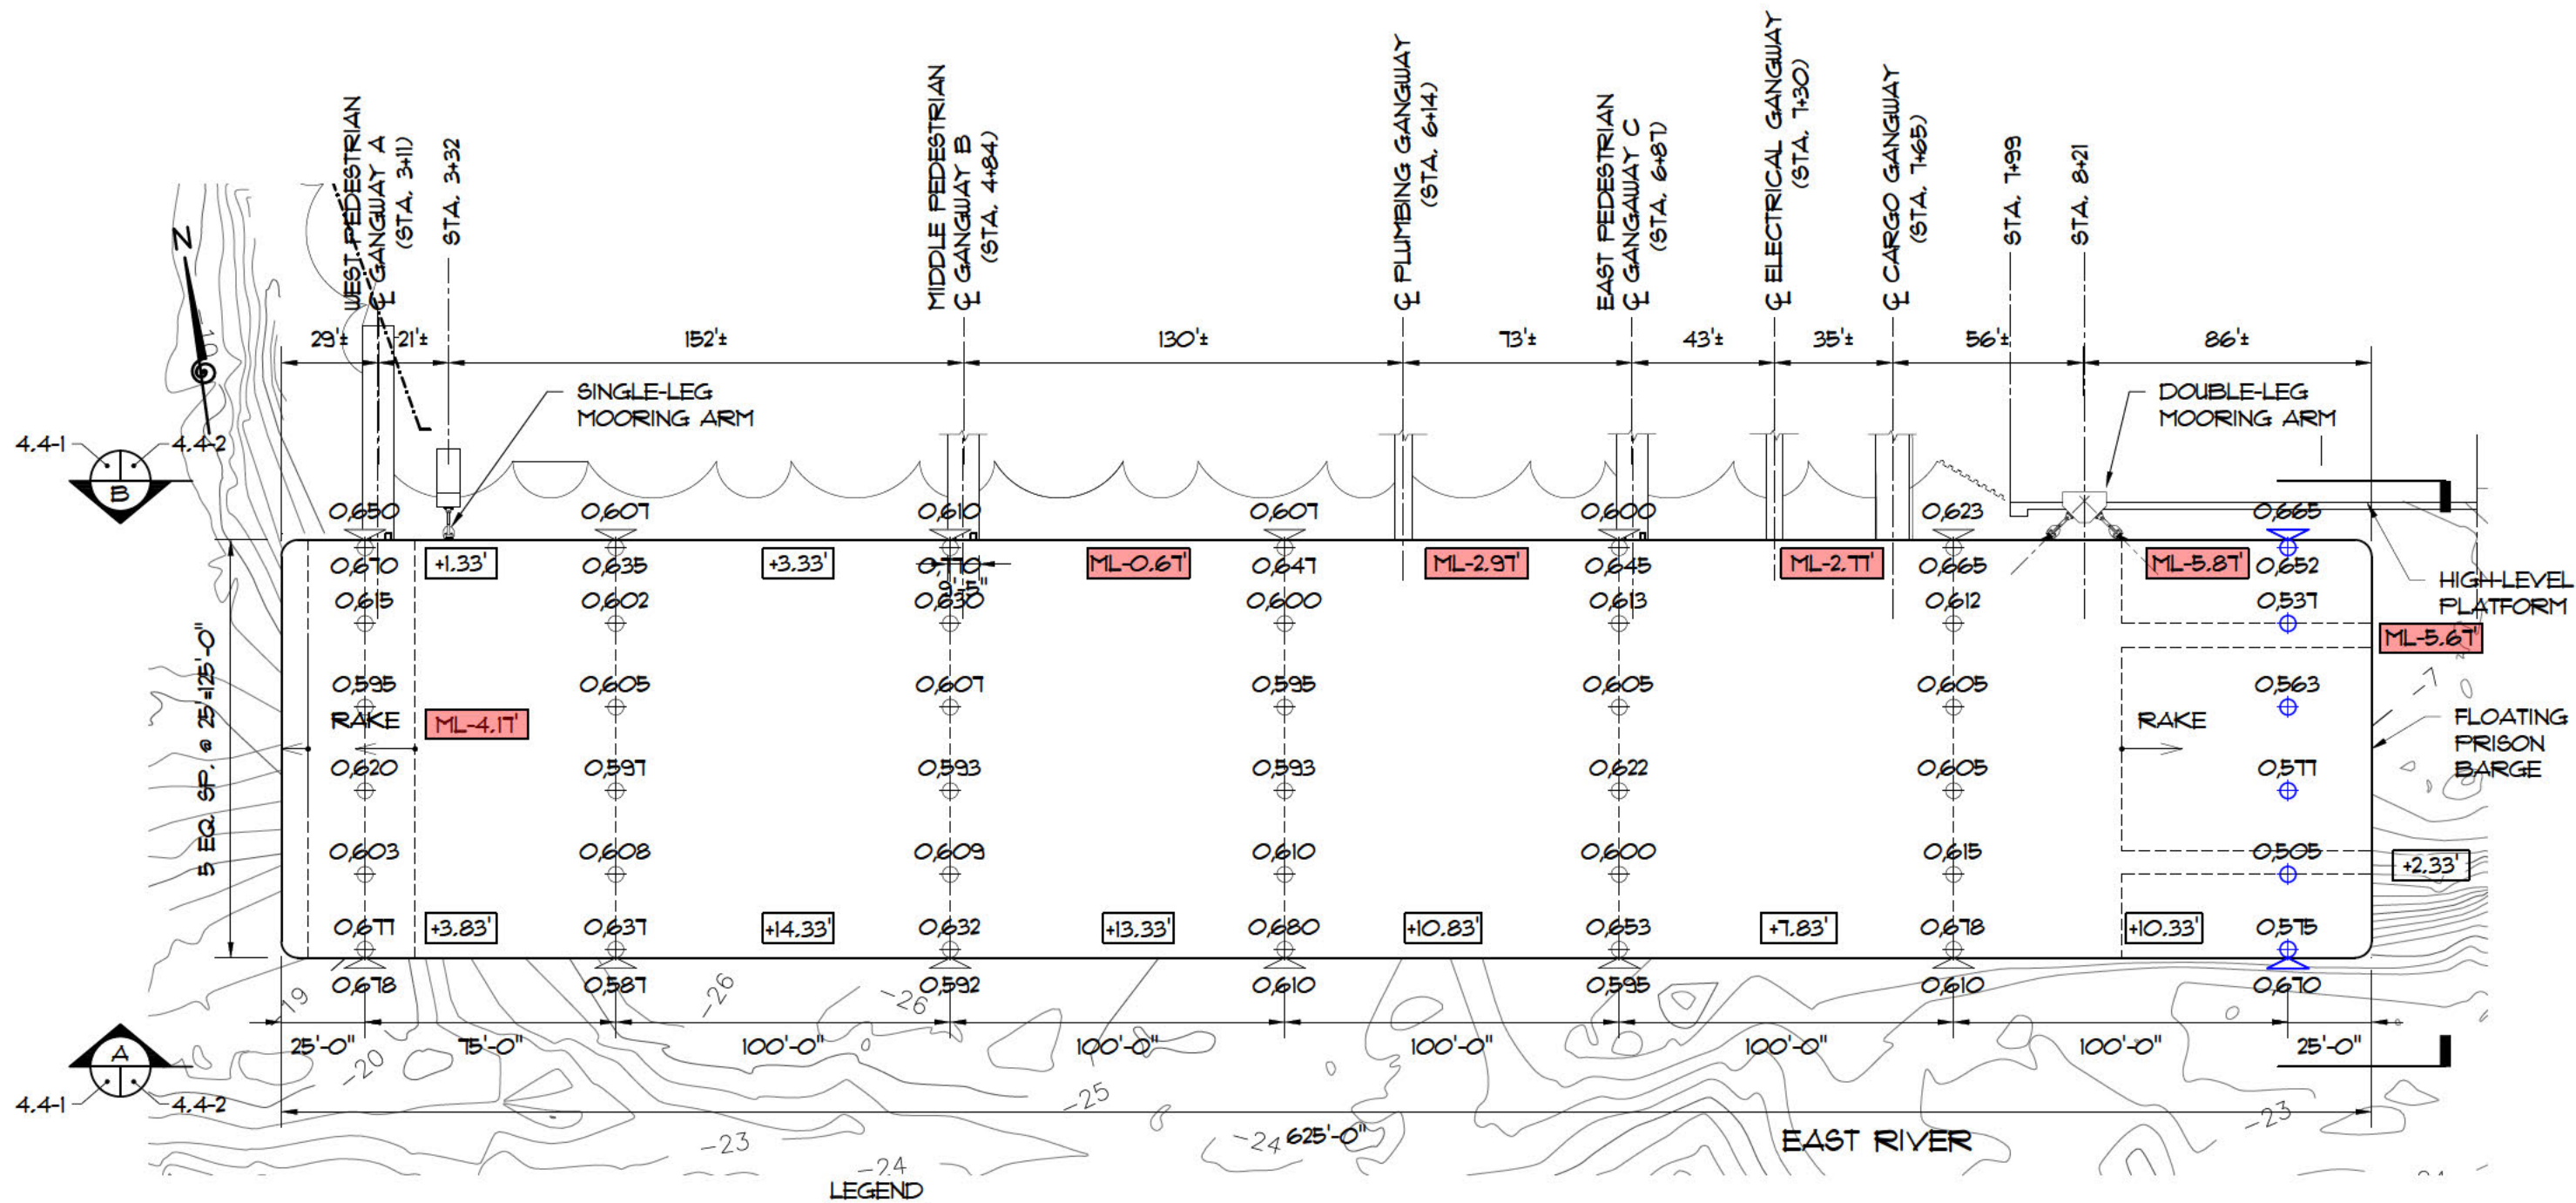
1 FLOATING DETENTION BARGE  
4.1-1 HULL PLAN

- NOTE:  
1. NOMINAL DESIGN THICKNESS OF BOTTOM  
KEEL PLATE IS 0.59 IN.  
2. NOMINAL DESIGN THICKNESS OF SIDE WALL  
HULL PLATE IS 0.65 IN.

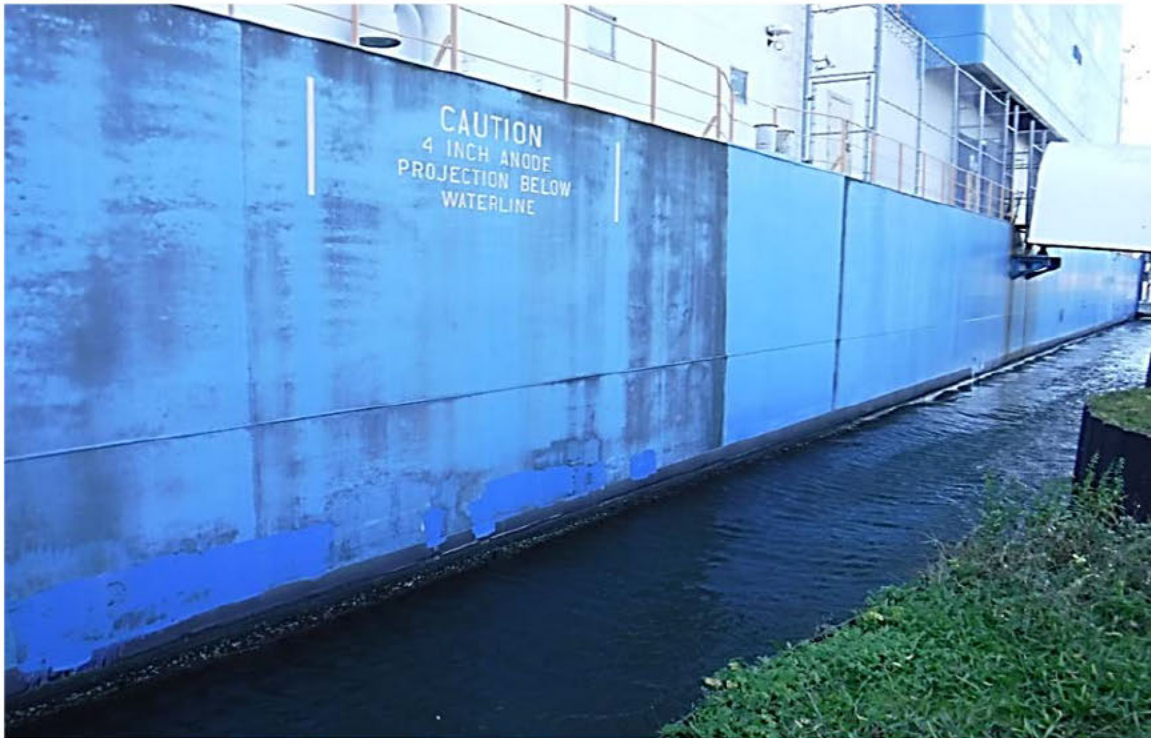
| Location | Description of Observed Conditions |
|---|---|
| Southern Side Hull | Statistically, the average amount of material loss due to corrosion along the southern side hull of the barge is approximately 4.6 percent. Based on the lowest average reading, not more than approximately 10 percent of the steel material has been lost to corrosion along the southern side hull at the waterline. |

**Photo 4.1-1:** Typical condition of the hull coating along the waterline.

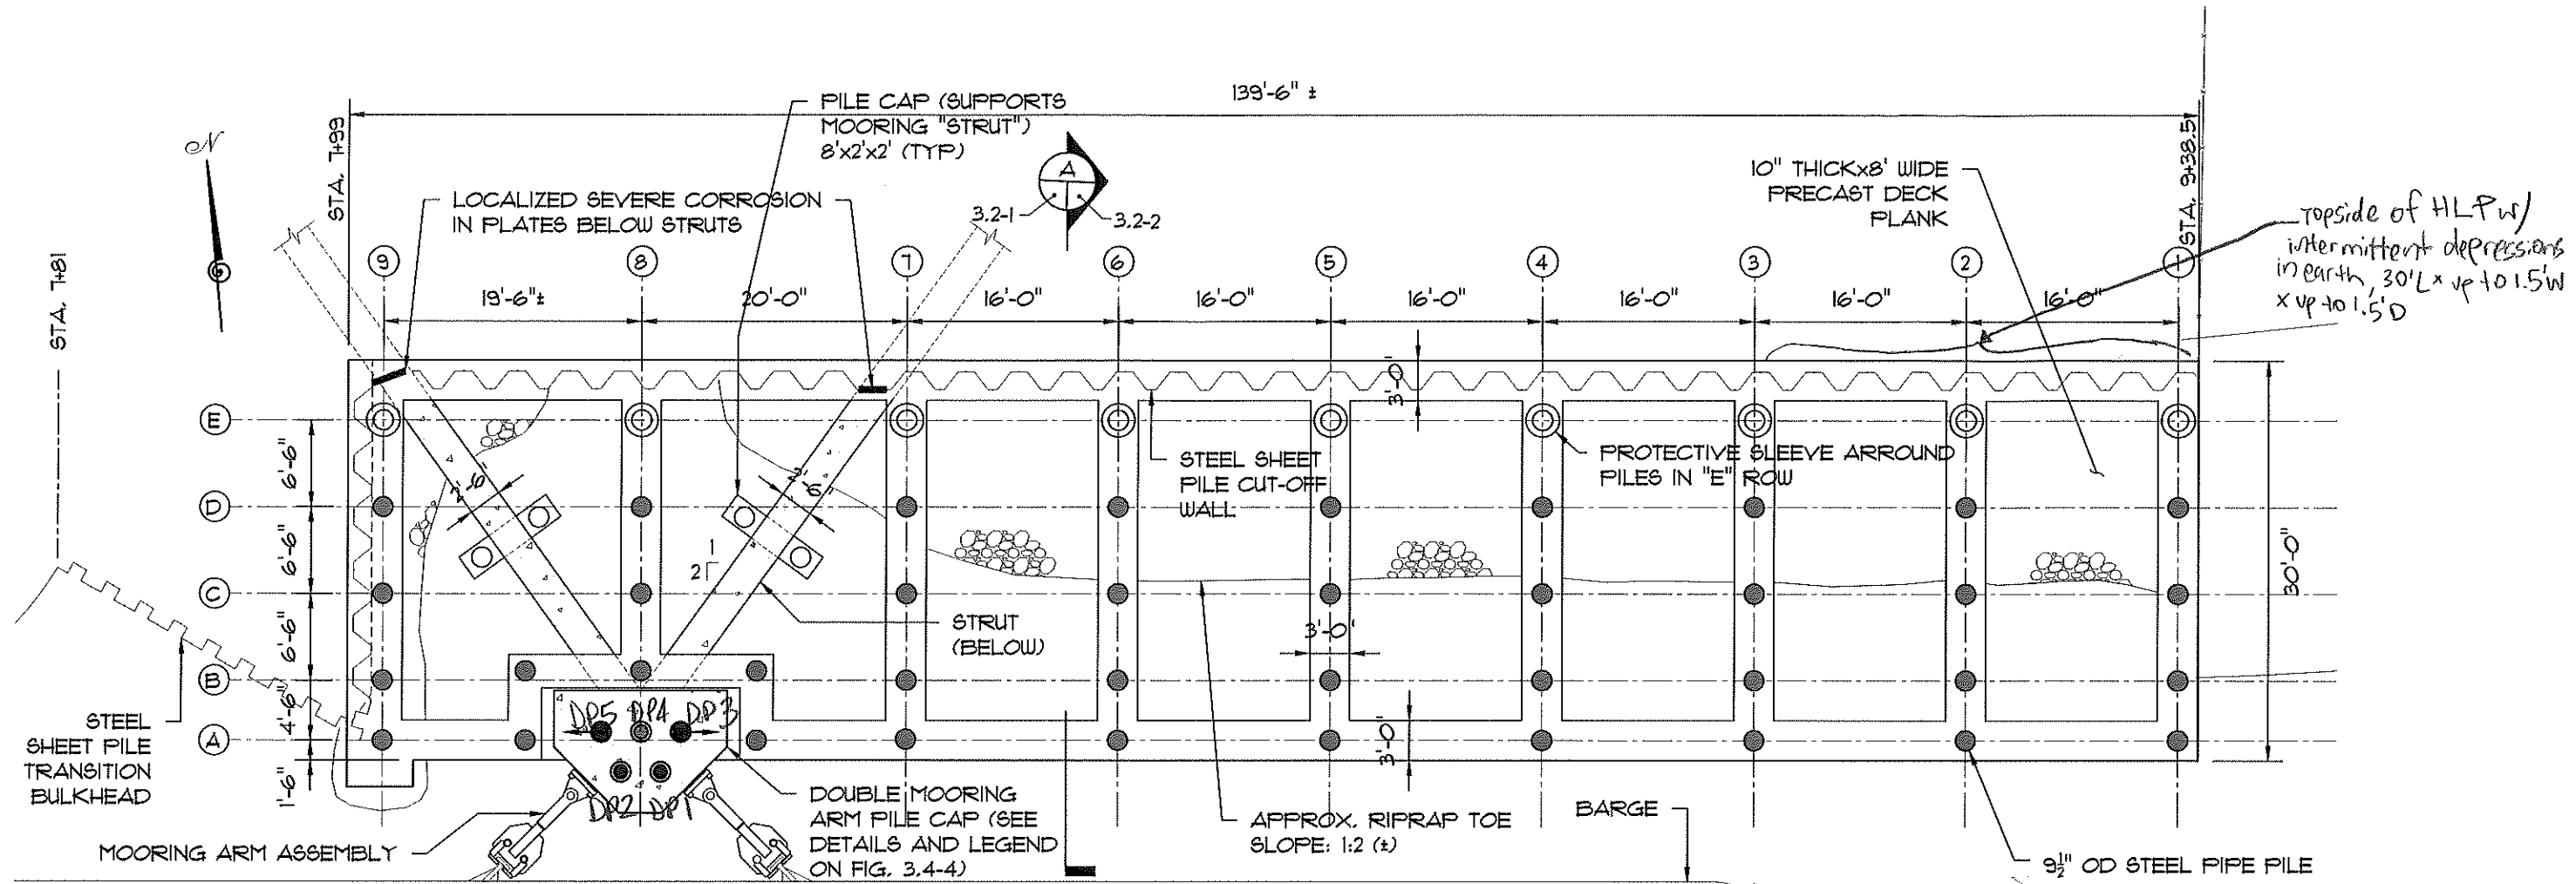
General Note: Underside of pile caps has isolated popouts and shallow rebar up to 1/4" deep

TOP OF PILE NOTES: DP1 - 0.2' EXPOSURE (PILE NOT VISIBLE)

NOTE: SHEET PILE CUT-OFF WALL AND TRANSITION BULKHEAD EXHIBIT COATING FAILURE AND MINOR CORROSION ABOVE MLW.
