NYC EDC East New York Industrial Business Zone:
116 Williams Ave, Brooklyn, NY 11207

Building Assessment Report

27 January 2025

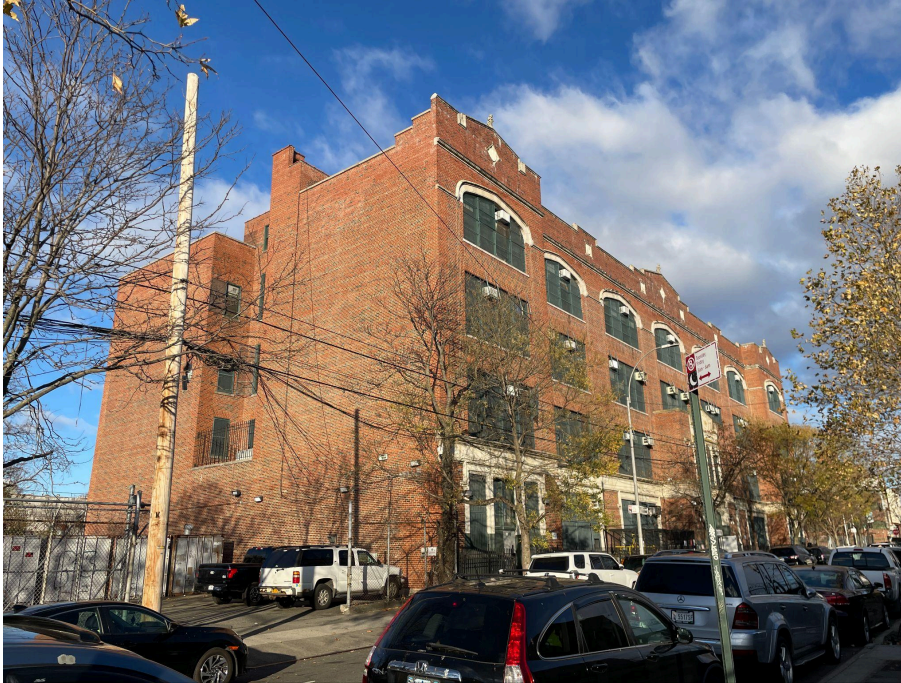
Photo 01: Looking northwest at corner of Williams Ave and Glenmore Avenue

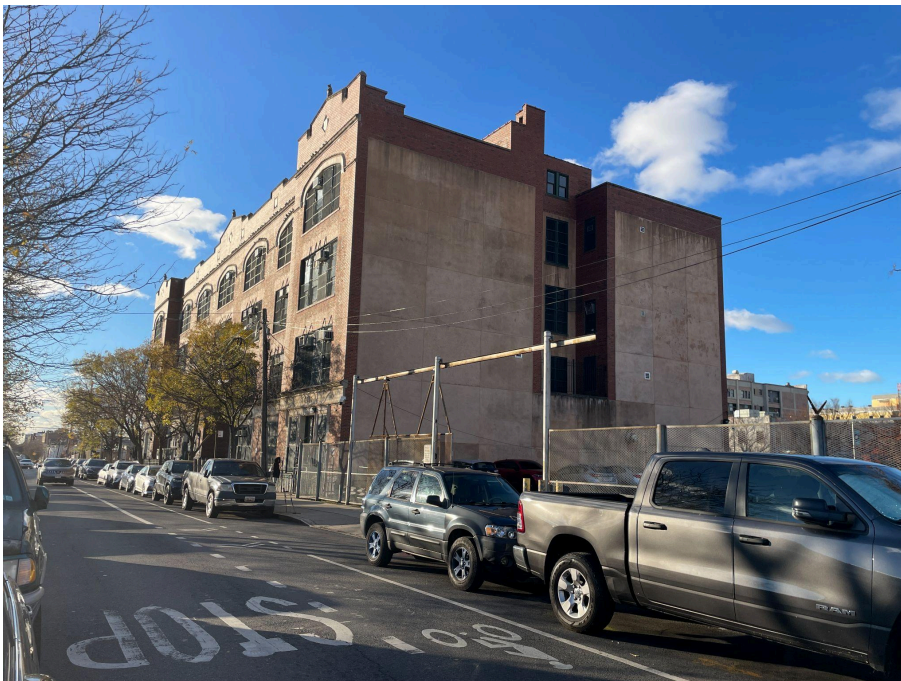
Photo 02: Looking southwest at corner of Williams Ave and Liberty Avenue

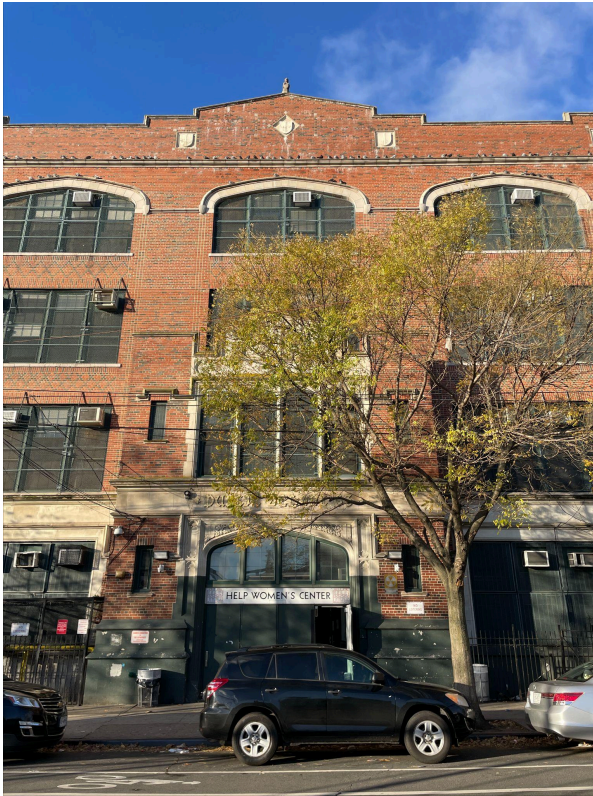
Photo 03: Main entrance at Williams Ave

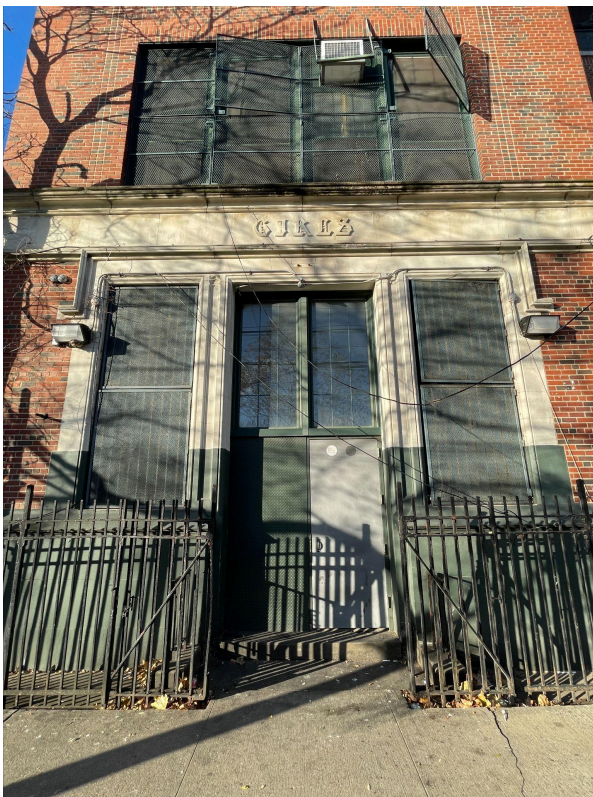
Photo 04: Articulation of the facade on Williams Ave

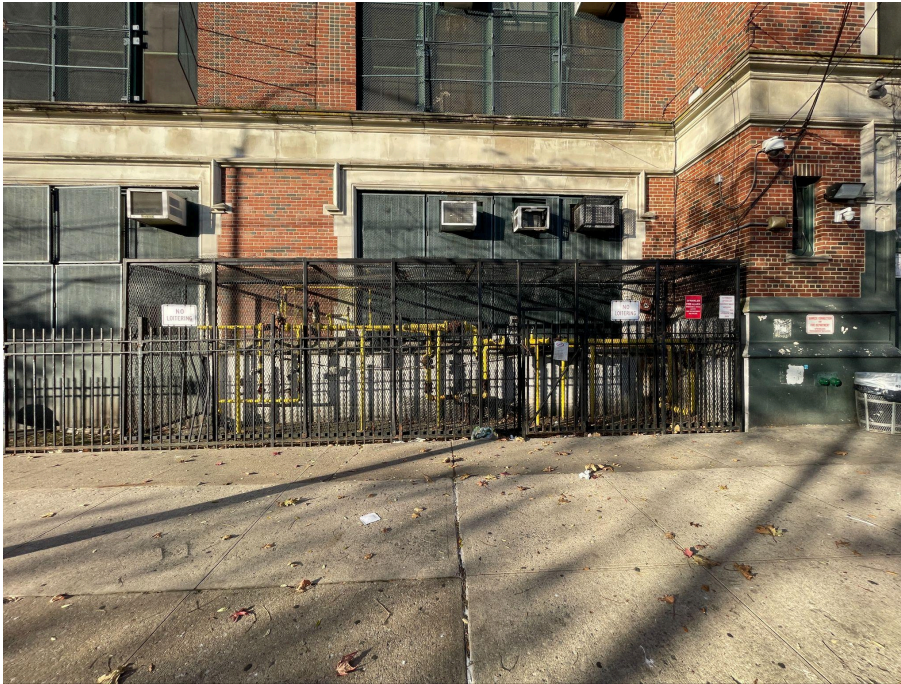
Photo 05: Incoming services behind fencing and AC window units

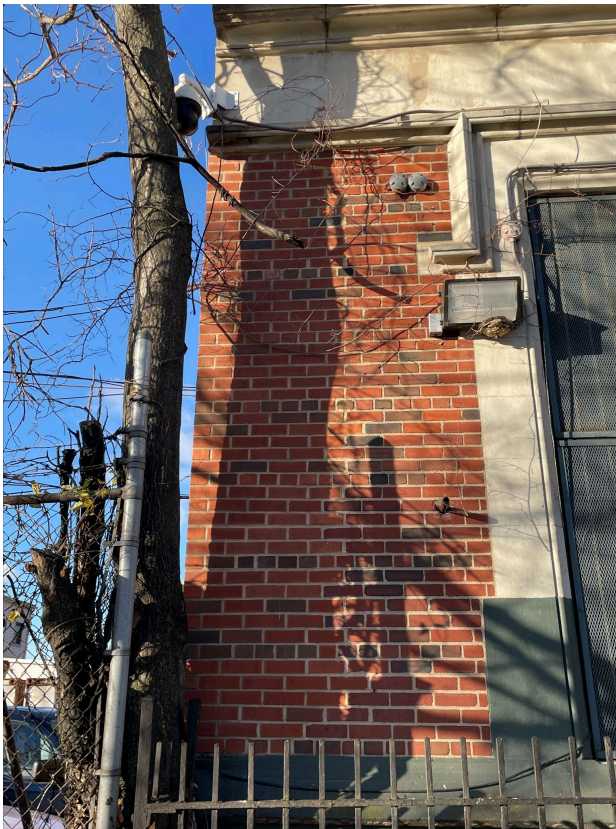
Photo 06: Cameras and Lighting at exterior

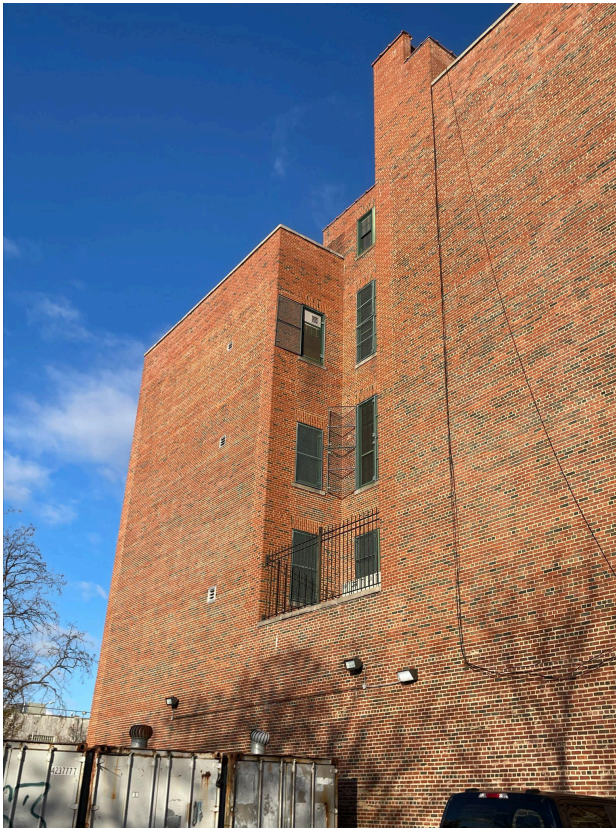
Photo 08: South facade with light well above Ground Flr.

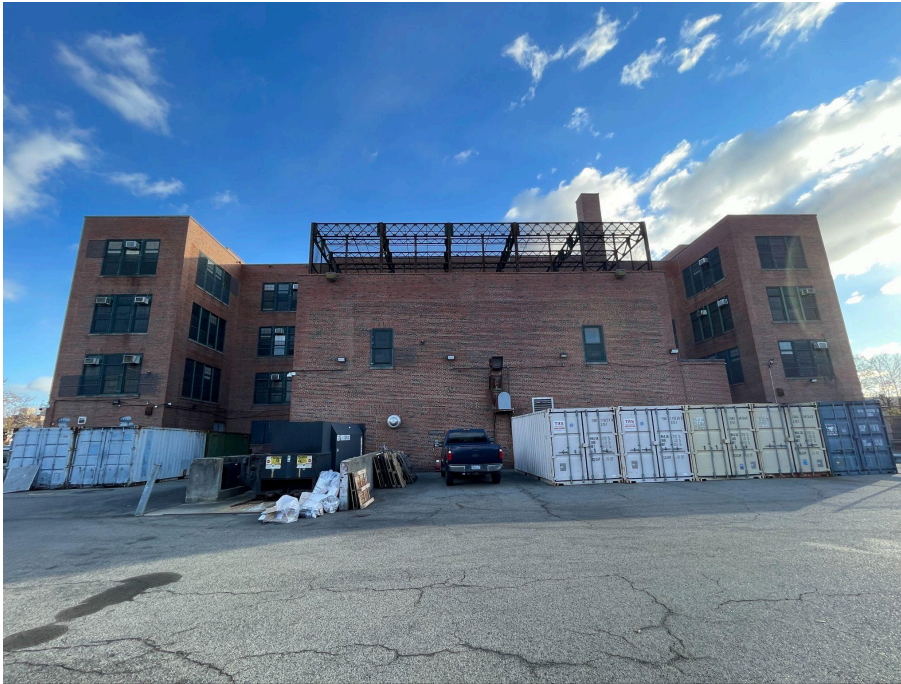
Photo 09: West facade

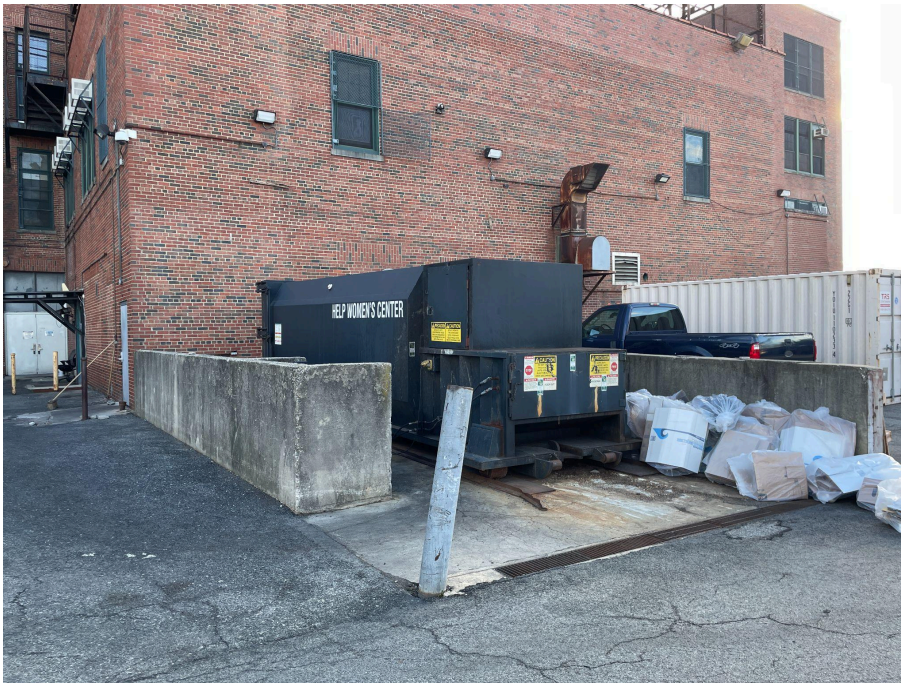
Photo 10: Trash Compactor in rear yard

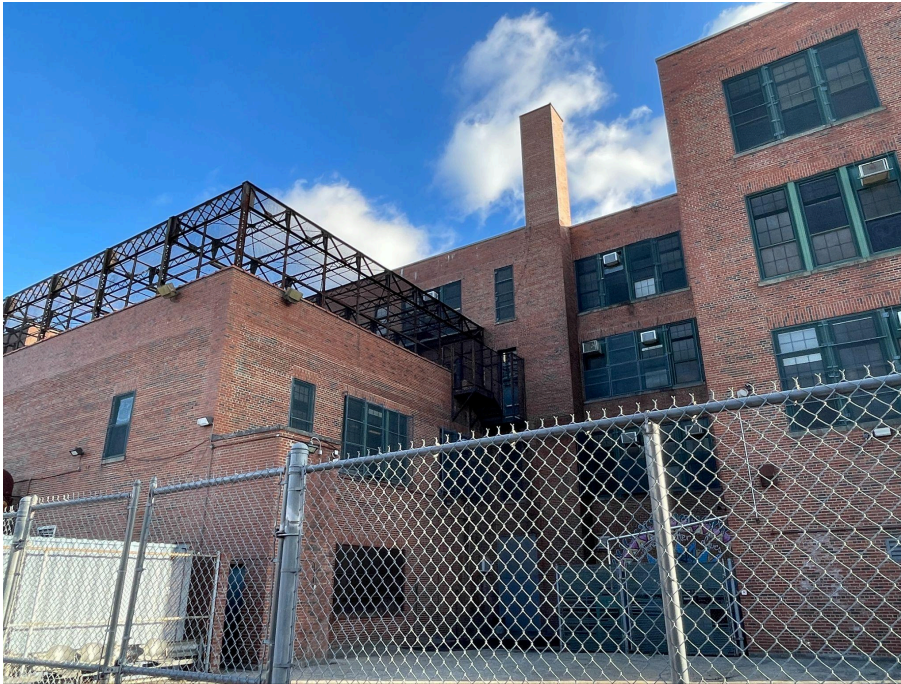
Photo 11: Looking at the Protrusion

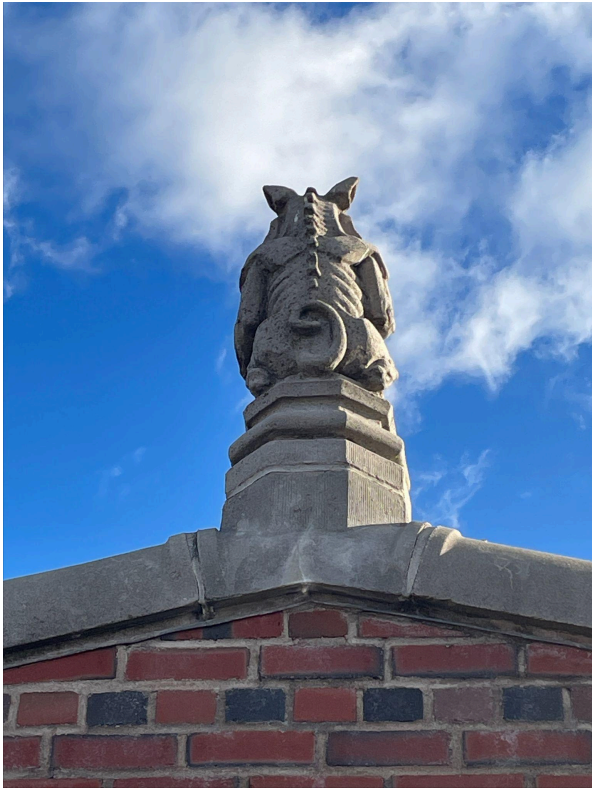
The building has a perimeter parapet consisting of exposed brick/masonry structure with stone coping with gargoyle sculptures at the Williams Ave side, which vary in height up to 9'-0" at the highest. Parapets for the mechanical penthouses and exhaust structures have terracotta coping that appears to have been re-caulked and re-flashed. The perimeter brick wall shows efflorescence and repointing done over the years. The condition of the parapet appears to be in fair condition. Photos 14, 15, 16, 17.

Photo 15: Detail of the back of gargoyle

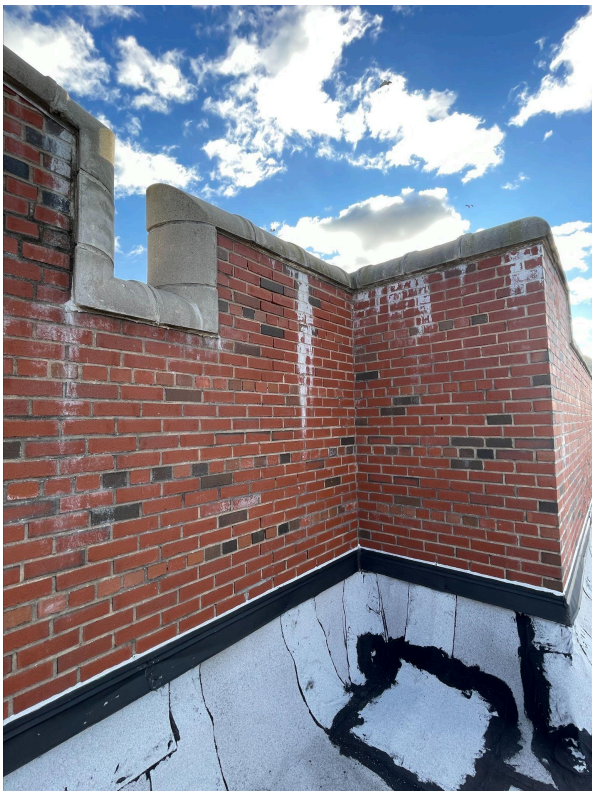
Photo 16: Efflorescence at the parapet wall; patching at roof

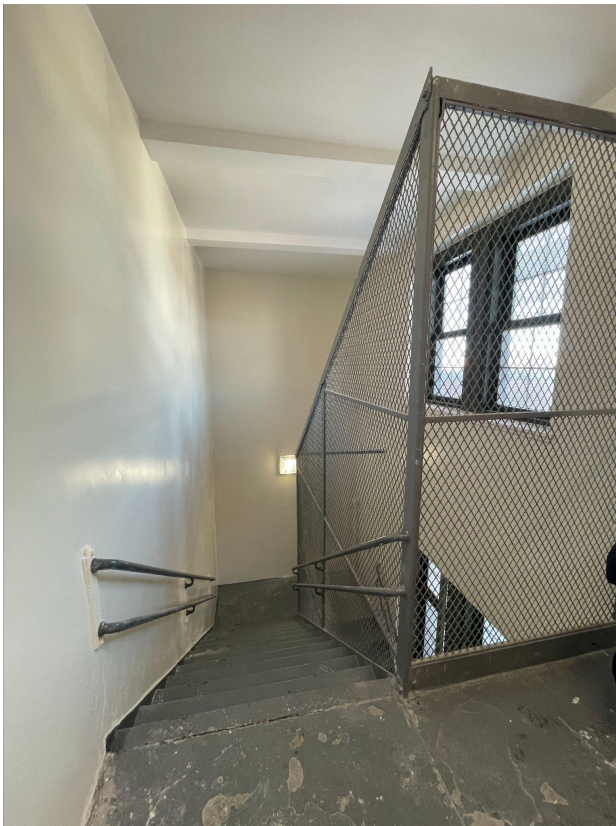
On the interior it appears that there is a lack of insulation on the exterior envelope (see photos 18,19,32,37).

Photo 18: Stair D at roof landing

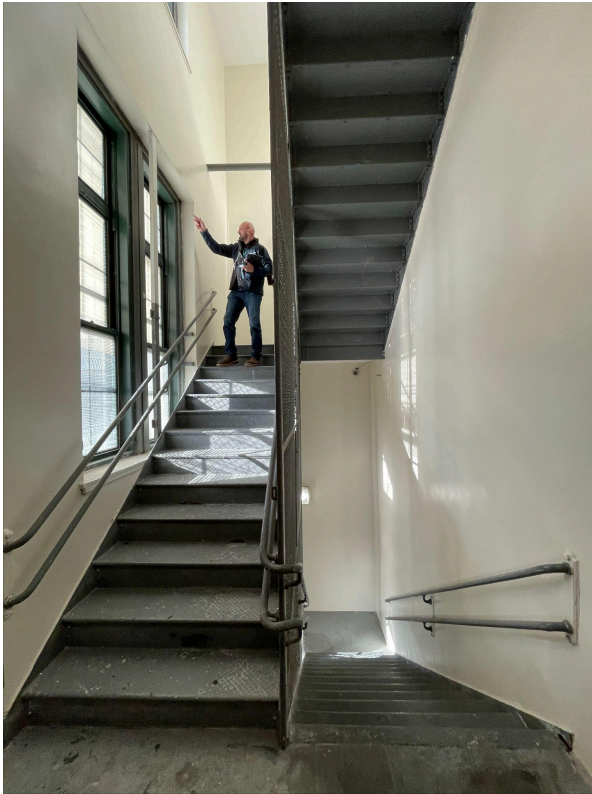
Photo 19: Stair D at floor landing

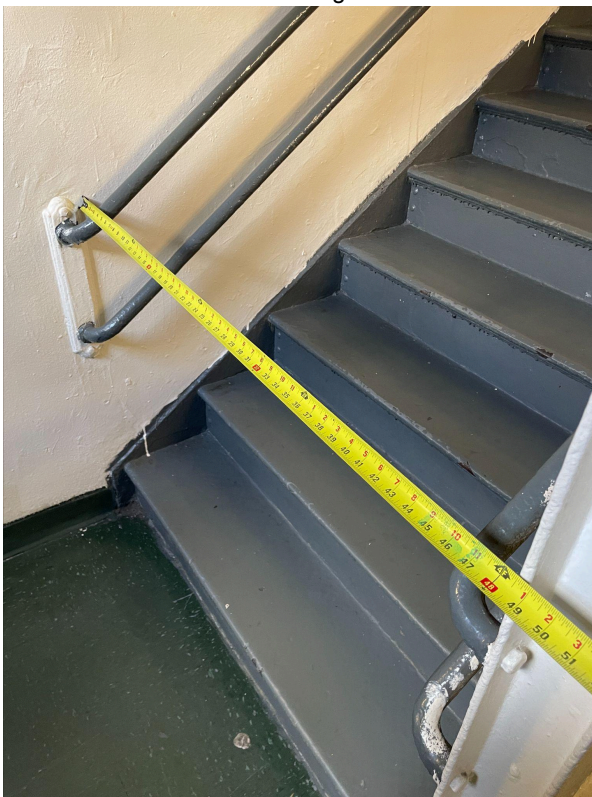
All the stairs have windows since they are located adjacent to the exterior walls. Instead of guardrails Stair B and Stair C have expanded metal mesh screens in between the flights with some intermediate landings cantilevering over. There are double-height handrails that were built at heights for children when the building was a school. Handrail height requires review in future renovations. The stairs are in fair to good condition with stair widths that will allow for occupant load for future uses. Photos 18, 19, 20, 21, 22, 23.

Photo 20: Stair width typically 4'-0"

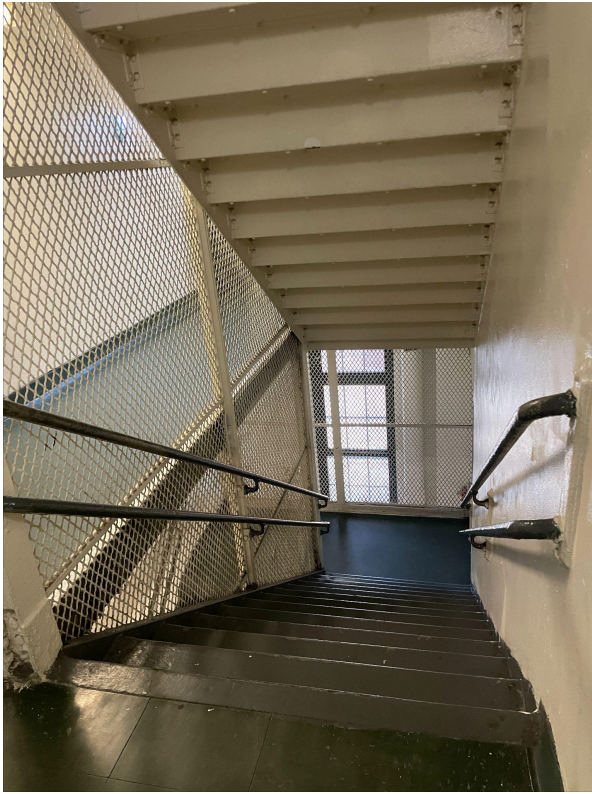
Photo 23: Cantilevered intermediate landing

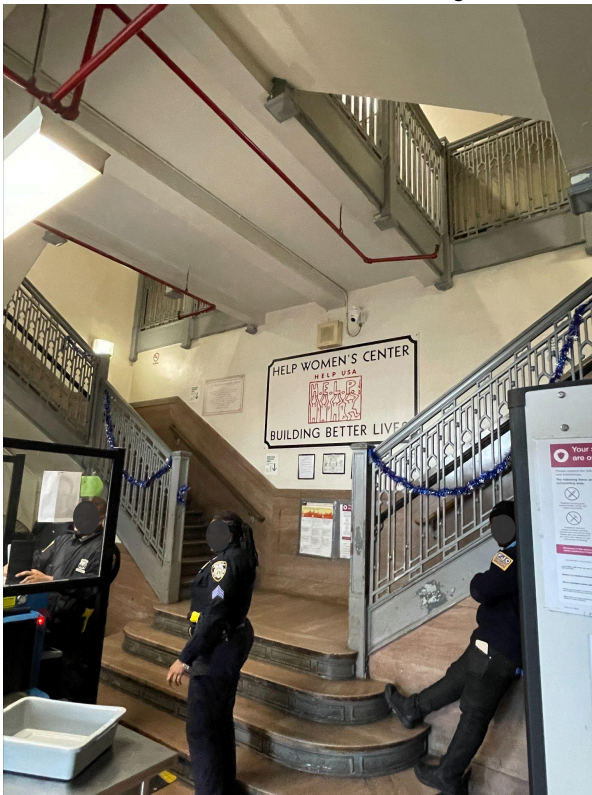
Photo 24: Open double stairs at Ground Flr

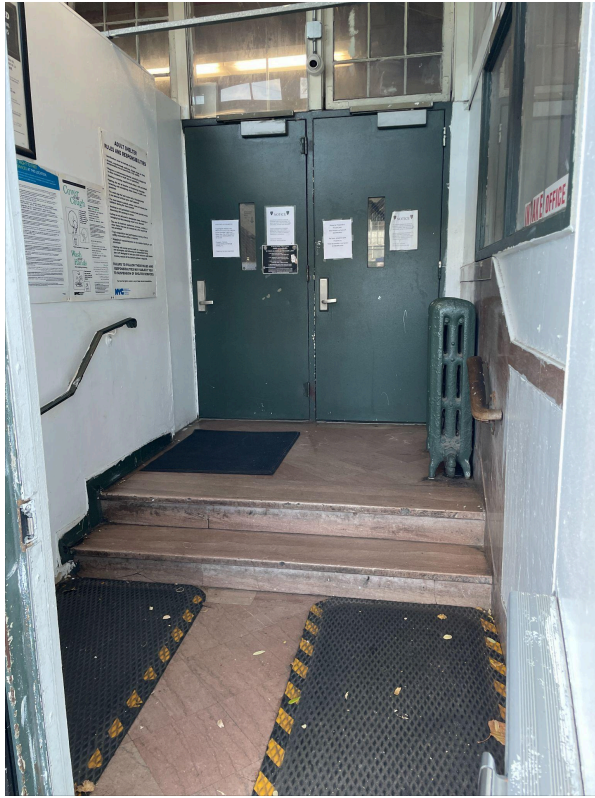
Main Entrance: The main entrance from Williams Ave has 2 risers up from sidewalk/grade level to the floor level of the Ground Floor in the vestibule. Photos 24, 25.

Photo 25: Steps at main entrance vestibule

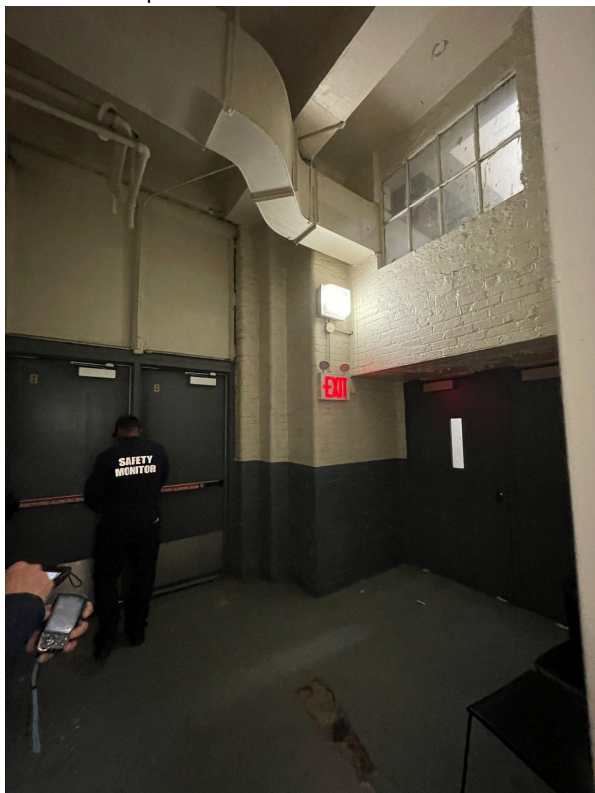
Photo 26: Egress to the exterior at west of bldg

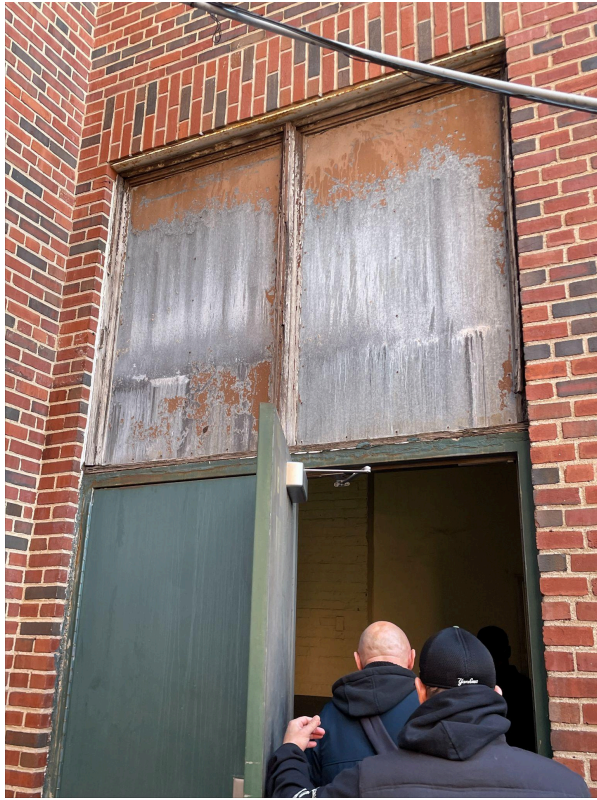
Photo 27: Stair B Egress at Ground Flr

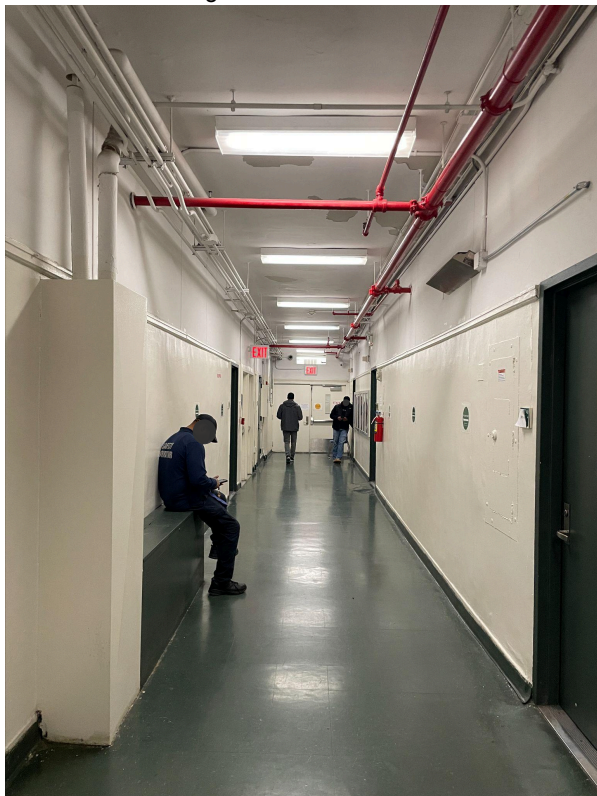
Photo 28: Central corridor at 4th Flr

Recommendations: All interior finishes may need to be replaced fully.

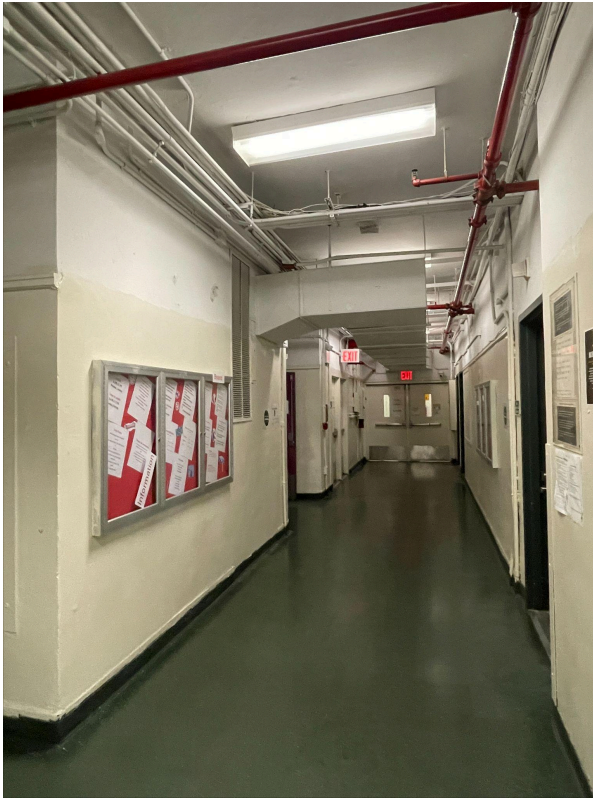
Photo 29: Central corridor at 3rd Flr

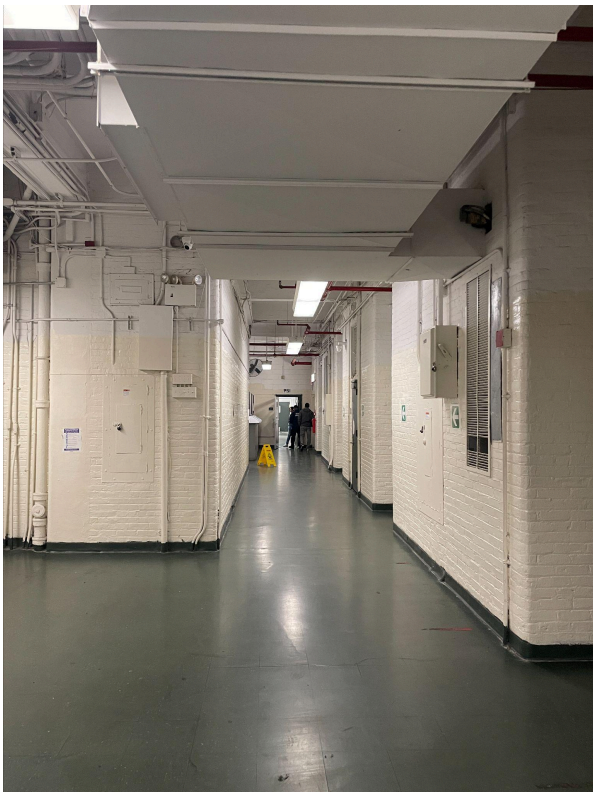
Photo 30: Central corridor at Ground Flr

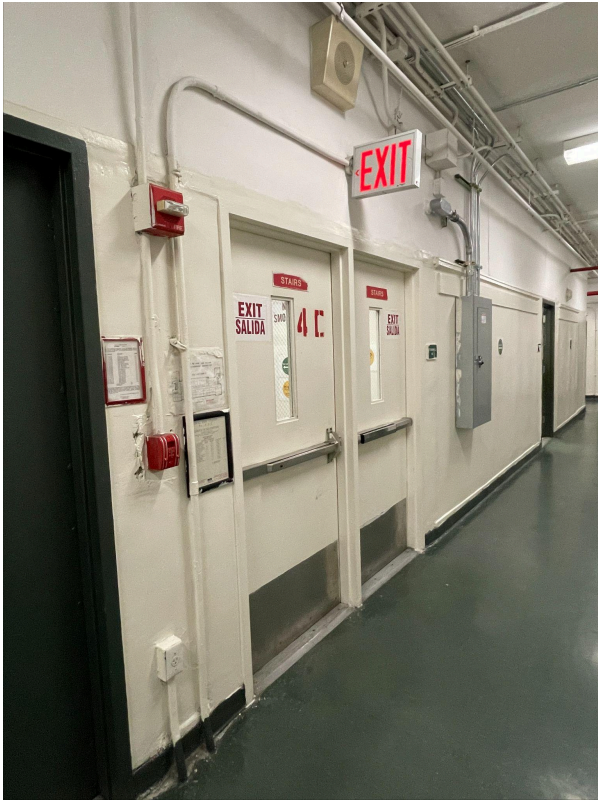
Photo 31: Typical stair doors from corridor

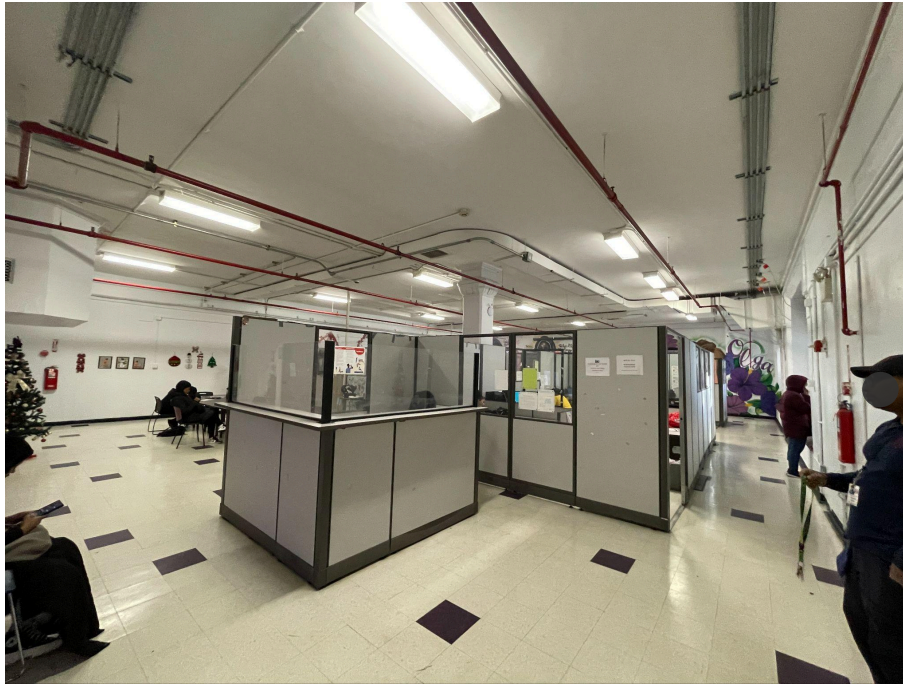
Photo 35: Looking into the 2nd Flr auditorium space turned offices with dividers

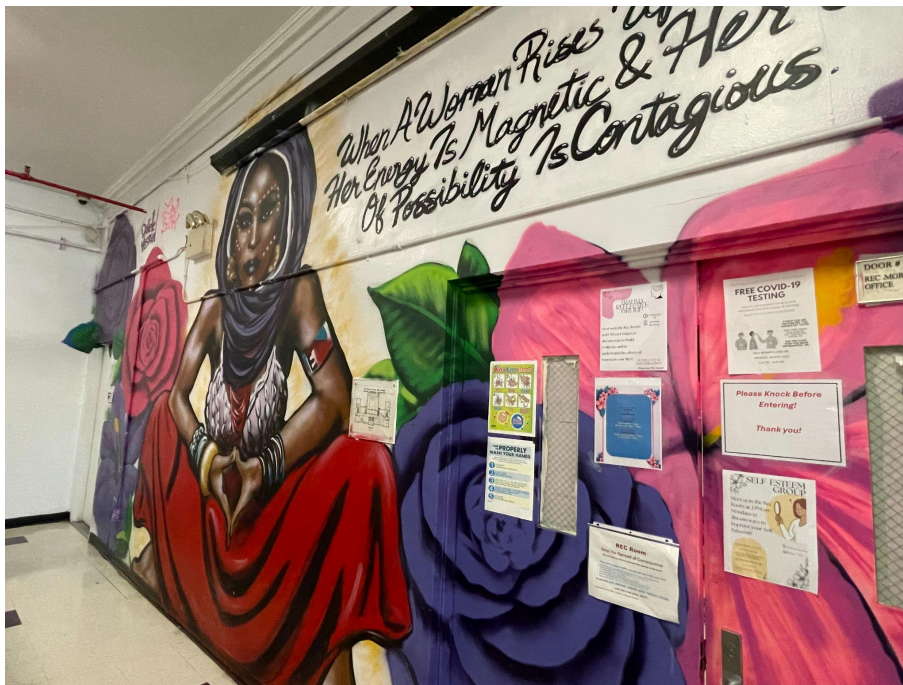
Photo 36: Looking to the west side of the auditorium space

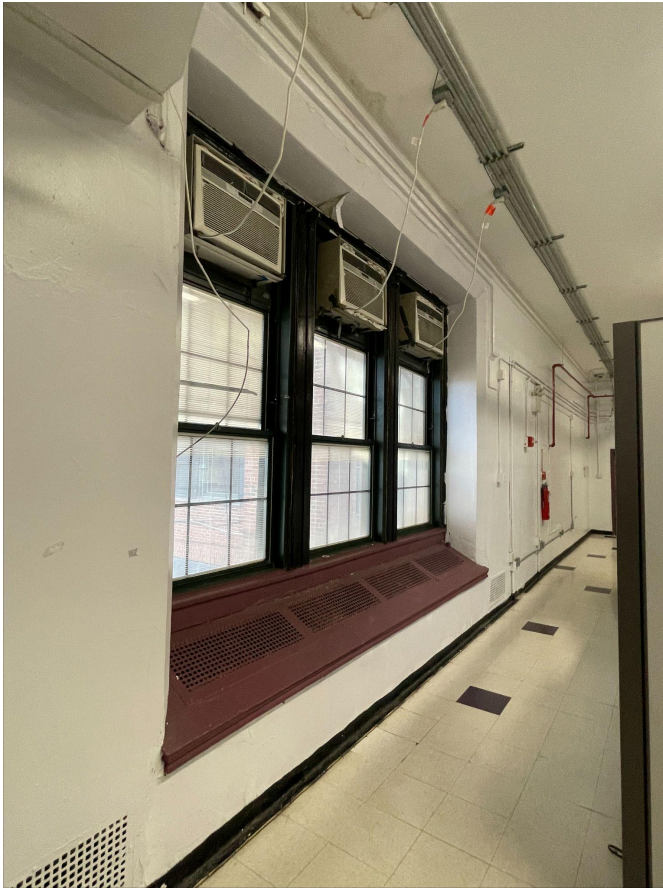
Photo 37: Looking to the north side of the auditorium space

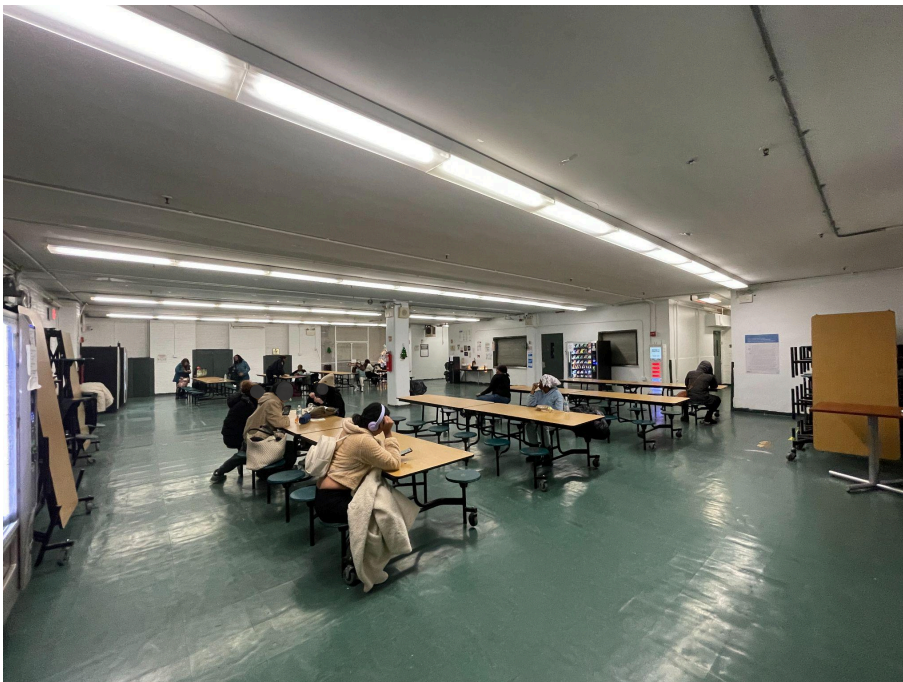
Photo 38: Looking into the cafeteria space at Ground Flr

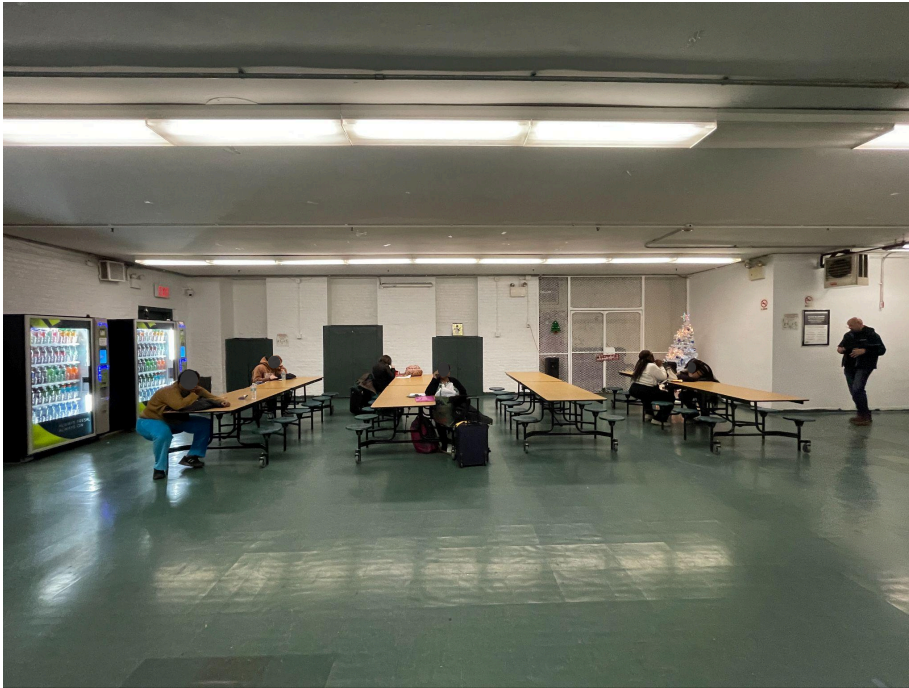
Photo 39: Looking into the cafeteria space at Ground Flr

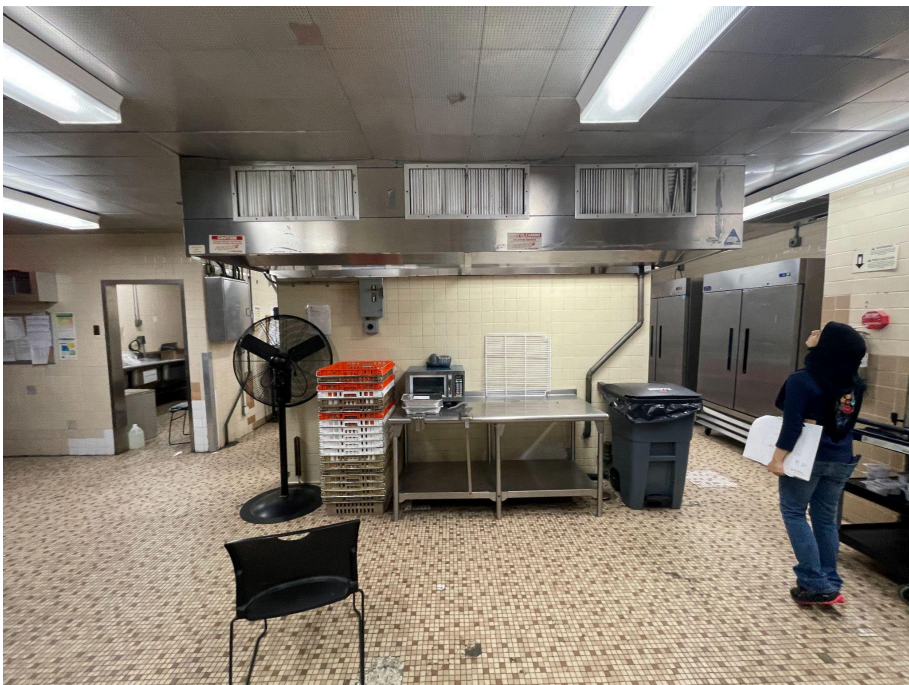
Photo 40: Looking into the kitchen space at Ground Flr

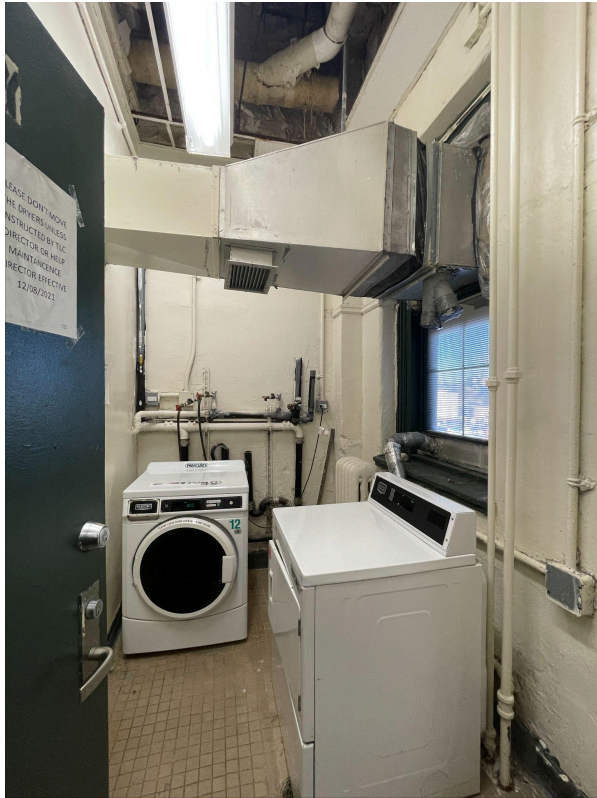
Photo 41: Looking into the laundry room on 3rd Flr

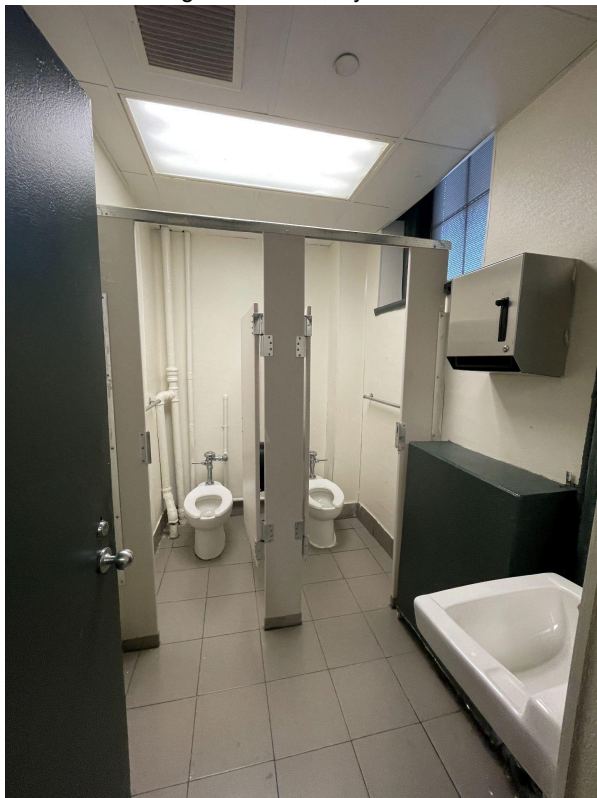
Restrooms: Due to the nature of the facility, the consultants had partial access to the bathrooms. The majority of the bathrooms are located on the north and south end of the building, stacked from floor to floor. The upper floors with dormitory facilities have shower stalls and toilets for the current occupants. Photo 42, 43.

Photo 42: Looking into bathroom at 3rd Flr

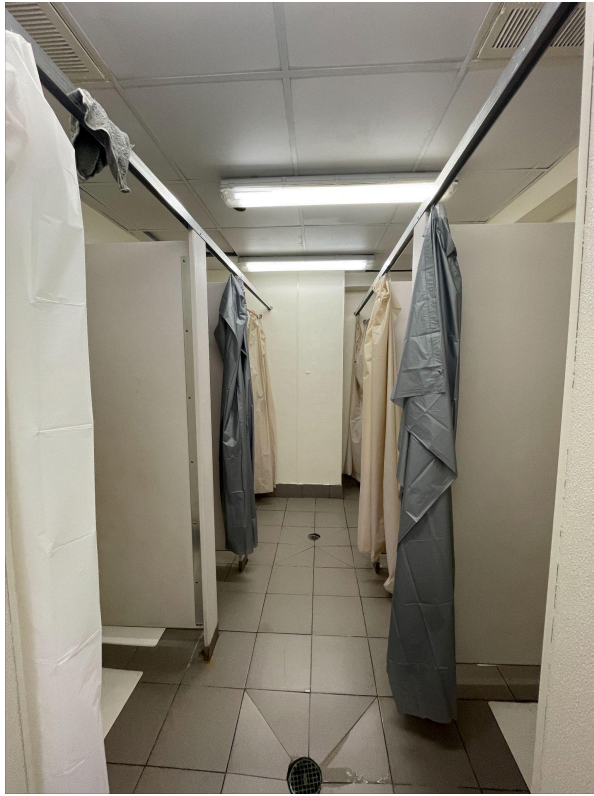
Photo 43: Looking into shower facility at 3rd Flr

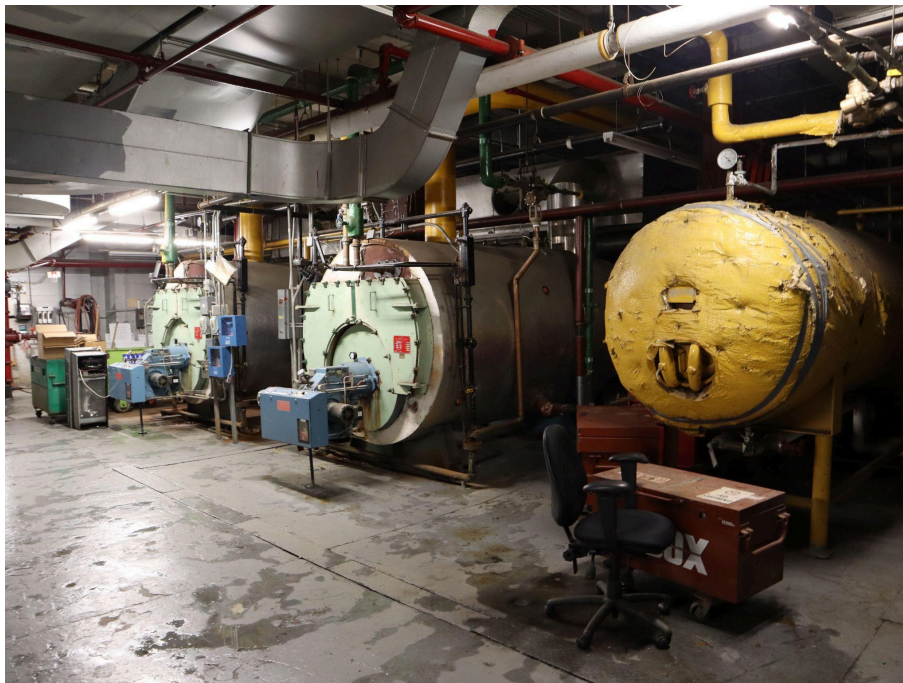
Photo 44: Looking into the Cellar boiler room

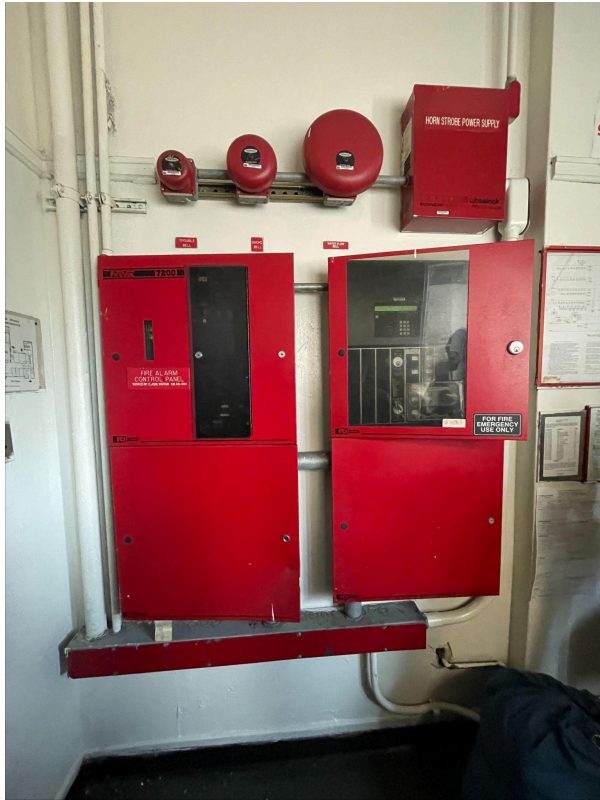
Photo 45: Fire Alarm Room at Ground Flr entrance

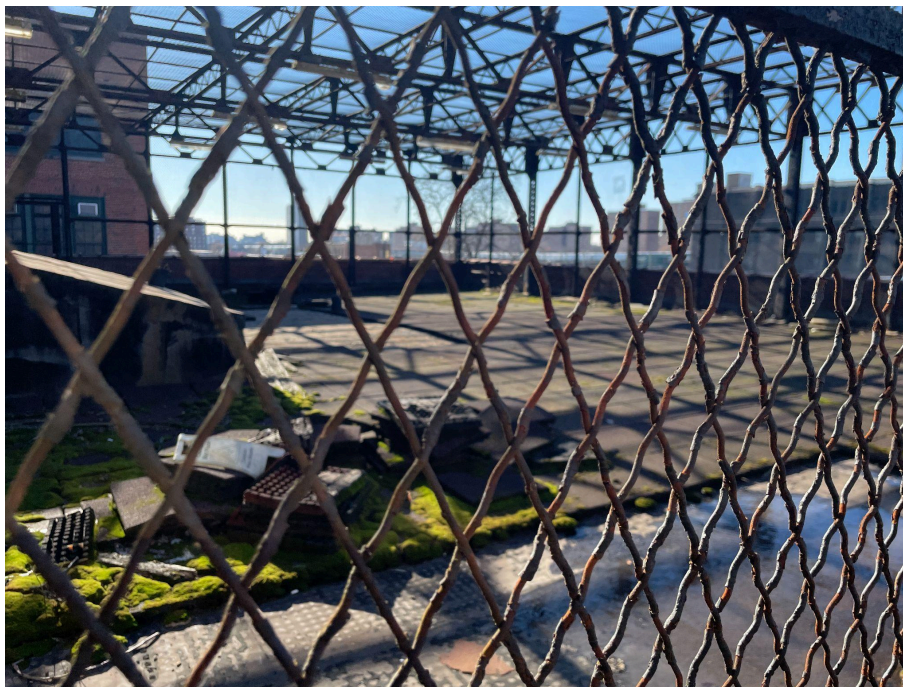
On the roof of the middle leg of the "E" part of the building, there's a playground with what appears to be pavers on top, and at the perimeter, an expanded metal mesh fence that is supported by steel trusses and columns enclosing the entire area. This roof area can be only accessed by traveling outside through Stairs B & C, and was only visually accessible at the time of the assessment. Photo 46.

Photo 46: Looking at roof over the middle leg of the "E" part of the building.

further investigation will be required to review the condition of this roof, steel structure, and metal mesh fencing.
