NYC EDC East New York Industrial Business Zone:
116 Williams Ave, Brooklyn, NY 11207

Building Assessment Report

27 January 2025

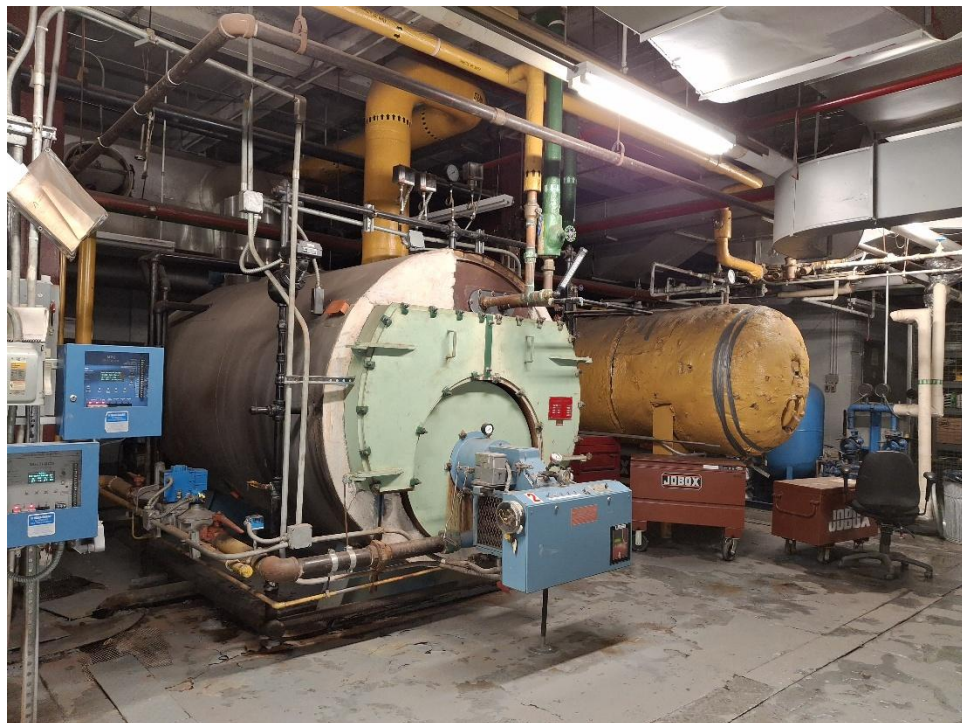
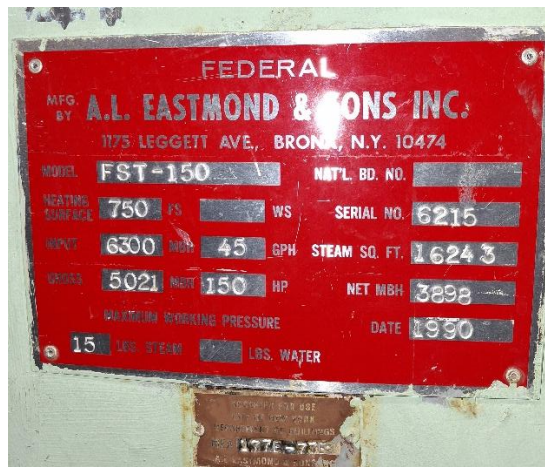
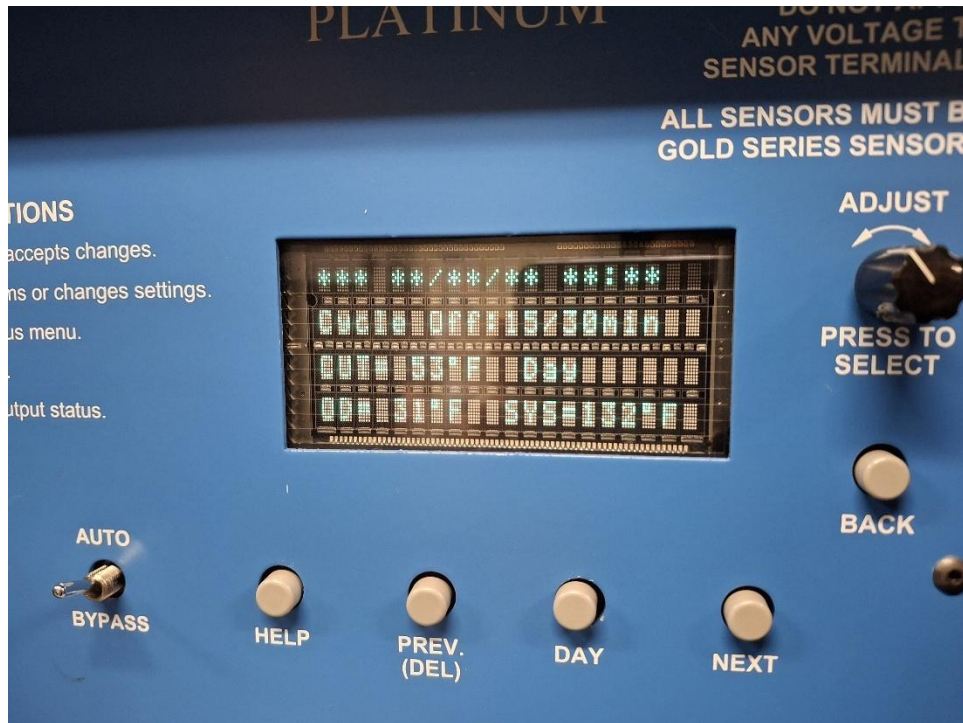
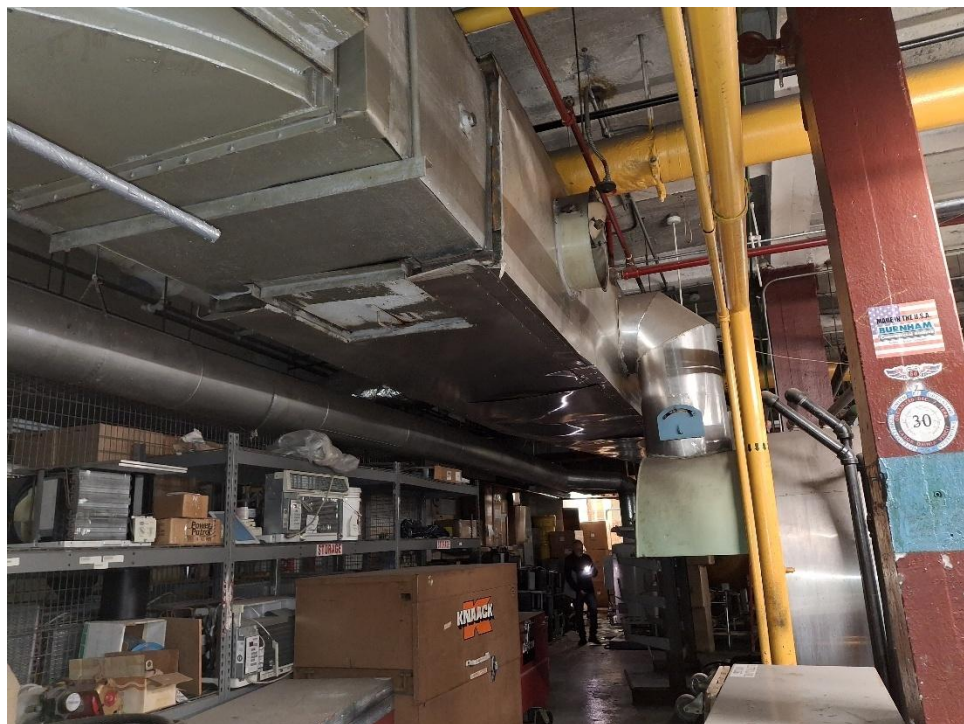
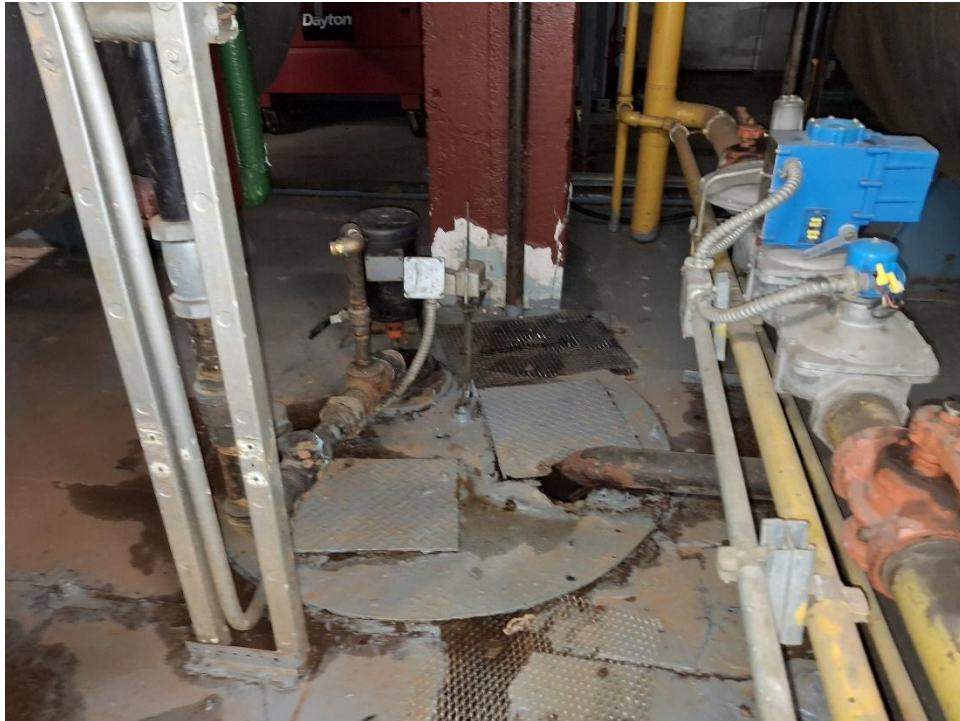
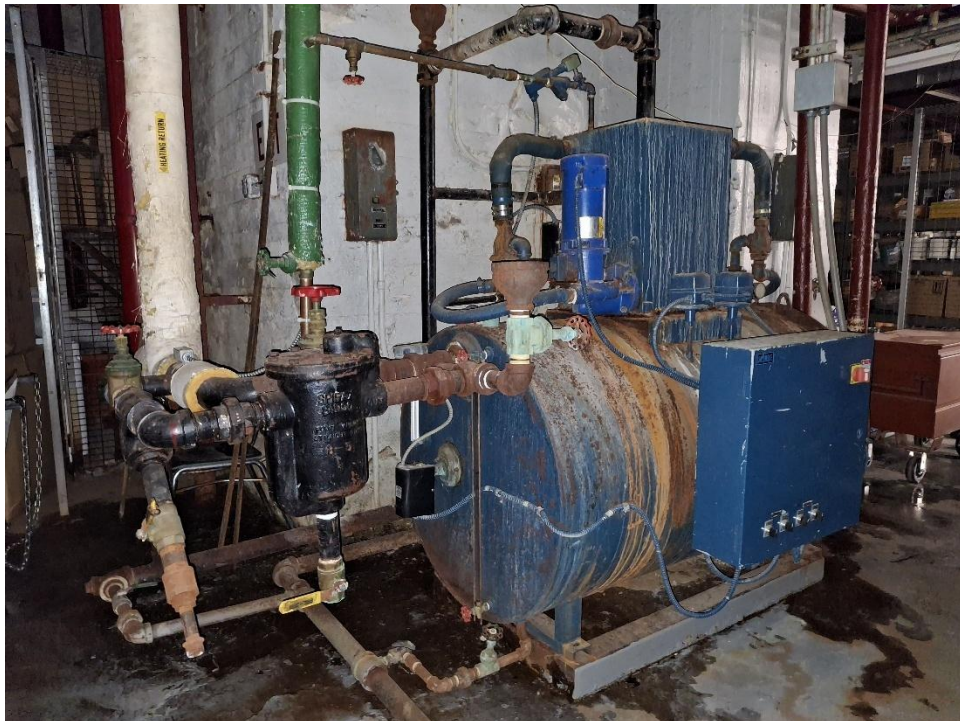
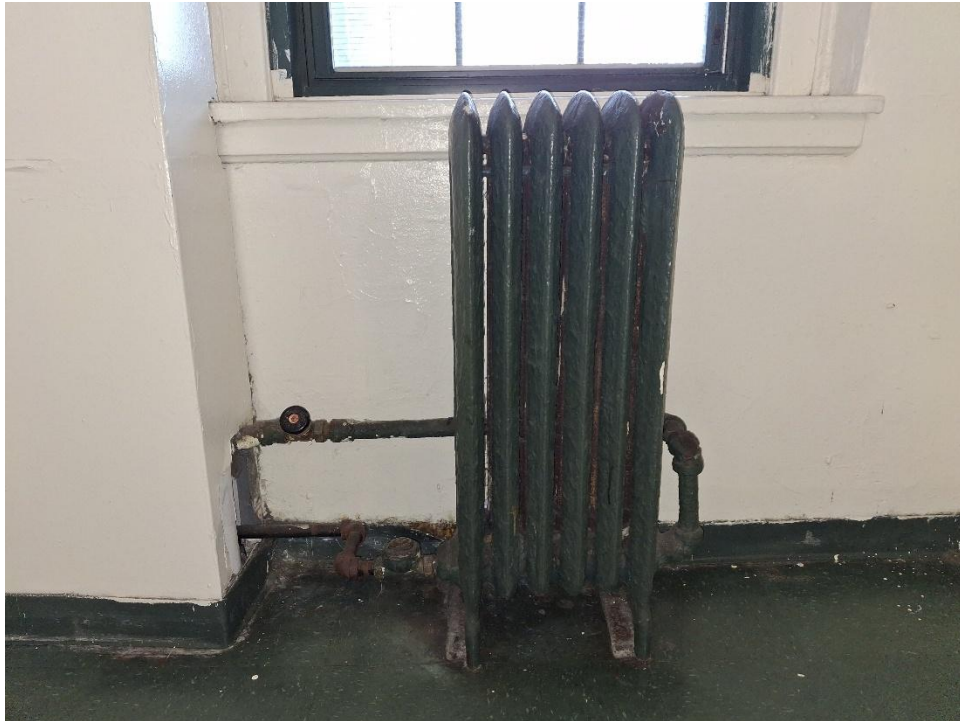
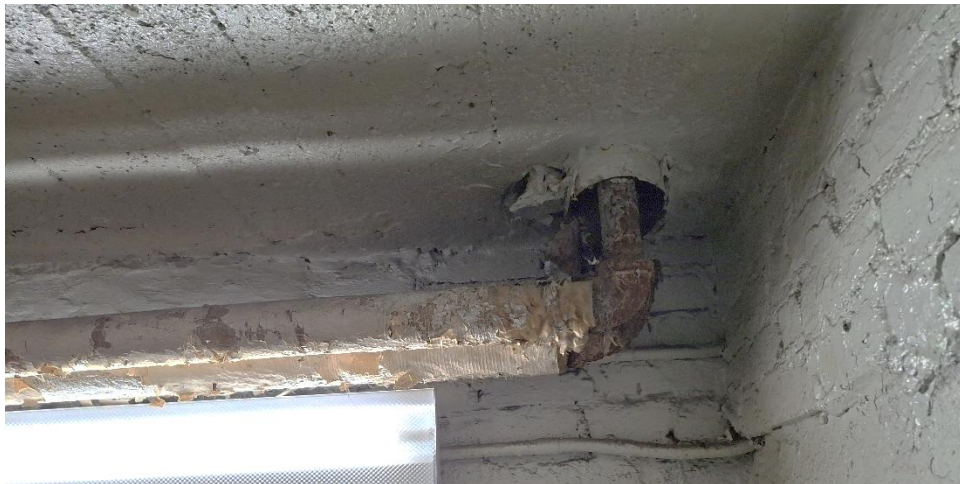
The facility's steam piping and radiators appear to be original to the building, with minimal repairs or upgrades over the years. The piping seems to be in poor condition. The building's maintenance team indicated that they perform a boiler blow-down twice a day.

The existing HVAC systems, including gas-fired boilers, window-mounted air conditioning units, and associated components such as pumps, piping, valves, and controls, have reached the end of their useful life. These systems should be disconnected and removed, including any necessary power and control wiring.

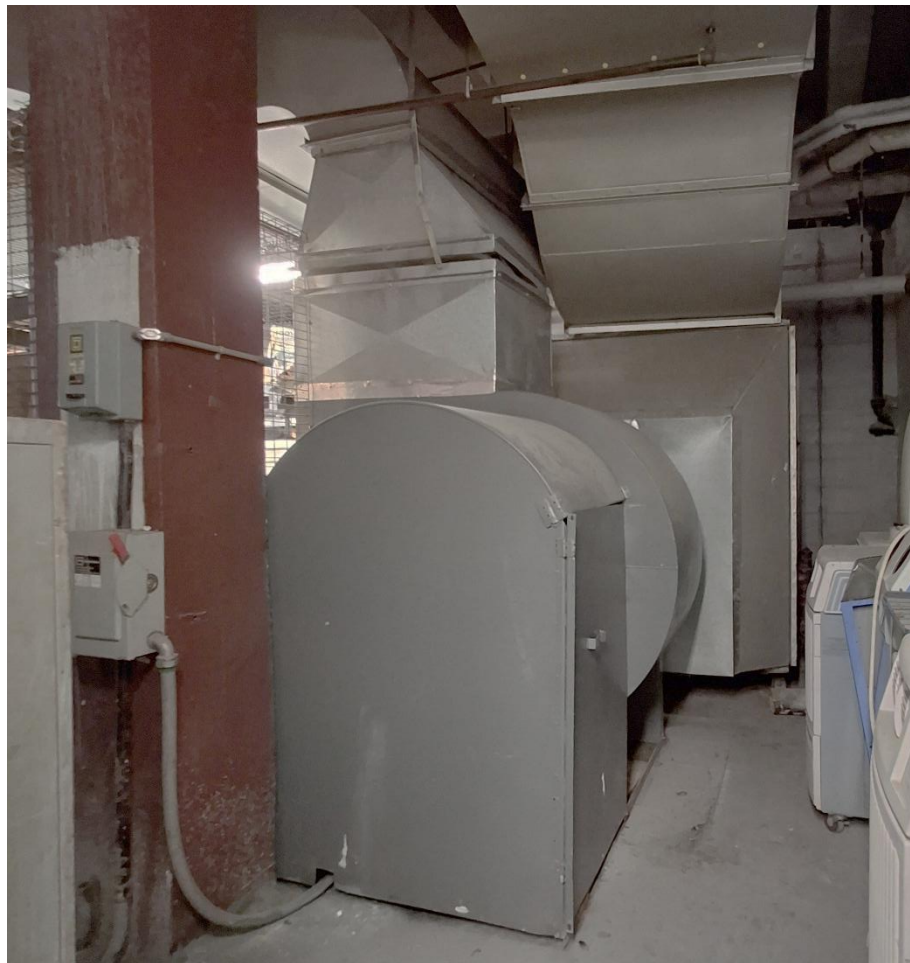
A single zone Heating and Ventilation (HV) unit, located in the basement, provides ventilation throughout the building. The supply fan draws outdoor air from a louver on the roof and discharges conditioned air into shafts on the floors above. The exhaust air is relief via return air openings through another louver on the roof. The steam valve serving the HV unit coil opens when the outside air temperature drops and enabling heating.

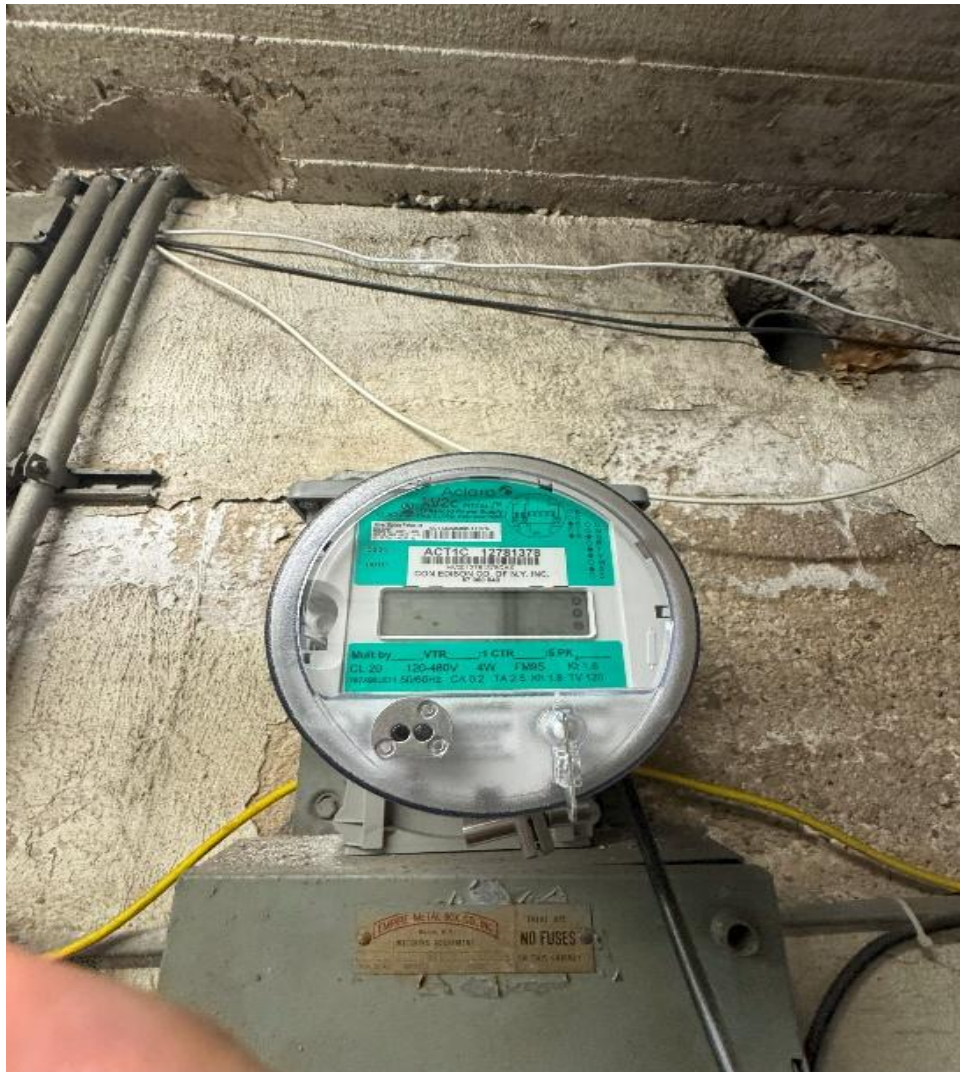
Existing Service Meter

The existing MDP, 208V, 3-Phase, 4-Wire 1200 ampere electrical infrastructure is sized for a warehouse type occupancy with partial office building fit-out undetermined programming. The existing panels located in the corridor and Electrical Service Room have met their useful life. These panels should be replaced in kind with megger tested feeders prior to reconnecting to new replacement panels. The panel replacement and new upgraded service will be based on the facility's final use.

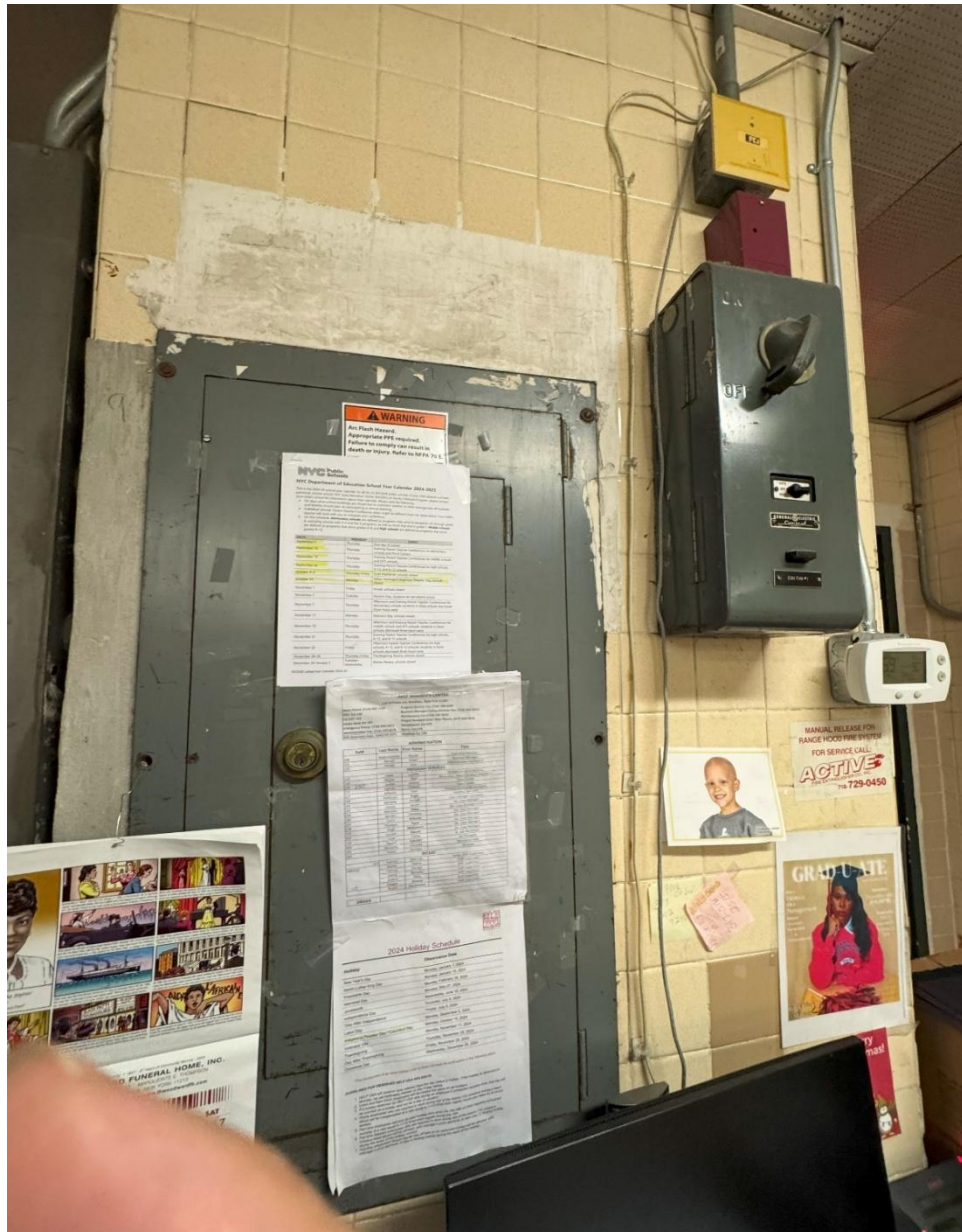
Existing floor corridor panel

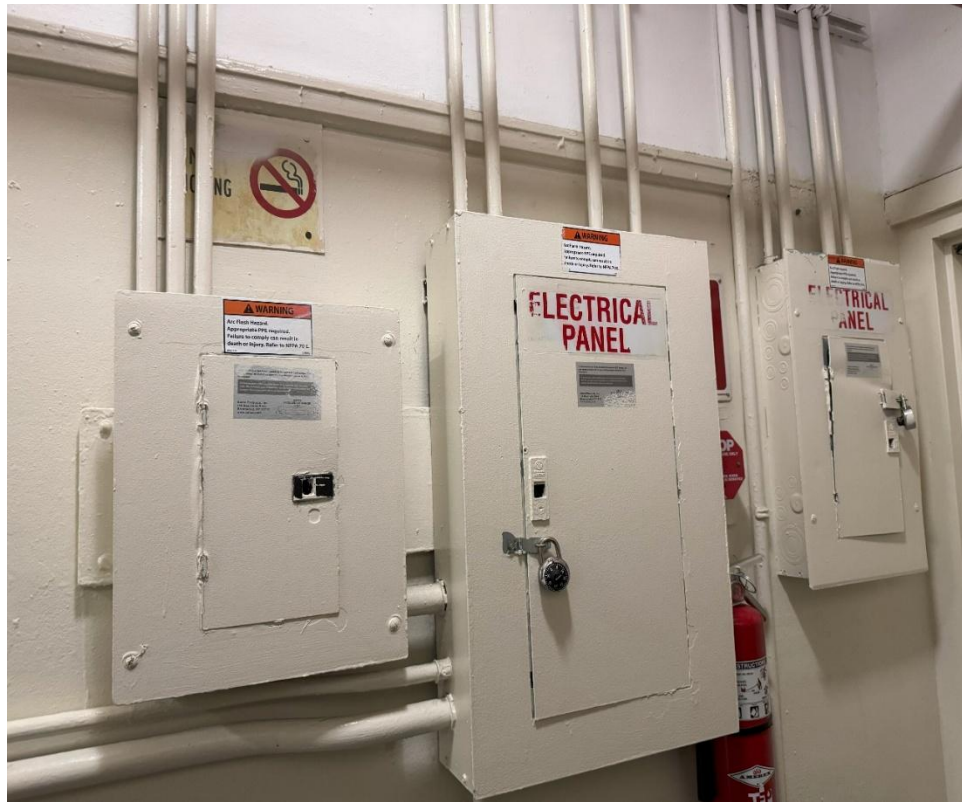
Existing corridor Floor Panels

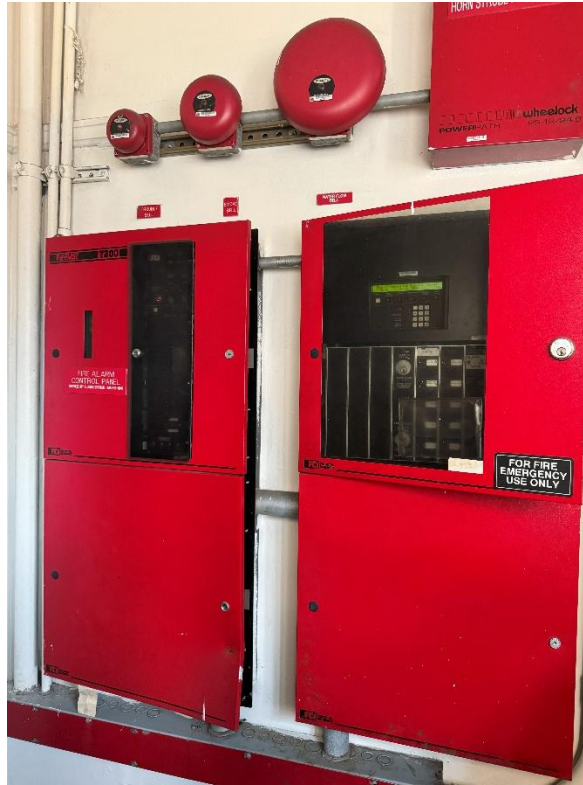
The building manual and automatic smoke, heat and carbon monoxide detection fire alarm system with central station communication is relatively old, in working condition and appears to be installed in 2002. It is an existing FIRE-VAC 7200 system located in an adjacent office at the Main Entrance.

Fire Alarm Control Panel

The fire alarm system shall be replaced with an addressable system to accommodate new potential programming upon an evaluation of the fire alarm system vendor.

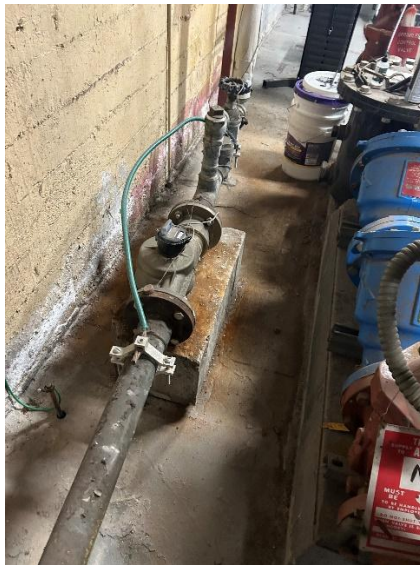
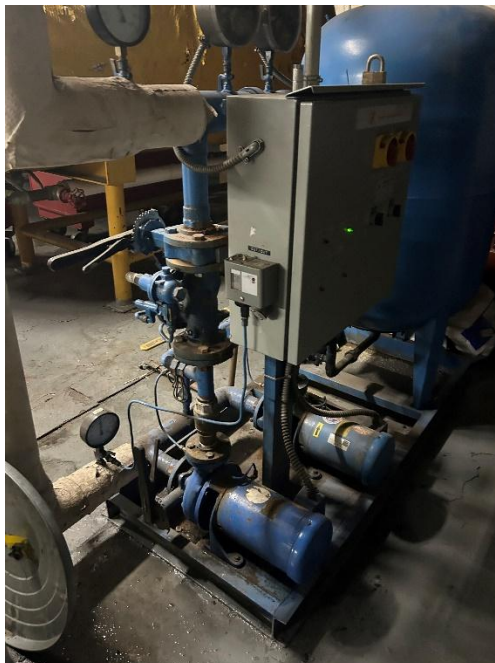
A 3-inch metered domestic water service enters the building from a William Street water main. The water service is not protected by a BFP device as per D.E.P. Cross connection requirements. The water service connects to a duplex water booster system that pressurizes water main and risers serving plumbing fixtures, kitchen equipment and laundry washers. Water piping consists of copper piping with solder joints.

The existing domestic service does not meet the D.E.P. backflow prevention code requirements. The water service will need to be filed with D.E.P. for BFP devices. The existing duplex booster will have to be evaluated due to the loss of incoming pressure. A new hydrant flow test is recommended. All equipment is in fair condition, pumps, heaters, etc. The domestic hot water system will be generated by three options:

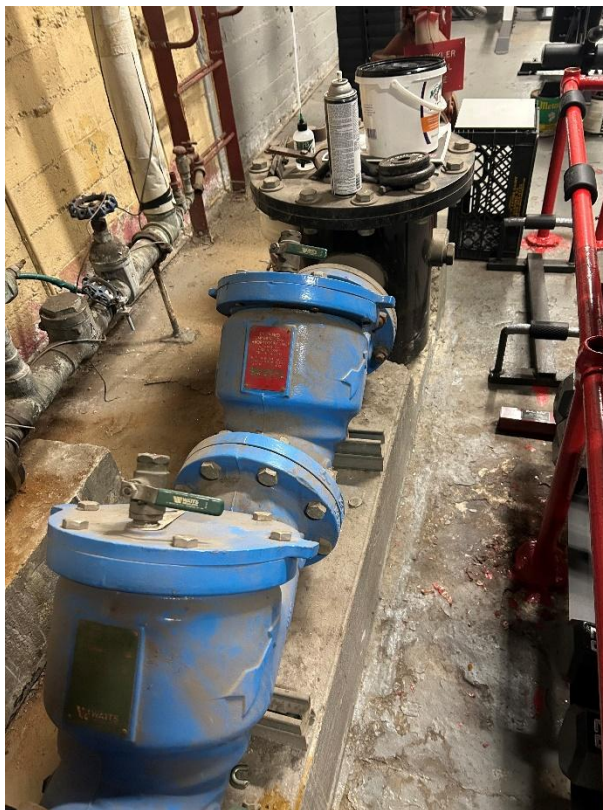
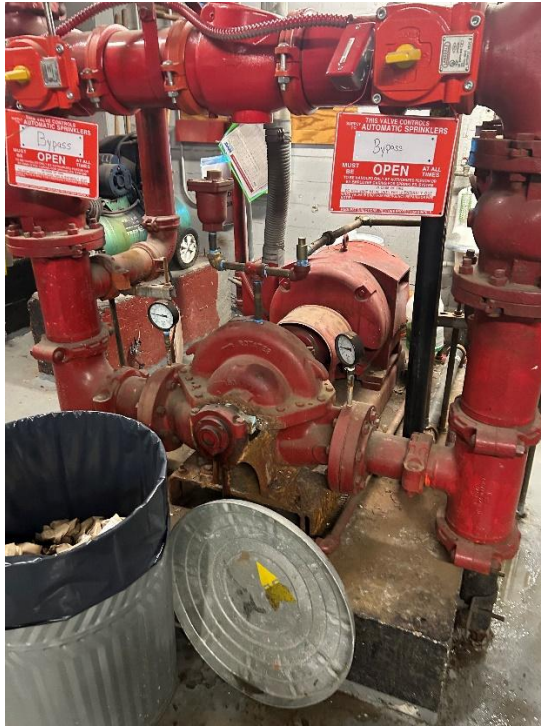
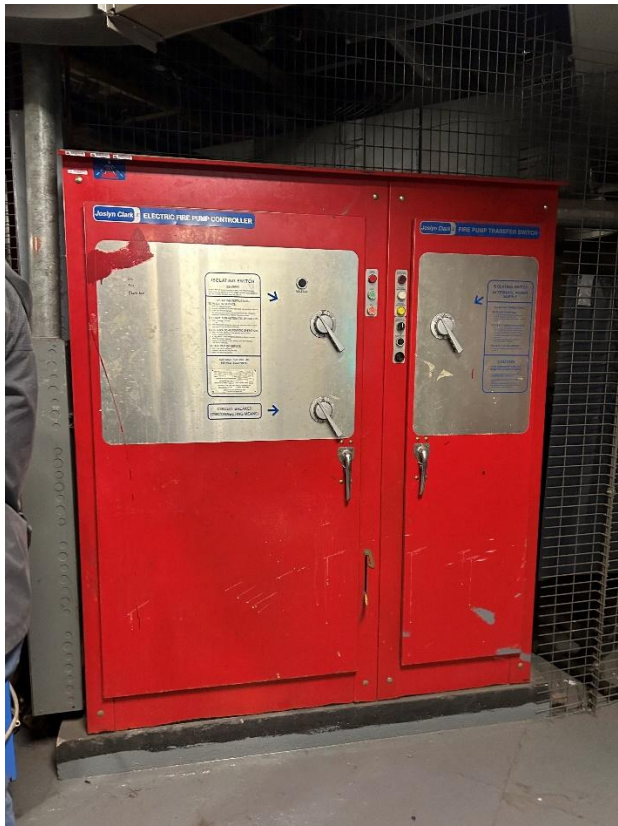
Two 6-inch water services enter the building, one is from William Street, the second is from Hinsdale Street. Both services are cross connected in the basement level to a fire pump, a jockey which connects to sprinkler risers, serving all floors through floor control assemblies. Fire department connections are provided from two streets, William and Hinsdale streets.

The existing fire service does not meet the D.E.P. backflow prevention code requirements. The service will need to be filed with D.E.P. for BFP devices. The existing sprinkler system is in good condition. Under the new code's recommendation, a fire standpipe system should be considered. The standpipe system will need to replace the existing fire pump with a new 100 H.P. pump controller etc. The present sprinkler system can be altered to provide sprinkler protection for light hazards (office) or industrial occupancy.

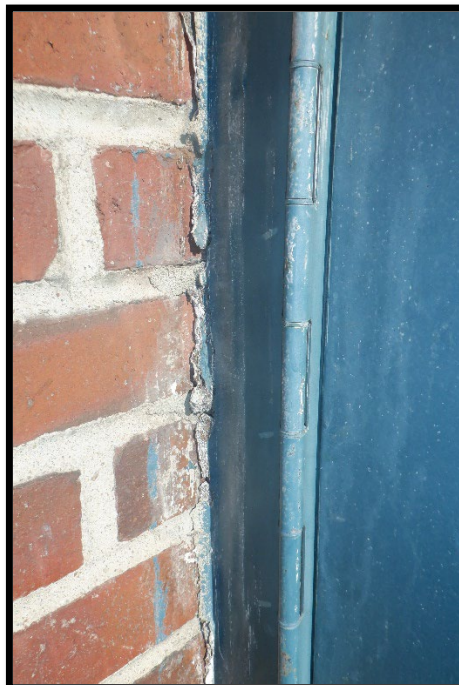
Photo #1: Suspect ACM roofing, flashing, coping stone mastic

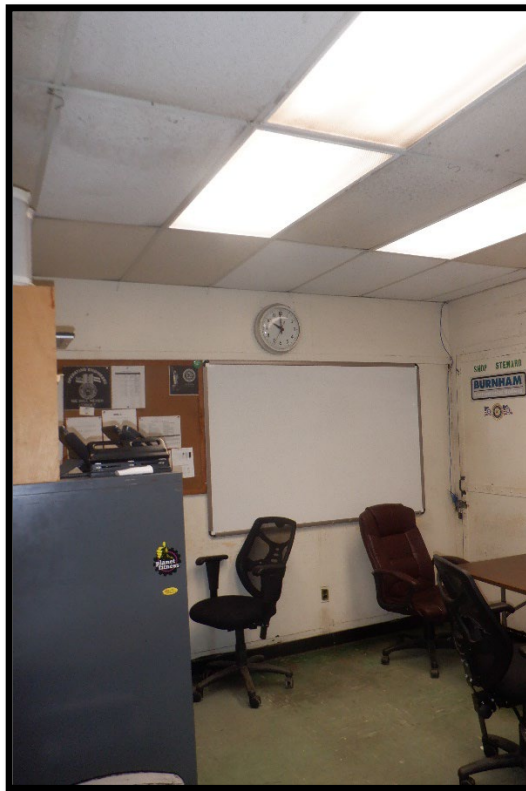
Photo #7: Suspect ACM Flooring and Door Core Insulation
